April 2, 2024

Larry MacDonell
Hillstreet Developments Ltd.
2015 Altona Road
Pickering, ON
L1V 2B9

**Re: Erosion Hazard Assessment
County Road 65, Osaca, Ontario
D.M. Wills Associates Project No. 22-11056**

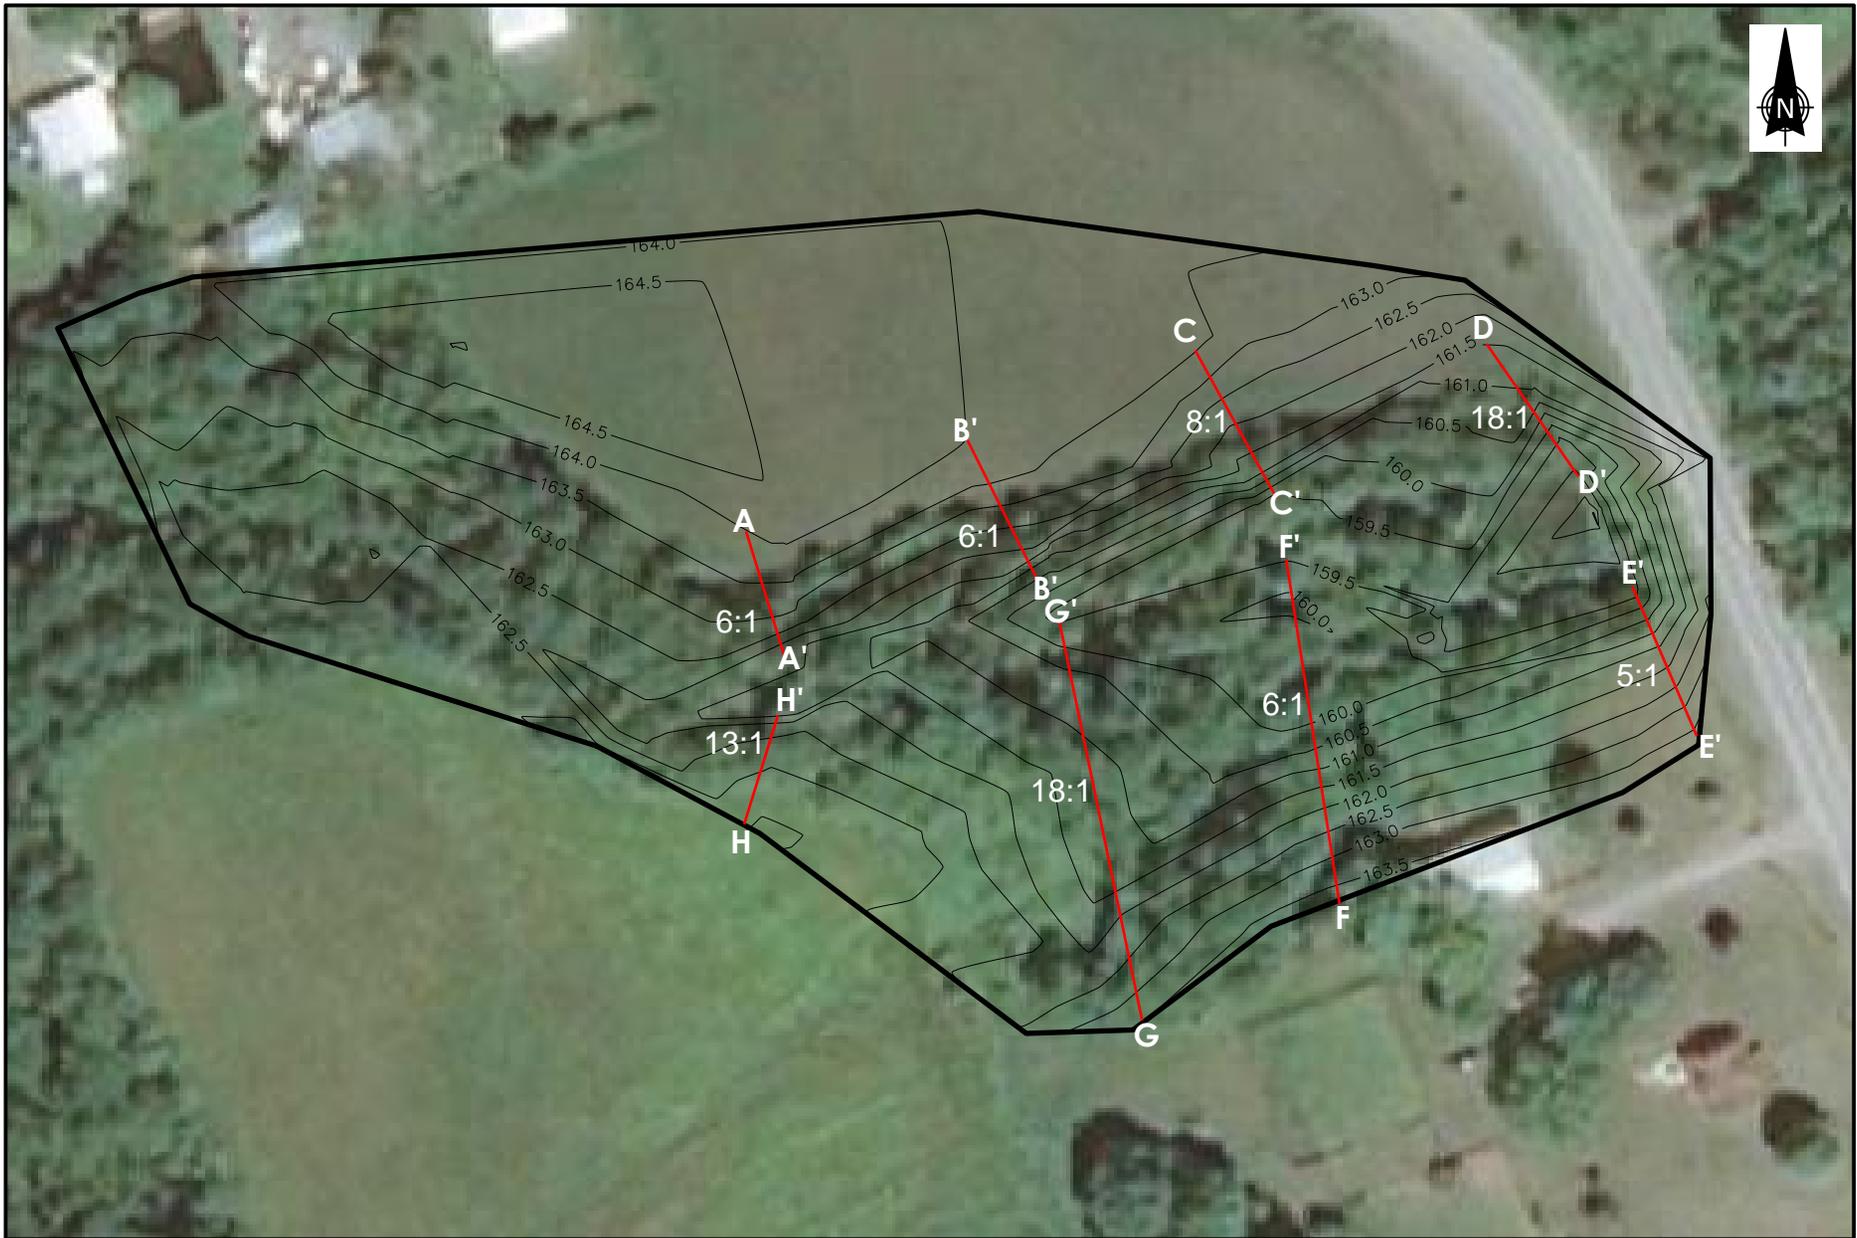
**Subject Slope
Topographic Map**

Eight slope profiles (four per slope) were assessed, and the respective section lines are shown on **Figure 2**. The following is provided with respect to the slope profiles:

- The Subject Slopes are considered stable and maintain slope gradients that range from 5H:1V (Horizontal: Vertical) to 18H:1V.
 - Stable slopes are considered to have gradients equal to or shallower than 3H:1V.

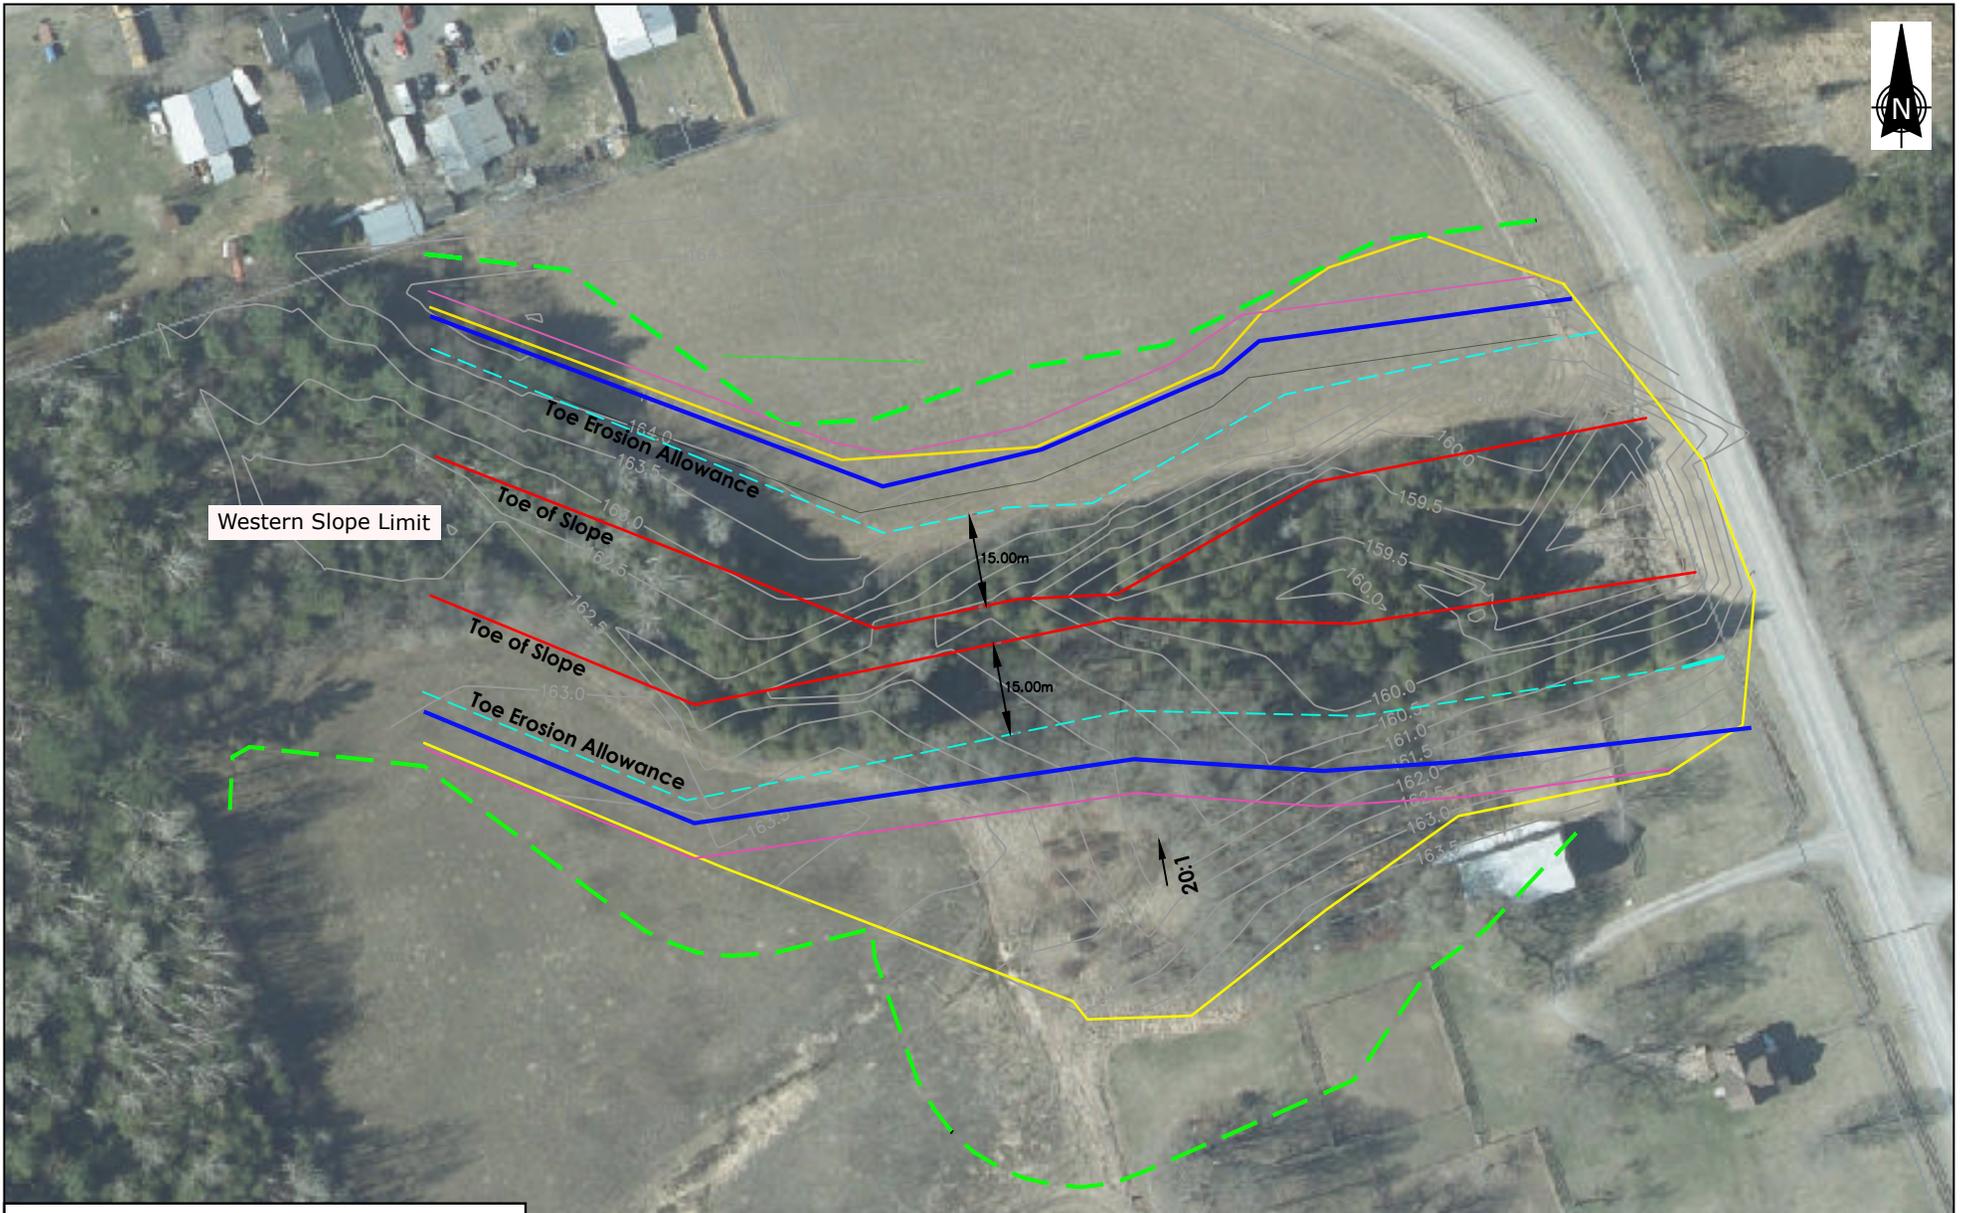
Erosion Hazard Limits
Erosion Hazard Assessment
County Road 65
Osaca, Ontario

- A conservative Toe Erosion Allowance of 15 m was applied based on the Technical Guideline.
 - If using Table 3 of the Technical Guideline, the Toe Erosion allowance could be reduced to 5 m based on a bankfull width between 5-30 m, no evidence of active erosion, and loose granular soils (sand).
- A 3H:1V stable slope allowance was applied from the Toe Erosion Allowance (projected into the shallower existing slope profiles).
 - In view of the existing stable slopes (5H:1V to 18H:1V), the stable slope allowance daylights along the existing slope faces and does not project beyond the physical top of slope.
- An Erosion Access Allowance of 6 m was applied beyond the stable slope allowance.
- In view of the stable slope conditions, all erosion hazard limits are contained within the gently sloping valley walls.

Figure 3 shows the erosion hazard limits, including the physical top of slope, toe of slope, and applicable hazard limits.

It should be noted that both the physical top of slopes and the erosion hazard limits are contained within the proposed 30 m wetland setbacks determined through Wills' Environmental Impact Study (EIS), provided under separate cover. The wetland setbacks are shown on **Figure 3**.

- The applied erosion hazard limits, including the physical top of slopes, are contained within the 30 m wetland buffer conveyed in Wills' EIS report.
- The proposed development is required to stay outside of the identified erosion hazard limits identified in this report.

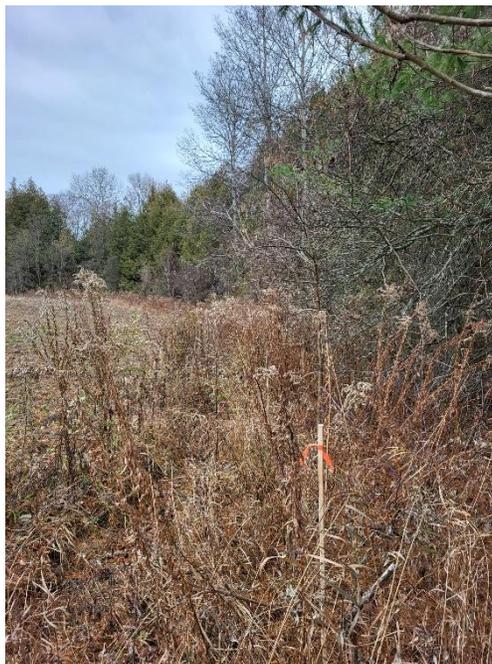
Photograph No.: 1

Top of North Slope –
dense forest along
slope.

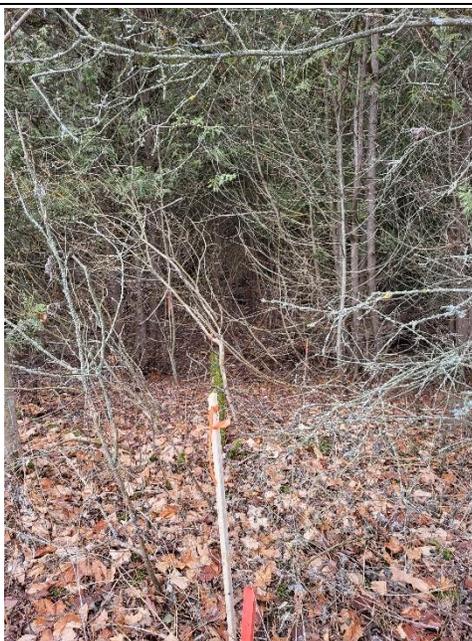
Photograph No.: 2

North Slope top of
slope towards
bottom of slope and
stream.

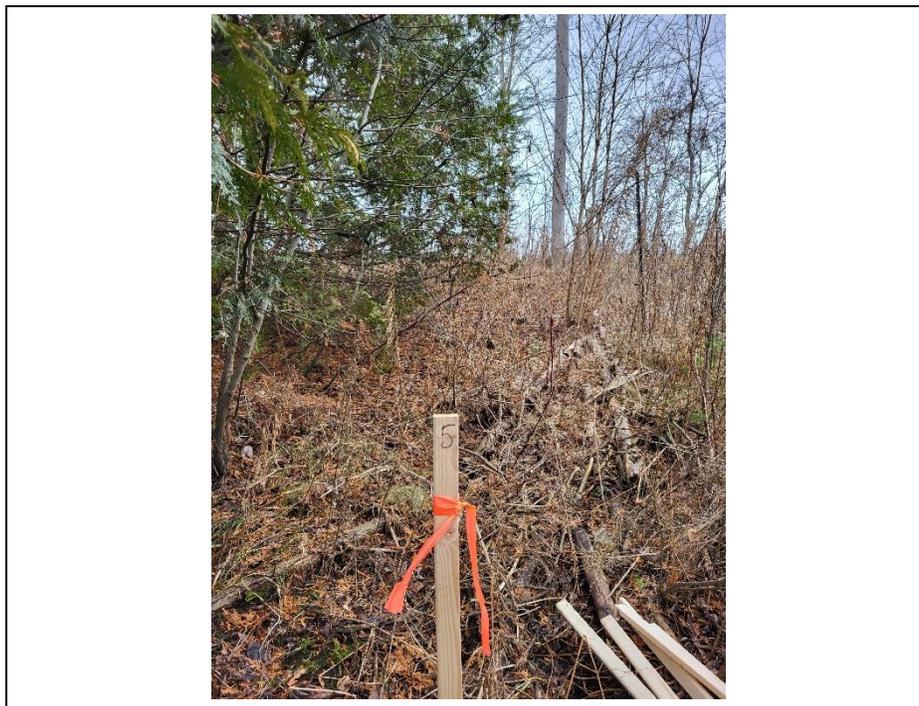
Photograph No.: 3
Date: December 05, 2023
Direction: North
Description: Bottom of North Slope on east boundary of property. Mature trees visible. No signs of erosion.

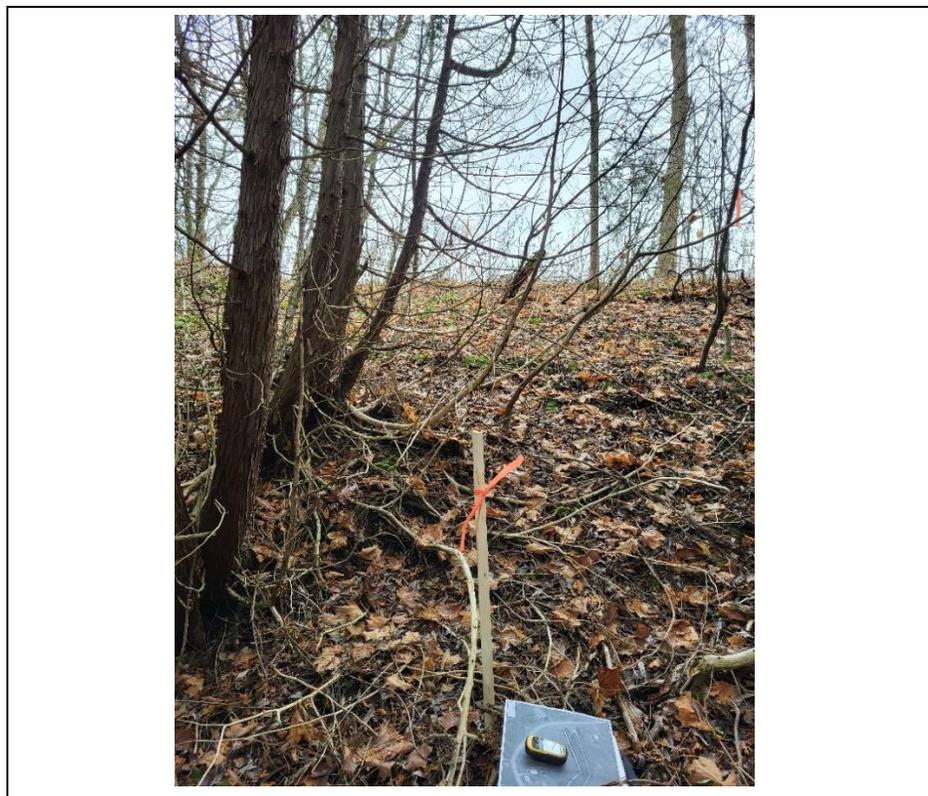
Photograph No.: 4
Date: December 05, 2023
Direction: North
Description: Bottom of North Slope to top of slope. East side of slope proximal to County Road 65.

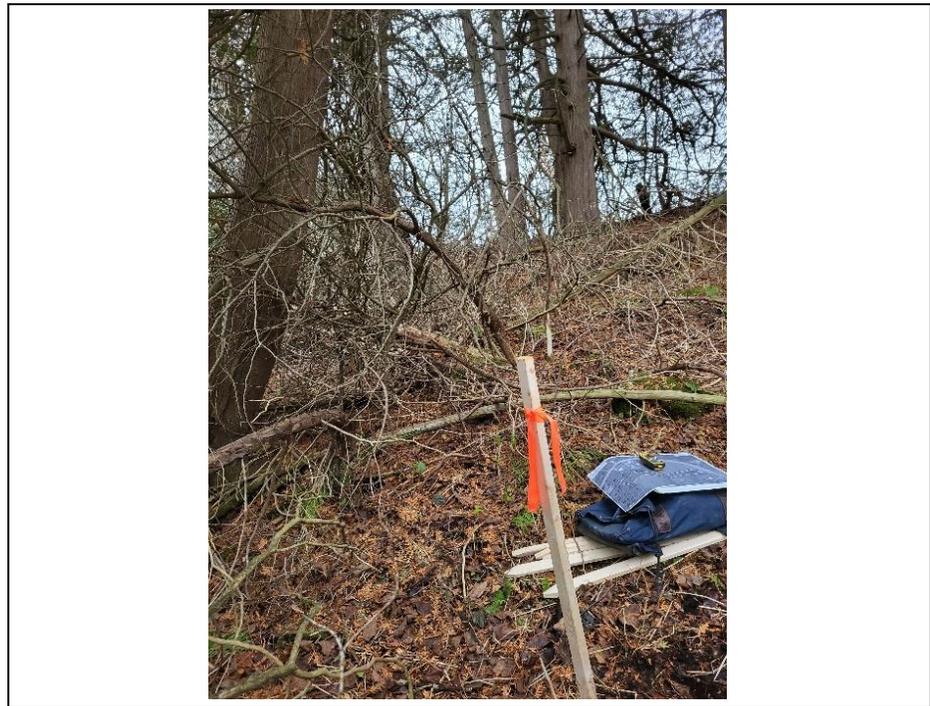
Photograph No.: 5
Date: December 05, 2023
Direction: North
Description: Bottom of North Slope, facing top of slope.

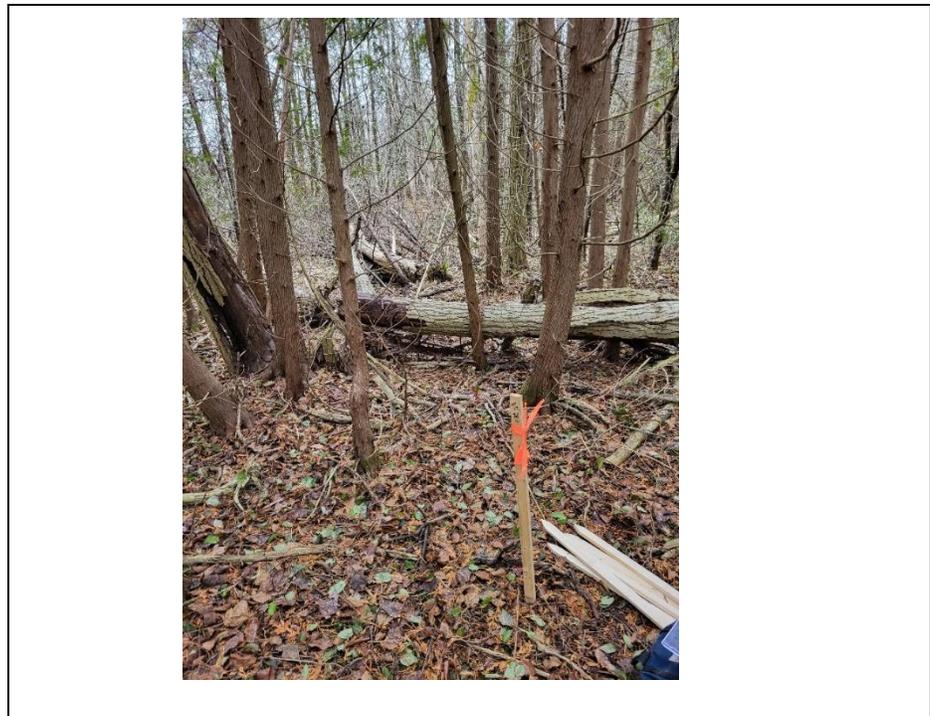
Photograph No.: 6
Date: December 05, 2023
Direction: Northwest
Description: Bottom of North Slope proximal to wetland area on Subject Property. Mature trees visible. Stream is dry. Slope has flattened in this area.

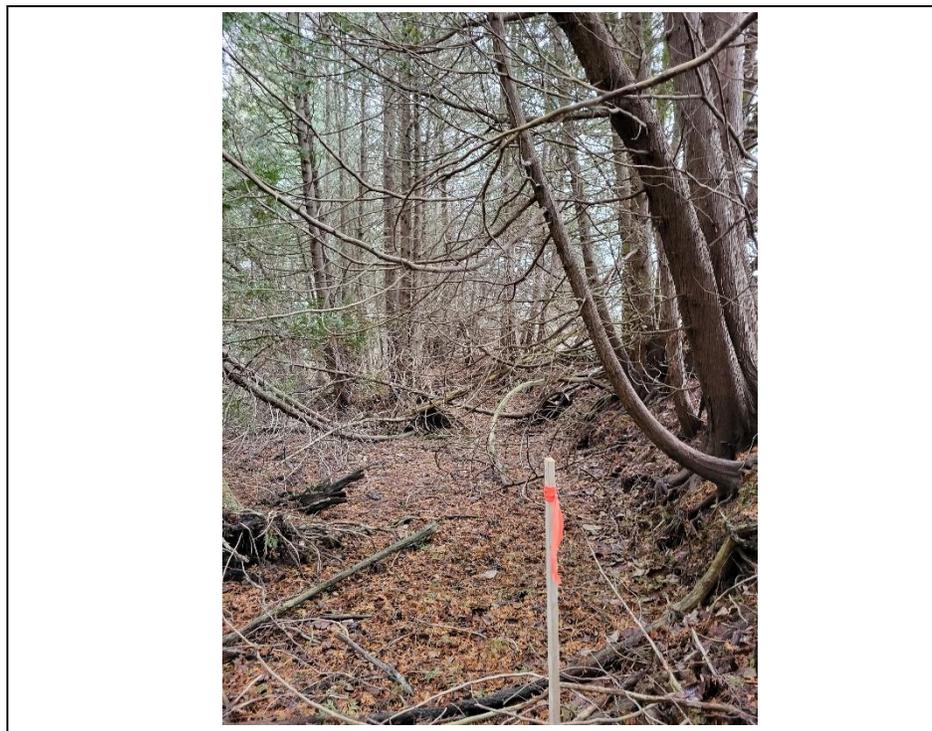
Photograph No.: 7
Date: December 05, 2023
Direction: Northwest
Description: Southern Slope profile. Stream is dry, slope diminishes as it approaches the wetland west of the stream.

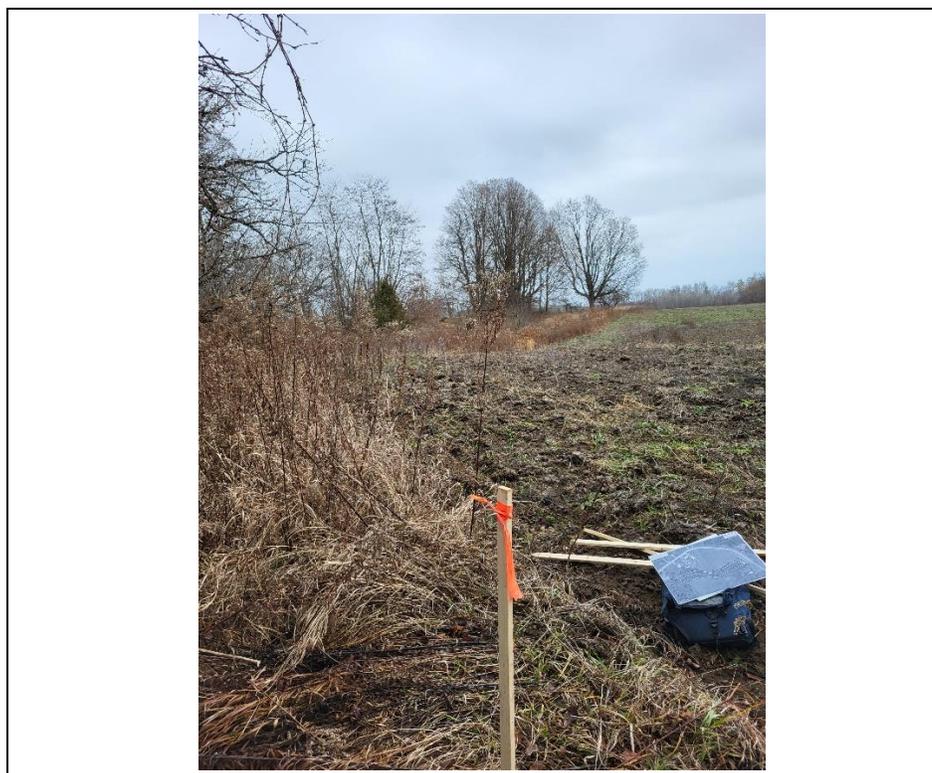
Photograph No.: 8
Date: December 05, 2023
Direction: Southeast
Description: Top of South Slope, highly vegetated area on the left side of photograph is the location of the Subject Slope.

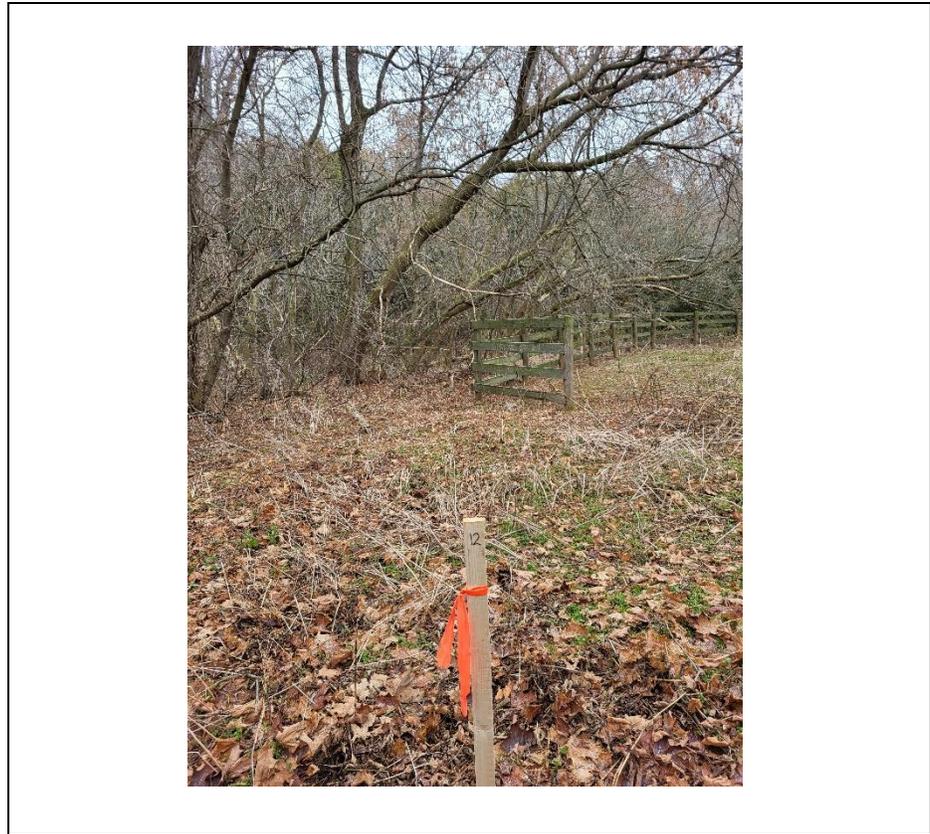
Photograph No.: 9
Date: December 05, 2023
Direction: East
Description: Top of South Slope proximal to County Road 65. Subject Slope flattens in this area towards an existing barn.

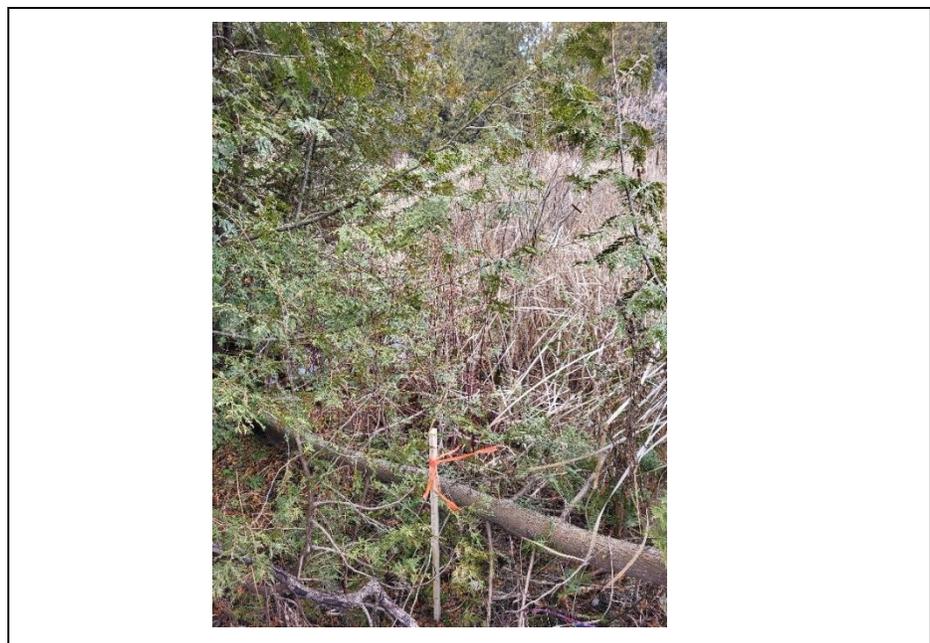
Photograph No.: 10
Date: December 05, 2023
Direction: South
Description: Bottom of South Slope in proximity to County Road 65 looking towards top of slope. Slope is heavily vegetated.

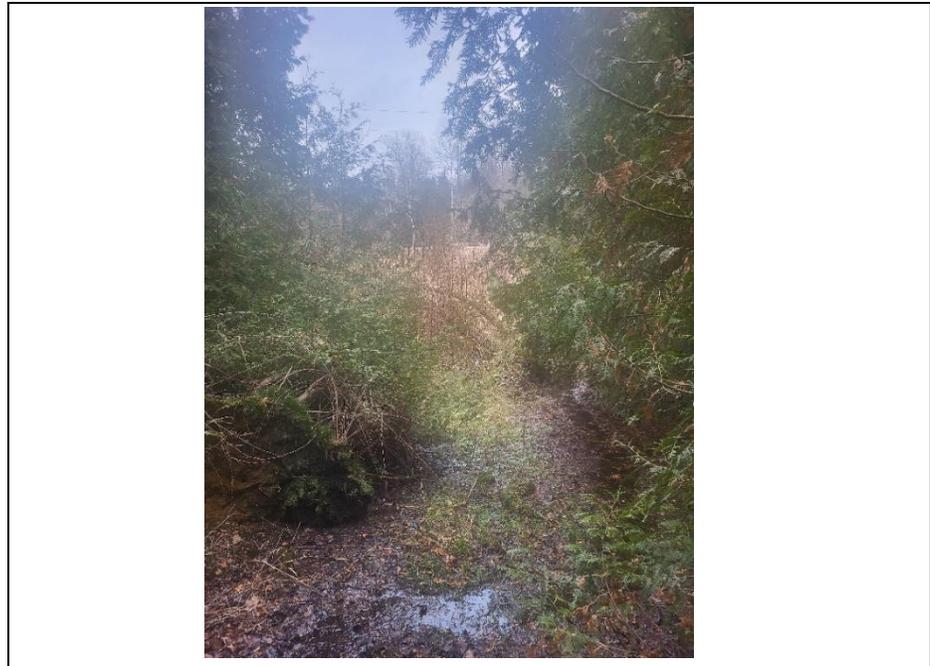
Photograph No.: 11
Date: December 12, 2023
Direction: East
Description: Photo of the stream area that contained surface water at the time of the inspection.

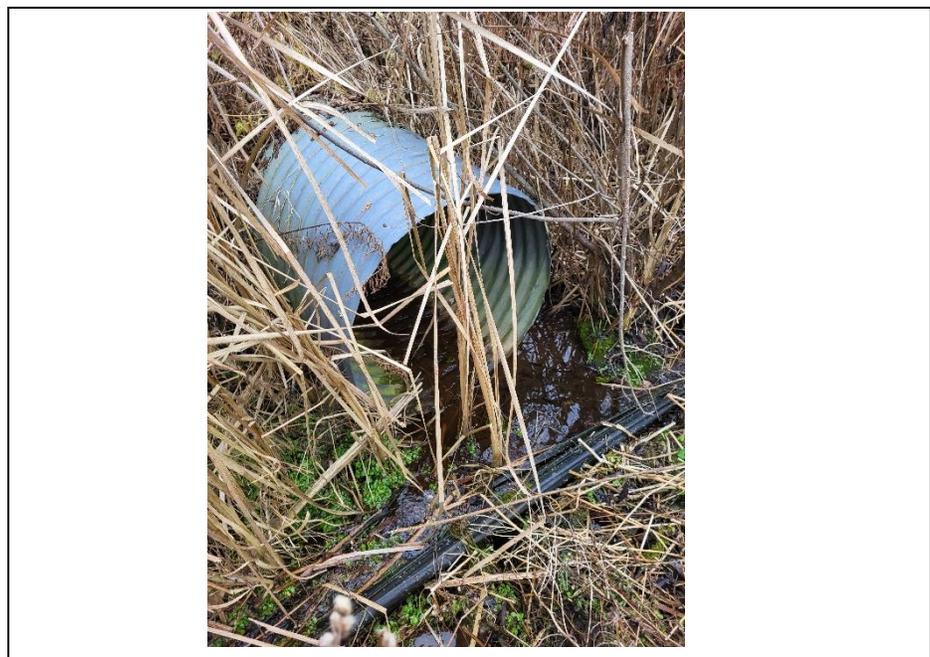
Photograph No.: 12
Date: December 05, 2023
Direction: East
Description: Photo of the inlet culvert on the Subject Property.
