**ARBORIST REPORT
&
TREE PROTECTION PLAN**

39 PINE STREET

Port Hope, ON,
L1A 3G5

Date: July 2, 2024

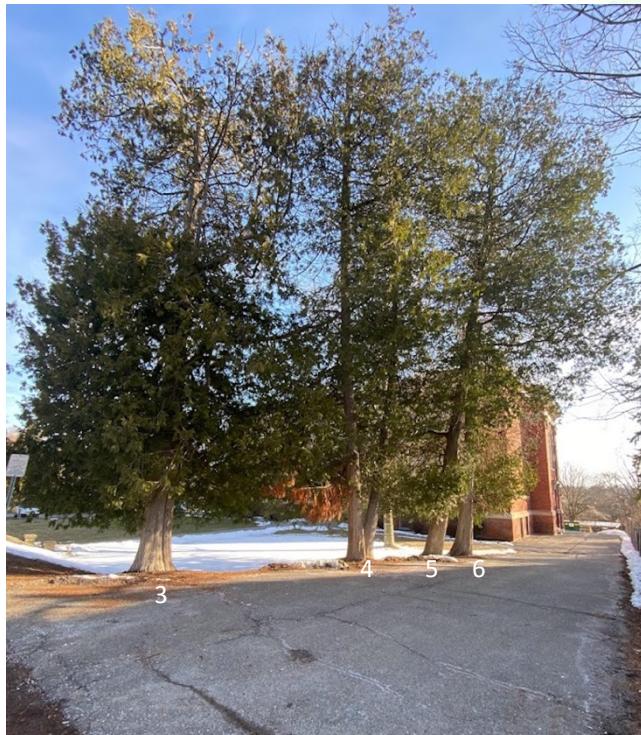
Photo 3. Trees 3-6.

Tree #	Common Name	Botanical Name	DBH (cm)	Trunk Integrity	Crown Structure	Vitality	Overall Rating	Location	Drip Line Diameter (m)	TPZ (m)	Condition Comments	Action
3	Eastern White Cedar	<i>Thuja occidentalis</i>	58	Fair	Fair	Fair	Fair	Private	10	3.6	Missing bark at the base, topped crown, fair health	Injure: excavation for water chamber at edge of TPZ; removal and replacement of asphalt driveway 0.8m from tree, 34% of TPZ.
4	Eastern White Cedar	<i>Thuja occidentalis</i>	42, 37 [56]	Fair	Fair	Fair	Fair	Private	9	3.6	Double stems, slight lean, multiple dead branches	Injure: excavation for water chamber at edge of TPZ; removal and replacement of asphalt driveway 0.8m from tree, 34% of TPZ.
5	Eastern White Cedar	<i>Thuja occidentalis</i>	52	Fair	Fair	Good	Good	Private	8	3.6	Lean, topped crown, fair health	Injure: excavation for water chamber at edge of TPZ; removal and replacement of asphalt driveway 0.65m from tree, 34% of TPZ.

4.1 WATER CHAMBER EXCAVATION, REMOVAL AND REPLACEMENT OF ASPHALT DRIVEWAY: TREES 3, 4, 5, 6

A WATER CHAMBER IS PROPOSED IN THE EXISTING DRIVEWAY ON THE WEST SIDE OF THE PROPERTY. INSIDE THE TPZs OF TREES 3, 4, 5, 6, REMOVAL OF THE EXISTING ASPHALT IS TO BE CARRIED OUT AS FOLLOWS:

4.1.1 UNDER THE SUPERVISION OF A QUALIFIED ARBORIST

4.1.2 THE ASPHALT DRIVEWAY MUST REMAIN IN PLACE, AS IS, INSIDE THE TPZs OF THE ADJACENT TREES, UNTIL CONSTRUCTION OF THE NEW BUILDING AND ALL SITE GRADING IS COMPLETE. THE DRIVEWAY WILL SERVE TO DISPERSE LOADS ABOVE AND PROTECT ANY TREE ROOTS BELOW THE ASPHALT.

4.1.3 THE ASPHALT IS TO BE CLEANLY CUT AT THE PERIMETER REQUIRED FOR INSTALLATION OF THE CHAMBER. ANY EXPOSED ROOTS ARE TO BE REVIEWED BY THE ARBORIST AND IF THE ARBORIST DETERMINES THAT THE HEALTH AND STRUCTURAL INTEGRITY OF THE TREES WILL NOT BE COMPROMISED, THE ROOTS ARE TO BE CLEANLY CUT.

4.1.4 FOLLOWING INSTALLATION OF THE CHAMBER AND SERVICES, THE ENTIRE DRIVEWAY, INCLUDING INSIDE THE TPZs MAY BE REMOVED AND REPLACED.

4.1.5 INSIDE OF TPZs, THE EXISTING ASPHALT IS TO BE REMOVED BY HAND DUE TO THE PROXIMITY TO THE BASE OF THE TREES. SCREENINGS BELOW MAY BE REMOVED BY HAND OR REMAIN IN PLACE. THERE IS TO BE NO CHANGE IN GRADE INSIDE THE TPZs.

4.1.6 THERE IS TO BE NO CONSTRUCTION ACCESS ON TOP OF BARE SOIL OR SCREENINGS INSIDE OF TPZs. IF ACCESS IS REQUIRED THROUGH THE DRIVEWAY PRIOR TO INSTALLING THE NEW ASPHALT SURFACE, THEN HORIZONTAL TREE PROTECTION MUST BE PLACED ON THE GROUND TO PROTECT TPZs. HORIZONTAL TREE PROTECTION MAY CONSIST OF INDUSTRIAL MATS, STEEL PLATES, BIAxIAL GEOGRID, OR OTHER AS APPROVED BY THE MUNICIPALITY.

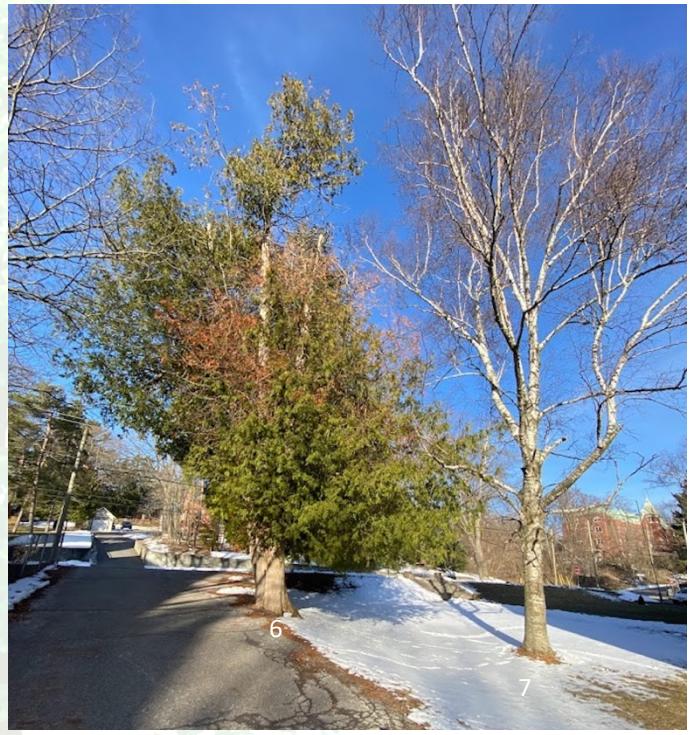
Photo 4. Trees 6 and 7.

6	Eastern White Cedar	<i>Thuja occidentalis</i>	45, 40 [64]	Fair	Poor	Poor	Poor	Private	8	4.2	Significant dieback, dead branches, chlorosis	Injure: excavation for water chamber at edge of TPZ; removal and replacement of asphalt driveway 0.35m from tree, 45% of TPZ.
7	White Birch	<i>Betula papyrifera</i>	45	Good	Good	Good	Good	Private	10	3	Minor dead branches	Protect
8	Norway Maple	<i>Acer platanoides</i>	39	Good	Good	Good	Good	Neighbour	9	2.4	Minor dead branches	Protect
9	Red oak	<i>Quercus rubra</i>	70	Good	Good	Good	Good	Neighbour	13	4.2	Minor dead branches	Protect

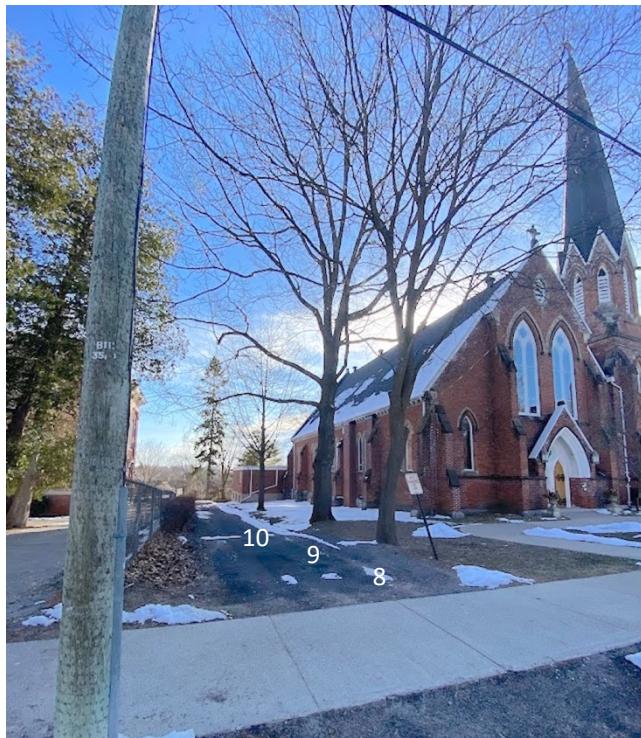
Photo 5. Trees 8 – 10.

Tree #	Common Name	Botanical Name	DBH (cm)	Trunk Integrity	Crown Structure	Vitality	Overall Rating	Location	Drip Line Diameter (m)	TPZ (m)	Condition Comments	Action
10	Red oak	<i>Quercus rubra</i>	41	Good	Good	Good	Good	Neighbour	8	3	Minor dead branches	Protect
11	White Spruce	<i>Picea glauca</i>	46	Good	Good	Good	Good	Neighbour	6	3	Minor dead branches	Injure: Retaining wall removal and replacement 2.1m from tree, 7% of TPZ.
12	Elm	<i>Ulmus sp.</i>	20	NA	NA	NA	Dead	Neighbour		n/a		Remove (dead): retaining wall excavation up to base of tree.
13	Elm	<i>Ulmus sp.</i>	15	NA	NA	NA	Dead	Boundary		n/a		Remove (dead): retaining wall excavation up to base of tree.
14	American Elm	<i>Ulmus americana</i>	45	Good	Good - Fair	Good	Good	Boundary	9	3	Codominant stem, bark included	Remove: retaining wall excavation up to base of tree.
15	Norway Maple	<i>Acer platanoides</i>	17	Good	Good	Good	Good	Neighbour	4	1.8	Minor dead branches	Remove: retaining wall excavation 0.8m to tree, close to base.

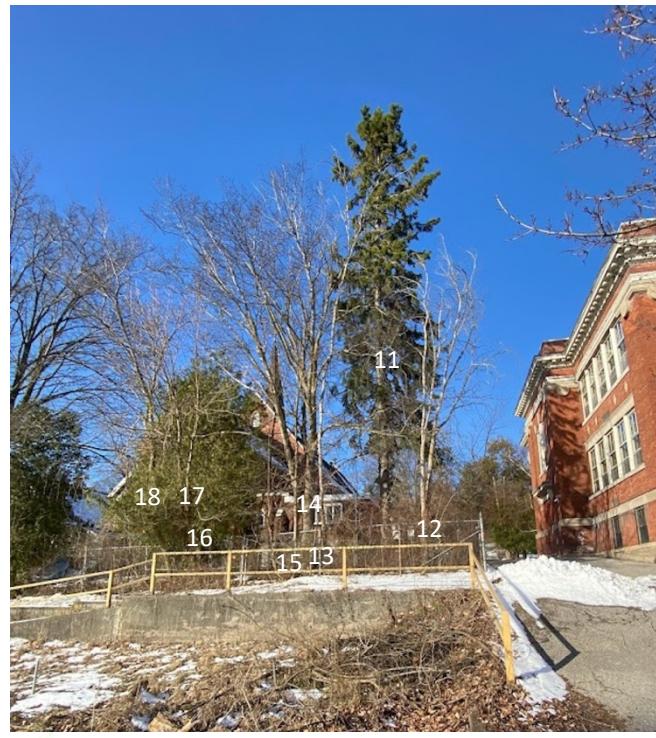
Photo 6. Trees 11 – 18.

16	Eastern White Cedar	<i>Thuja occidentalis</i>	22	Fair	Fair	Fair	Fair	Neighbour	5	1.8	Close to the fence.	Remove: retaining wall excavation 0.25m to tree, up to base.
17	White Ash	<i>Fraxinus americana</i>	17	Fair	Fair	Fair	Fair	Boundary	4	1.8	Girdled with metal fence.	Remove: retaining wall excavation up to base of tree.
18	White Ash	<i>Fraxinus americana</i>	18	Fair	Good	Good	Good	Boundary	5	1.8	Minor dead branches	Remove: retaining wall excavation up to base of tree.
19	White Pine	<i>Pinus strobus</i>	21	Fair	Fair	Poor	Poor	Neighbour	5	1.8	Declining health, appears to have fungal infection.	Protect

4.2 RETAINING WALL REMOVAL AND REPLACEMENT: TREE 11 AND 36.

THE EXISTING RETAINING WALL ALONG THE WEST SIDE OF THE PROPERTY IS TO BE REMOVED AND REPLACED. THE TPZs OF TREES 11 AND 36 EXTEND OVER THE WALL. REMOVAL AND REPLACEMENT OF THE WALL INSIDE THE TPZ IS TO BE CARRIED OUT AS FOLLOWS:

4.2.1 REMOVAL OF THE WALL INSIDE THE TPZs MUST BE COMPLETED UNDER ARBORIST SUPERVISION.

4.2.2 REMOVAL OF THE WALL IS TO BE CARRIED OUT USING A BUCKET TO PULL THE WALL FROM THE ADJACENT SOIL. AT NO POINT IS THE BUCKET TO DIG INTO THE ADJACENT SOIL.

4.2.3 THE ARBORIST IS TO ASSESS IF THE ROOT DISTURBANCE IS LIKELY TO AFFECT THE HEALTH OR STRUCTURAL STABILITY OF THESE TREES. IF THE DETERMINATION IS THAT THE TREES CAN BE RETAINED, ANY EXPOSED ROOTS ARE TO BE CLEANLY PRUNED. IT IS RECOMMENDED THAT ANY EXPOSED ROOTS ARE IMMEDIATELY COVERED WITH 4-6" OF SOIL OR WET BURLAP, AND COVERED/SECURED IN PLACE TO PREVENT DRYING.

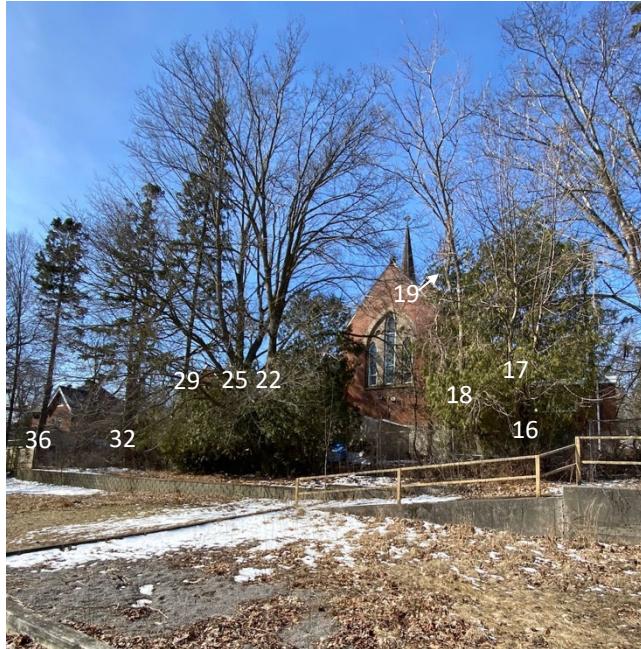
Photo 7. Trees 16 – 36.

Tree #	Common Name	Botanical Name	DBH (cm)	Trunk Integrity	Crown Structure	Vitality	Overall Rating	Location	Drip Line Diameter (m)	TPZ (m)	Condition Comments	Action
20	Eastern White Cedar	<i>Thuja occidentalis</i>	10	Good	Good	Good	Good	Neighbour	4	1.8	Minor dead branches	Remove: retaining wall excavation up to base of tree.
21	Eastern White Cedar	<i>Thuja occidentalis</i>	18	Good	Good	Good	Good	Neighbour	5	1.8	Minor dead branches	Remove: retaining wall excavation up to base of tree.
22	American Elm	<i>Ulmus americana</i>	56	Good	Good	Good	Good	Neighbour	9	3.6	Codominant stems, minor dead branches	Remove: retaining wall excavation up to base of tree.
23	American Elm	<i>Ulmus americana</i>	17	Good	Good	Good	Good	Neighbour	5	1.8		Remove: retaining wall excavation 0.25m to tree, close to base.
24	American Elm	<i>Ulmus americana</i>	10	Good	Fair	Fair	Fair	Neighbour	5	1.8		Remove: retaining wall excavation up to base of tree.

25	Sugar Maple	<i>Acer saccharum</i>	69	Good	Good	Good	Good	Neighbour	12	4.2		Remove: retaining wall excavation up to base of tree.
26	Eastern White Cedar	<i>Thuja occidentalis</i>	13	Good	Good	Good	Good	Neighbour	4	1.8		Remove: retaining wall excavation 0.35m to tree, close to base.
27	Eastern White Cedar	<i>Thuja occidentalis</i>	10	Good	Good	Good	Good	Neighbour	4	1.8		Remove: retaining wall excavation up to base of tree.
28	Eastern White Cedar	<i>Thuja occidentalis</i>	12	Good	Good	Good	Good	Neighbour	5	1.8		Remove: retaining wall excavation up to base of tree.
29	White Spruce	<i>Picea glauca</i>	33	Good	Good	Good	Good	Neighbour	6	2.4		Remove: retaining wall excavation up to base of tree.

Tree #	Common Name	Botanical Name	DBH (cm)	Trunk Integrity	Crown Structure	Vitality	Overall Rating	Location	Drip Line Diameter (m)	TPZ (m)	Condition Comments	Action
30	Sugar Maple	<i>Acer saccharum</i>	11	Good	Good	Good	Good	Boundary	4	1.8		Remove: retaining wall excavation up to base of tree.
31	Sugar Maple	<i>Acer saccharum</i>	13	Good	Good	Good	Good	Boundary	4	1.8		Remove: retaining wall excavation up to base of tree.
32	White Spruce	<i>Picea glauca</i>	29	Good	Good	Good	Good	Neighbour	6	1.8		Remove: retaining wall excavation up to base of tree.
33	Chokecherry	<i>Prunus virginiana</i>	12	Fair	Fair	Fair	Fair	Neighbour	4	1.8	Minor dead branches	Remove: retaining wall excavation 0.5m to tree, close to base.
34	Black Walnut	<i>Juglans nigra</i>	70	Good	Good	Good	Good	Neighbour	14	4.2		Protect
35	Norway Maple	<i>Acer platanoides</i>	40-45	Good	Good	Good	Good	Neighbour	11	3		Protect
36	White Spruce	<i>Picea glauca</i>	45-50	Good	Good	Good	Good	Neighbour	9	3		Injure: Retaining wall removal and replacement 1.7m from tree, 6% of TPZ.

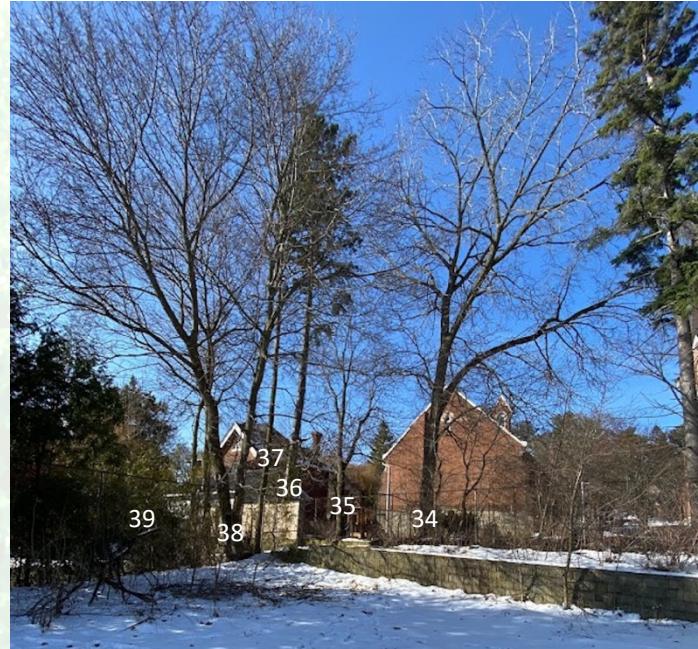
Photo 8. Trees 34 – 39.

37	Elm	<i>Ulmus sp.</i>	22	Good	Good	Good	Good	Neighbour	6	1.8		Injure: Retaining wall removal and replacement 1.6m from tree, 2% of TPZ.
38	Norway Maple	<i>Acer platanoides</i>	41, 30	Good	Good	Good	Good	Neighbour	13	3		Injure: removal of retaining wall, grading; no disturbance to retaining wall on south p. line.
39	Eastern White Cedar	<i>Thuja occidentalis</i>	2-5	Good	Good	Good	Good	Neighbour	2	1.2		Injure: removal of retaining wall, grading; no disturbance to retaining wall on south p. line.

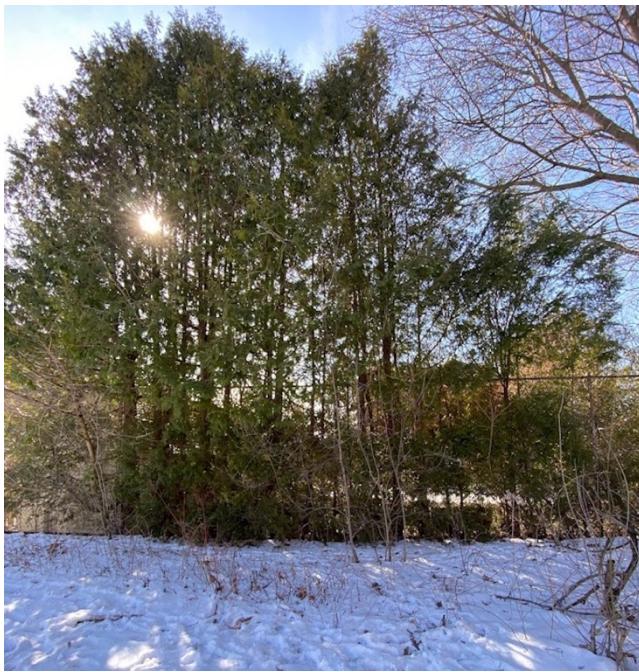
Photo 9. Trees 40 -50.

Tree #	Common Name	Botanical Name	DBH (cm)	Trunk Integrity	Crown Structure	Vitality	Overall Rating	Location	Drip Line Diameter (m)	TPZ (m)	Condition Comments	Action
40	Eastern White Cedar	<i>Thuja occidentalis</i>	10-15	Good	Good	Good	Good	Neighbour	5	1.8		Injure: removal of retaining wall, grading; no disturbance to retaining wall on south p. line.
41	Eastern White Cedar	<i>Thuja occidentalis</i>	10-15	Good	Good	Good	Good	Neighbour	5	1.8		Injure: removal of retaining wall, grading; no disturbance to retaining wall on south p. line.
42	Eastern White Cedar	<i>Thuja occidentalis</i>	10-15	Good	Good	Good	Good	Neighbour	5	1.8		Injure: removal of retaining wall, grading; no disturbance to retaining wall on south p. line.
43	Eastern White Cedar	<i>Thuja occidentalis</i>	10-15	Good	Good	Good	Good	Neighbour	6	1.8		Injure: removal of retaining wall, grading; no disturbance to retaining wall on south p. line.

44	Eastern White Cedar	<i>Thuja occidentalis</i>	10-15	Good	Good	Good	Good	Neighbour	5	1.8		Injure: removal of retaining wall, grading; no disturbance to retaining wall on south p. line.
45	Eastern White Cedar	<i>Thuja occidentalis</i>	15-20	Good	Good	Good	Good	Neighbour	5	1.8		Injure: removal of retaining wall, grading; no disturbance to retaining wall on south p. line.
46	Eastern White Cedar	<i>Thuja occidentalis</i>	10-15	Good	Good	Good	Good	Neighbour	5	1.8		Injure: removal of retaining wall, grading; no disturbance to retaining wall on south p. line.
47	Eastern White Cedar	<i>Thuja occidentalis</i>	15-20	Good	Good	Good	Good	Neighbour	5	1.8		Injure: removal of retaining wall, grading; no disturbance to retaining wall on south p. line.
48	Eastern White Cedar	<i>Thuja occidentalis</i>	10-15	Good	Good	Good	Good	Neighbour	5	1.8		Injure: removal of retaining wall, grading; no disturbance to retaining wall on south p. line.

49	Eastern White Cedar	<i>Thuja occidentalis</i>	15-20	Good	Good	Good	Good	Neighbour	5	1.8		Injure: removal of retaining wall, grading; no disturbance to retaining wall on south p. line.

Tree #	Common Name	Botanical Name	DBH (cm)	Trunk Integrity	Crown Structure	Vitality	Overall Rating	Location	Drip Line Diameter (m)	TPZ (m)	Condition Comments	Action
50	Eastern White Cedar	<i>Thuja occidentalis</i>	20-25, 15-20 [29]	Good	Good	Good	Good	Neighbour	6	1.8		Injure: removal of retaining wall, grading; no disturbance to retaining wall on south p. line.
51	Butternut	<i>Juglans cinerea</i>	45-50 20-25 [53]	Good	Good - Fair	Good	Good	Neighbour	9	3.6	Codominant stems, bark included	Protect
52	Black Walnut	<i>Gleditsia triacanthos</i>	30-35, 20-25 [40]	Good	Good - Fair	Good	Good	Neighbour	8	2.4	Codominant stems, bark included	Protect
53	Eastern White Cedar	<i>Thuja occidentalis</i>	15-20	Good	Good	Good	Good	Neighbour	4	1.8		Protect
54	Norway Maple	<i>Acer platanoides</i>	40-45	Good	Good	Good	Good	Neighbour	9	3		Injure: remove and replace asphalt. Work 1m from base; existing wall and fence to remain.

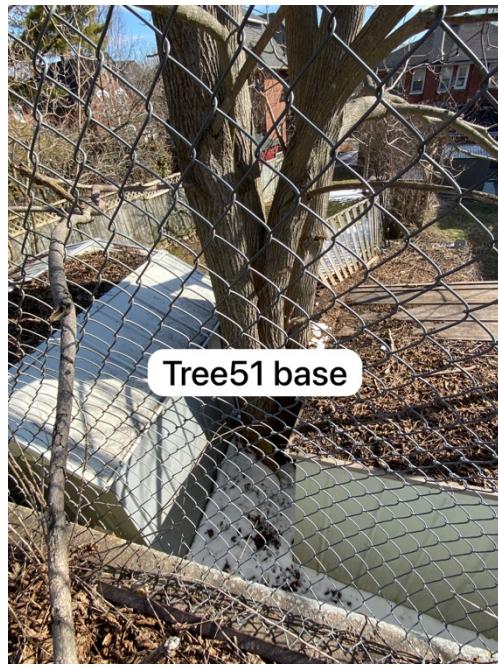
Tree 51 and Tree 59 are identified as butternut trees (*Juglans nigra*). Butternut trees are listed under the *Endangered Species Act, 2007* (ESA) as an endangered species. It is an offence under the ESA to kill, harm, or take a live butternut tree. It is also an offence to possess, transport, collect, buy, or sell butternut, or products made from a butternut tree. Exemptions can be made under the ESA for particular actions. An authorization (a permit or agreement) or a conditional exemption under Ontario Regulation 242/08 or 830/21 may be obtained for certain activities that may harm or removal butternut trees.

On this site, there are no proposed impacts to Tree 51. The existing retaining wall north of Tree 59 is to be removed and the site is to be graded to meet the municipal sidewalk. Tree 59 is exhibiting symptoms of severe butternut canker disease. The owner has been made aware of the Provincial regulation of butternut. The property owner is aware of the Provincial requirements and any further actions regarding butternut regulation is beyond the scope of this report.

Photo 10. Base of Tree 51, adjacent property separated by wall.

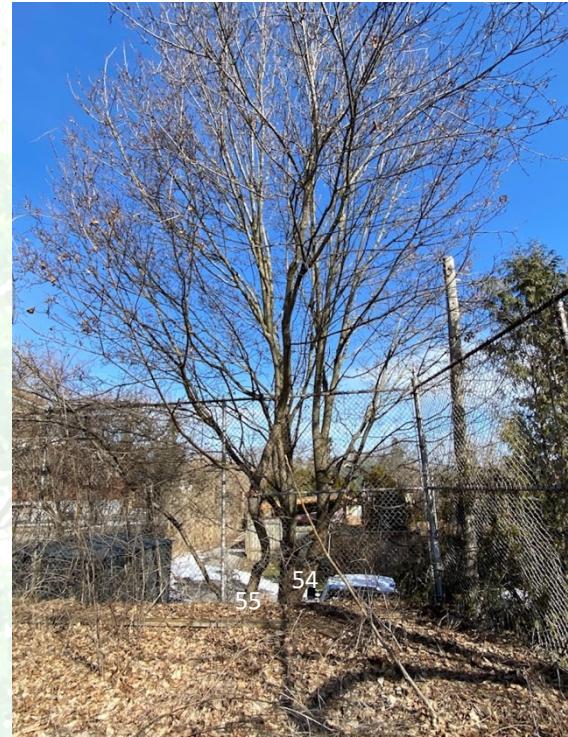
Photo 12. Tree 54 and 55.

55	Norway Maple	<i>Acer platanoides</i>	15-20	Fair	Fair	Fair	Fair	Neighbour	4	1.8		Injure: remove and replace asphalt. Work 0.3m from base; existing wall and fence to remain.
56	Mulberry	<i>Morus alba</i>	18,14	Good	Good	Good	Good	Private	4	1.8		Remove: within footprint of proposed grading for swale.
57	Crabapple	<i>Malus sp.</i>	22	Fair	Fair	Fair - Poor	Fair	Neighbour	5	1.8	Multiple dead branches, declining health	Injure: grading on subject site; existing retaining wall and fence to remain.
58	Black Locust	<i>Robinia pseudoacacia</i>	13	Good	Good	Good	Good	Private	4	1.8		Remove: within footprint of proposed grading for swale; future conflict with wall.
59	Butternut	<i>Juglans cinerea</i>	41	Poor	Poor	Poor	Poor	Neighbour	5	3	Significant cracks, canker, declining health	Injure: grading on subject site; existing retaining wall and fence to remain.
60	Norway Maple	<i>Acer platanoides</i>	49	Good	Good	Good	Good	Private	11	3	Balanced crown, minor dead branches	Remove: within footprint of proposed driveway/parking area and servicing.

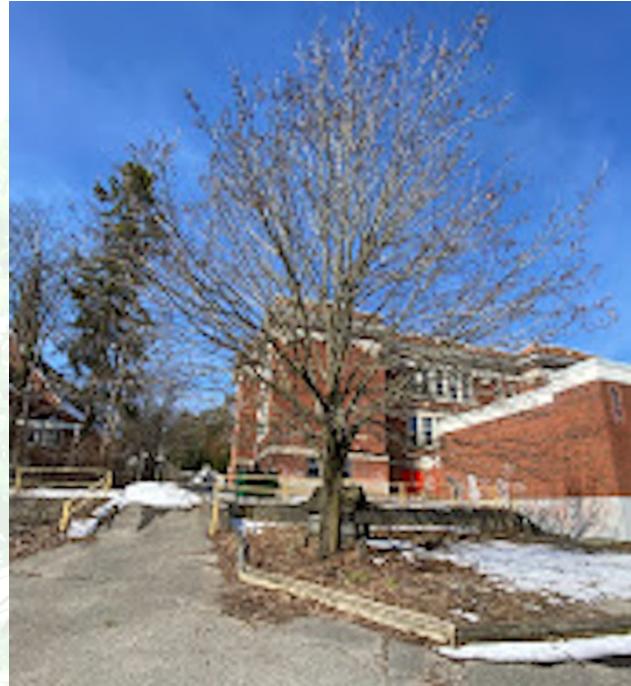
Photo 16. Tree 60.

Proposed Action/Tree Number	Action
Injure: 3, 4, 5, 6, 54, 55	To facilitate site servicing (watermain, sanitary and associated asphalt removal and replacement).
Injure: 38, 39, 40 – 50, 57, 59 Remove: 56, 58	To facilitate site drainage and associated grading.
Injure: 36, 37, 11 Remove: 12 (dead), 13 (dead), 14-18, 20-33	Relative to removal of the west retaining wall and new retaining wall along west property line.
Remove: Tree 60	Relative to new driveway/parking area.

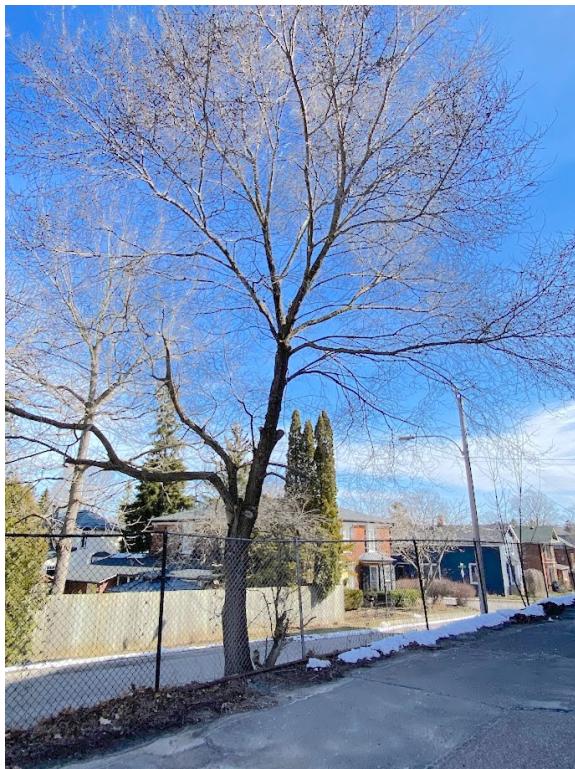
Photo 17. Tree 61.

Tree #	Common Name	Botanical Name	DBH (cm)	Trunk Integrity	Crown Structure	Vitality	Overall Rating	Location	Drip Line Diameter (m)	TPZ (m)	Condition Comments	Action
61	Siberian Elm	<i>Ulmus americana</i>	32	Fair	Fair	Fair	Fair	Private/Municipal	7	2.4	Growing in restricted space, dead branches	Protect
