Tree Inventory & Preservation Plan
Penryn-Mason Homes - Port Hope Phase 5
Port Hope, ON

October 10, 2019

Treescape Consulting Project TC293

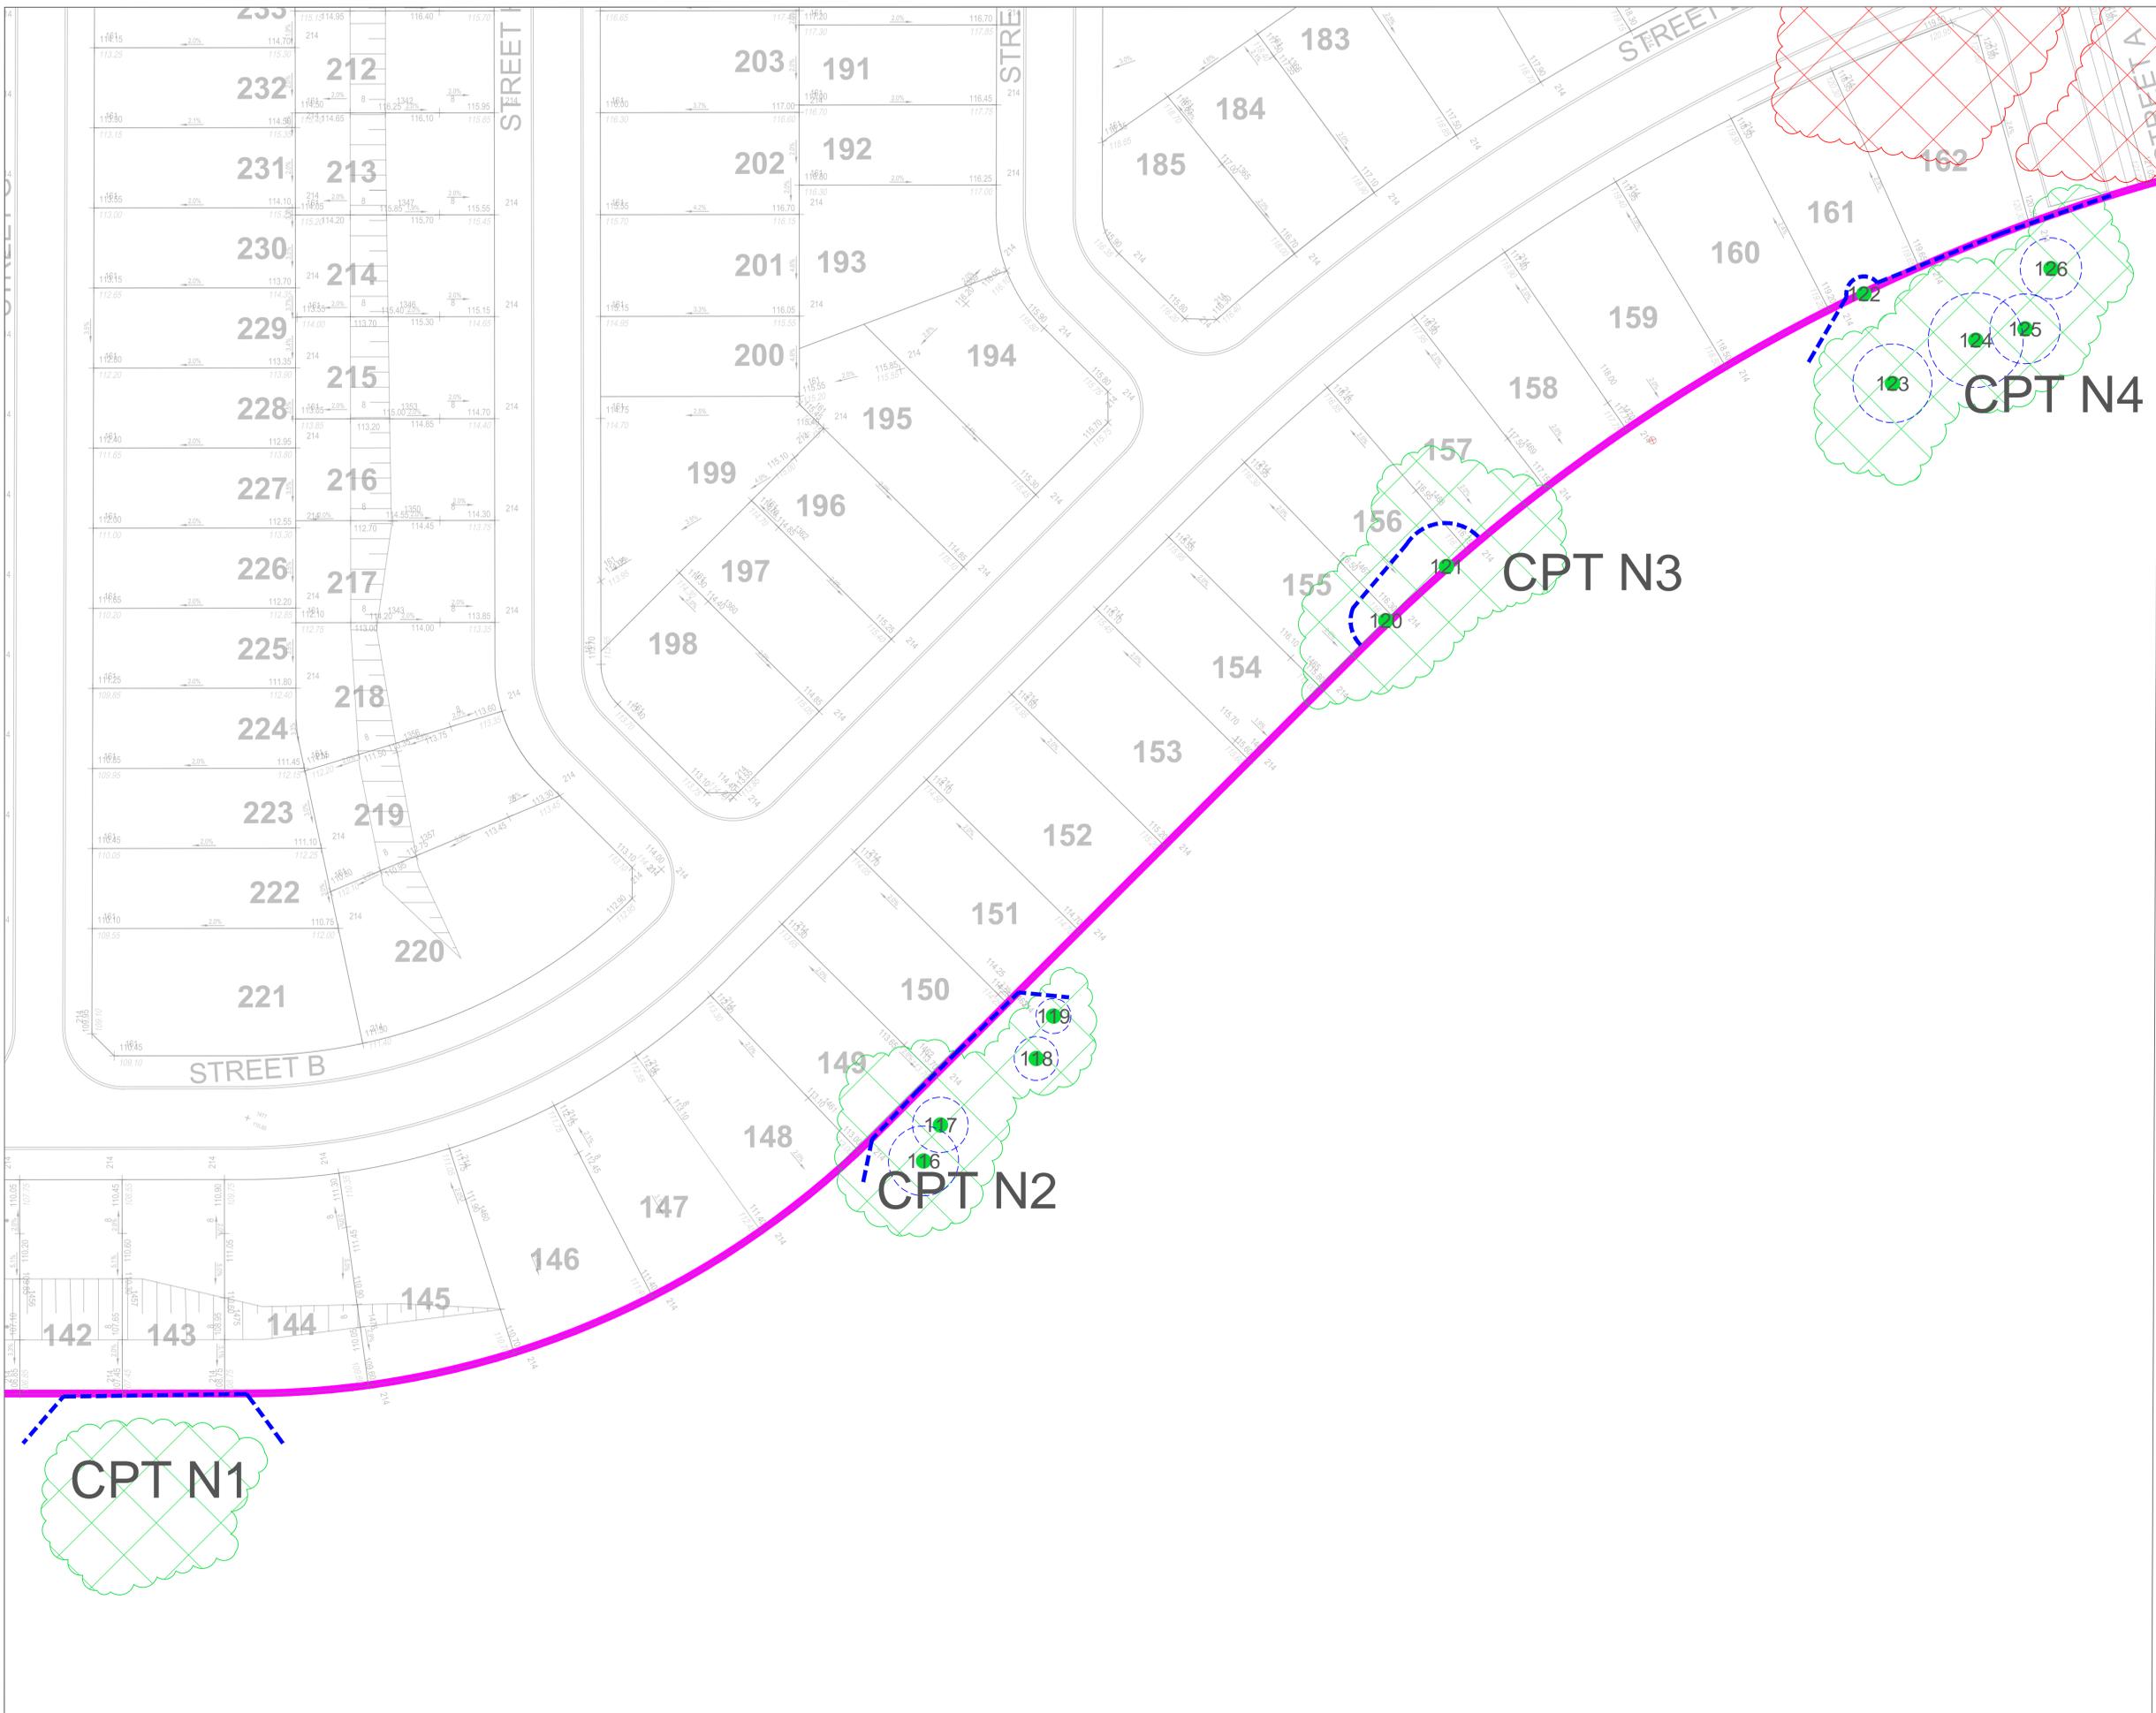
SCALE
 DO NOT SCALE
 SHEET
 TC293-02

Compartment (CPT) / Tree #	Development Impact	Recommendation
Tree 1-11, 127-131, CPT N1, CPT N2, and CPT N4	These are shared or neighbouring trees located along the south edge of the development property and do NOT conflict with the proposed development.	<p>Preserve trees and install protective fencing as specified.</p> <p>Some pruning of the upper canopy of CPT N2 adjacent the development may be necessary to accommodate construction. This pruning should be executed or supervised by an ISA certified arborist.</p>
Tree 108, 122 and CPT N3	These trees are in close proximity to the grading limits and CPT N3 will approximate 0.2m of fill placed on the outer edges of the root zone. Impact to these trees is deemed to be minimal.	<p>Preserve trees and install protective fencing as specified.</p> <p>Some pruning of the upper canopy of tree 121 will be necessary to accommodate construction. This pruning should be executed or supervised by an ISA certified arborist.</p>

CPT N5, N6 & N7	These are neighbouring (municipal) trees located on the east side of the development property and are in close proximity to or in direct conflict with the proposed development.	Obtain permission from municipality to remove trees.
Tree 101-107, 109-115, CPT 1, CPT 2 and CPT 3	<p>These trees are in direct conflict or close proximity to limits of excavation and/or grading.</p> <p>Note that trees 109-115 are Ash and are also recommended for removal due to their inevitable demise from Emerald Ash Borer.</p>	Remove trees.
