John, Ontario and Queen Street Heritage Conservation District Plan

Municipality of Port Hope, Ontario

Final Revision – January 2008

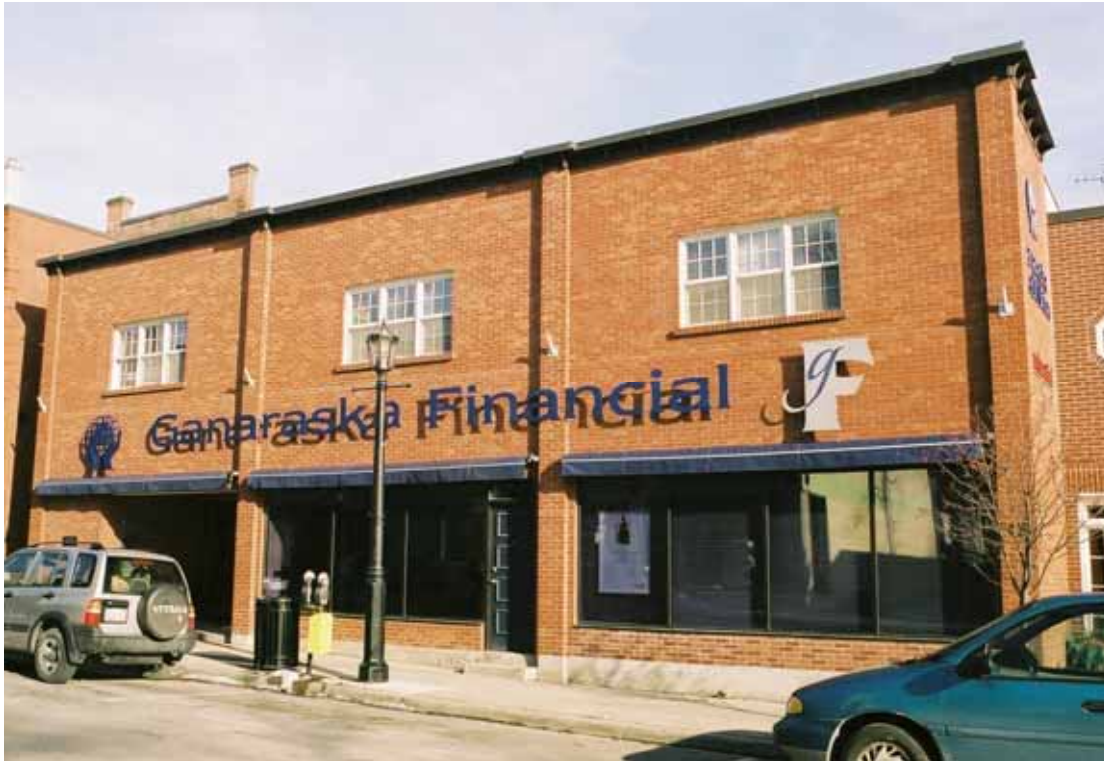
13, 15 and 17 Queen Street

- Austere, three-bay, two-storey red-brick building with triple 6/6 upper windows (c.1990).
- Description – Recent red-brick building is divided into three bays by simple pilasters rising from exposed concrete foundation up to cornice level, with each bay having traditional canvas awning. LH bay has recessed entry to upper level, reached via aluminum-framed glass doors. Central and RH bays have large windows framed in modern aluminum sections, with entry to single shop via modern, slab door having planted mouldings to give unusual, eight-panel effect and set, unusually, in front wall-plane. At second floor, each bay has group of triple, apparent 6/6 windows (with false dividers) over rowlock header sills, and with steel lintels and no voussoirs above. Modest cornice steps forward at pilasters, comprising regularly spaced, plain wooden brackets supporting deep, painted metal flashing at wall-head.

- Comments – Recent commercial building has a distinctly horizontal look foreign to Heritage District, with 6/6 upper windows inappropriate in type (given evident newness of structure), as well as modest size and grouping (in threes). Prominent concrete foundation and red-brick stall-risers, without recessed shop entry, are all foreign to traditional types. Awnings help to mask this, but building is not in character, nor are individual letters of sign and large logos at either side. Introduction of a continuous wooden fascia, with paired brackets at pilasters and integral lettering, would be a simple yet dramatic improvement. Similarly at rear, back-lit sign and metal door are utilitarian and contemporary, and brightly coloured stucco above is not appropriate. Given prominence of rear relative to Rotary Walkway these aspects of building should be re-considered. Scuppers and round rainwater pipes, however, are suitable to back-lane aesthetic.

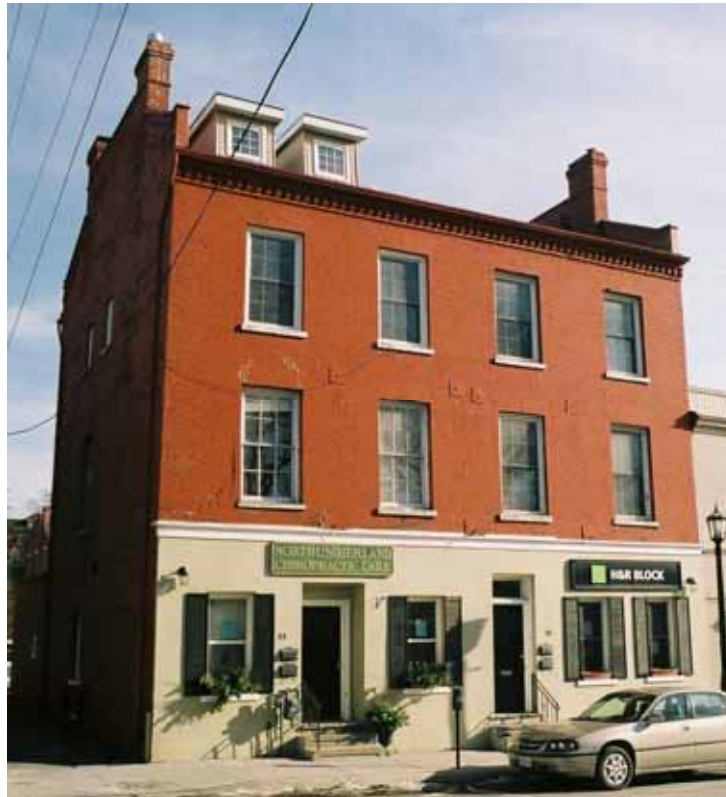
23 and 25 Queen Street

- Imposing, three-storey, Georgian brick building with original windows at no. 23 (c.1850).
- Ground Floor – Tall, painted red-brick building has ground floor set well above street level, suggesting no previous shopfronts. Existing rendered surface projects 4” beyond masonry above, and is recent. At both addresses, doors are reached by modest flight of concrete steps with contemporary metal handrails. At no. 23, old slab-type door apparently formed by five, vertical boards, has three small upper panes, and is set in recessed, plain aperture. Windows at either side are small, recent, 1/1 metal units set into old wooden cases, and flanked by recent wooden shutters. At no. 25, entrance is near centre of building, with door as at no. 23, set in tall narrow aperture wall-plane, with modest transom window above. Two windows to right are as at no. 23. A lone, three-pane basement window, within segmental arch, exists at grade level at extreme RH side. Signage at both addresses consists of plain boards, centrally located, but in quite contrasting styles. Modest wooden fascia and flashing crown this level.

- Second and Third Floors – Masonry at upper levels is painted red over assumed red brick. Both levels have four regularly spaced 6/6 windows, originals remaining only at no.23 second floor, and replacements (with false muntins and screens) elsewhere. Thick wooden sills remain throughout, and all heads are flat-arched, but with elegant, diagonally laid voussoirs forming herringbone motif at top floor. Various metal plates suggest former outward movement in masonry. Cornice consists of corbelled course, band of projecting, dentil-like sailor bricks, and further corbelled course adjacent narrow eaves having plain soffit boards. Front gutter is traditional, ogee-type profile with single narrow downspout at LH side.

- Comments – Tall brick building is a unique presence on Queen Street, and more in keeping with Walton, providing an indication of what has been lost along this road. Stucco at ground floor is assumed to hide alterations and possibly variety of brick types, whereas remainder of building is little altered, aside from various replacement windows. Only following careful investigation of the existing fabric, and ideally archival photographs also, might one be able to determine the original configuration here. Steel plates at front, second and third floor levels suggest former problems with front and rear walls spreading, now assumed to be inactive. Cement pointing and render at parapets and chimneys should be carefully removed and masonry repointed. At rear elevation, hodge-podge of old one-storey additions, wood and steel stairs, and even new dormer, give an appealing back-lane presence. Modern doors at second floor, especially “French” door with peripheral white vinyl frame, are out of keeping, as are long PVC electrical conduits.

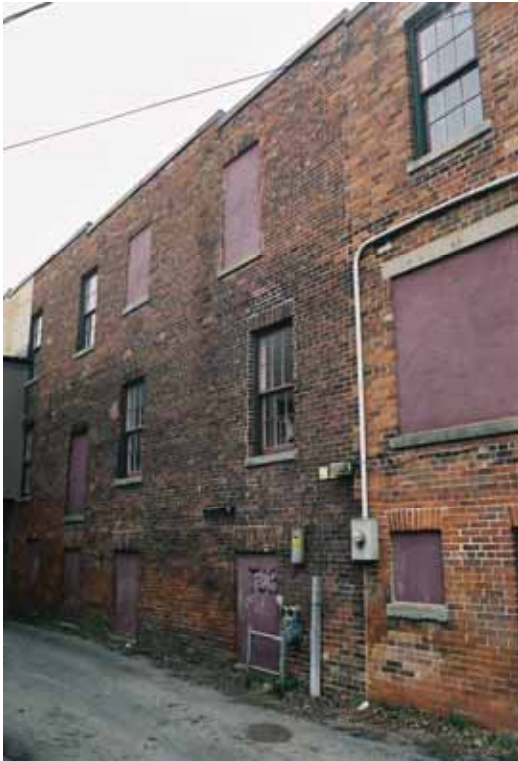
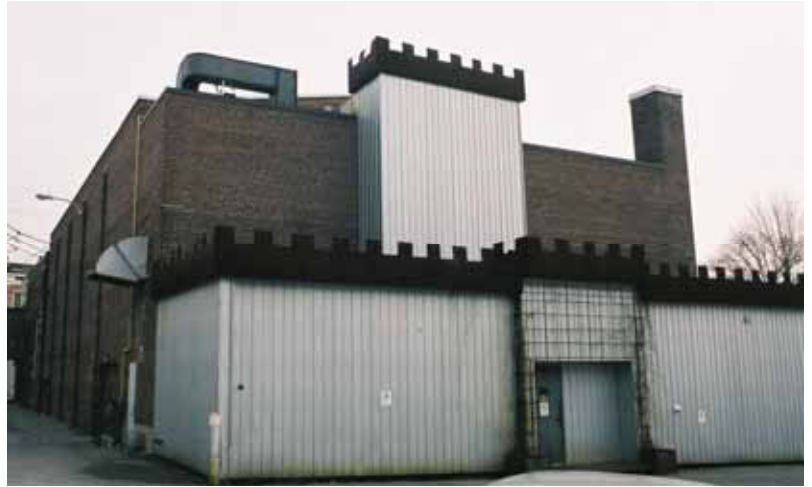
10 and 12 Queen Street (continued)

- Side Elevation – North elevation of this building is a wonderful lane structure, an imposing three stories of various periods of old, red-brick masonry, with headers every sixth course, and a number of tall apertures, some with 6/6 windows in surprisingly good repair, and some boarded over. A single door, with segmental-arch head, is boarded up just beyond covered passageway. Elsewhere at ground floor, window-heads are flat arches, built with multiple-brick voussoirs extending to uniform course line. At two upper levels, voussoirs are simple, soldier-course bricks only, again in flat-arch form. Sills are concrete throughout and parapet is capped with pre-painted metal flashing. More recent addition, buttressed at regular intervals and without windows, extends building deep into lane, and is part of Capitol Theatre, and so circa 1930, whereas volumes to east appear to date from late 19th century.

- Rear Elevation – West elevation, plainly visible from Lent Lane, is rear of Capitol Theatre, and is also built of red brick as at north side but is windowless, in keeping with theatre use. Plain, one-storey addition to rear is clad in vertical metal siding and topped with a exotic crenellations in rusted iron. Similar, set-back addition rises full-height at centre of building, also with crenellations. Beyond a horizontal, metal-flashed parapet to rear wall is another, similarly capped, gable wall.

- Comments – At front elevation, building is unique within Port Hope, with its recessed front wall and two-storey round arches. Unusual doors to shop should be replaced with more suitable period doors. At second floor, central voussoirs are failing and require attention. And at third floor, extensive spalling paint and bricks indicate water (whether rain or vapour problem), which should be investigated and remedied. At side elevation, diversity of building provides attractive back-lane presence, though revealing of windows – if these exist – would be an improvement, and these could be blacked-up with painted glass if necessary. At rear elevation, blank brick wall is not unattractive, and though metal-clad and rusty crenellations are odd they are in keeping with a theatrical building. This elevation, facing the parking lot and lane beyond, is sufficiently prominent that there might be something more for the public view – perhaps suitable advertising for events being staged at the theatre.

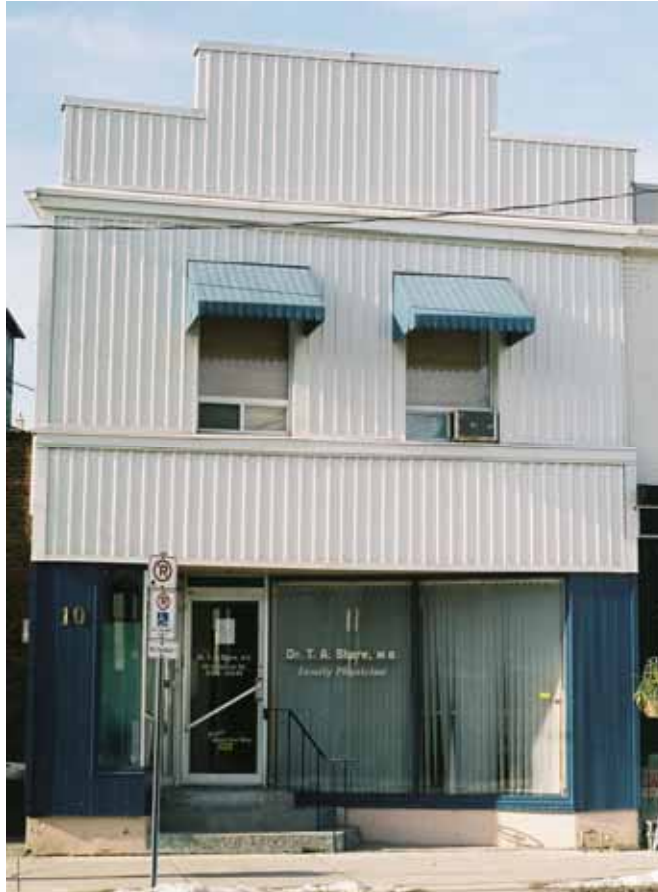
10 Ontario Street

- Two-storey, commercial building with metal-clad top floor and boomtown parapet (c.1890).
- Front Elevation – Traditional building with ground-floor commercial is compromised by later alterations and cladding. Entry, at LH side, is reached by cast-in-situ concrete steps and small landing leading to fully glazed, aluminum-framed door with small transom-window. Wall below windows has concrete render on unknown substrate, while modest stall risers on either side are clad in narrow, vertical v-jointed boards. Similar boards clad piers at either side of façade, and older material (i.e. brick) is assumed to exist behind. Shopfront itself is angled relative to street, having window frames in profiled (painted) aluminum with attached corner pieces, typical of 1950s. Ground floor ends with very deep band of ribbed metal cladding which projects beyond lateral piers and presumably hides other finishes below, including perhaps older shopfront glazing and fascia. At second floor, horizontal band of profiled metal flashing spans full-width at window-sill height. Replacement windows are metal-framed units, with large top-sash over small bottom-sliders. Window-heads are concealed in boxy metal canopies and entire wall surface is, again, clad in vertical ribbed metal, presumably over brick. Band of profiled metal at wall-head probably conceals older cornice within. Stepped parapet is also metal-clad and rises some two feet at either side and a further two feet at centre, presumably to hide pitched roof. Parapet is capped with pre-painted metal flashing.

- Comments – Building appears to be the Sleeping Beauty of Ontario Street. Although shopfront may retain little heritage fabric aside from, perhaps, high-level glazing, there seems a strong possibility that original fabric remains behind extensive metal-cladding above. Selective removal of finishes is encouraged to see what exists behind, and in what condition this may be. Historic photos may also exist. Upper floor window canopies should be removed and windows should be replaced with period facsimiles. If sufficient 1950s material remains at shopfront level a composite approach to this restoration might be considered. *(NAH much of this restoration work has been completed since the photograph was taken)*

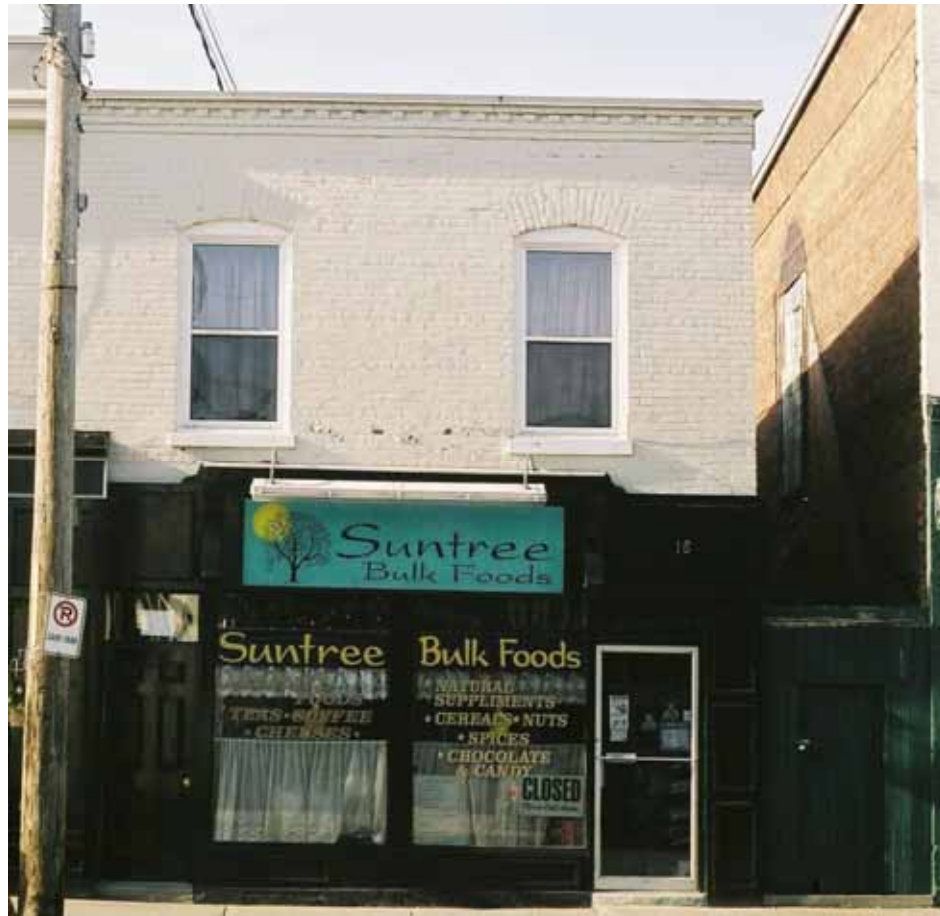
16 and 18 Ontario Street

- At second floor, wall is built of painted red brick (assumed to be without polychromy), with headers typically every sixth course. Windows are two, 1/1 aluminum replacement units, retaining wooden sills (RH unit is visibly repaired), and are set within segmental arches.

- Comments – Modest main-street building is much altered at shopfront, but older elements appear to remain behind and above Post Modern signage and trim. These should be investigated. Recent installation of planted mouldings on plywood appears at first suitable to the historic context, but these could be improved and a more suitable period-type shopfront might one day be installed. Brickwork has presumably been painted because of spalling at upper levels. This should be investigated and water ingress, or humidity migrating though wall, should be prevented. Ideally paint should then be carefully removed from bricks. Loss of original windows at second floor, presumably with curved upper sashes, is unfortunate.

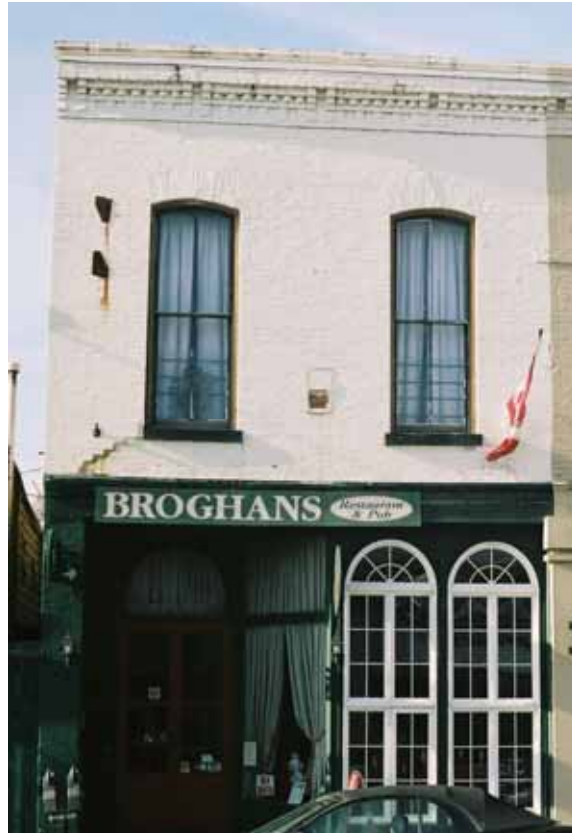
20 Ontario Street

- Two-storey brick building with original upper 2/2 windows and ornate brick cornice (c.1875).
- East Elevation – Imposing, commercial main-street building is similar to no. 24. Ground-floor entry consists of pair of replacement, tall entry doors, each with two upper panes over modest panel, set in recess at LH side. Original arched transom window remains, including capitals below, all apparently in cast-iron, and with unusual, vermiculated fretwork at spandrels above. Ceiling is finished in beaded boards, with crude metal patch at inner corner. Outer wall of recess is also clad in vertical, beaded boards. Shopfront has older portion extending into recess, with vertically boarded stall-riser, and large bottom sash, transom and smaller sash above. Main shopfront is recent, consisting of pair of round-arch French windows, each with stacked pair of vinyl casements having six panes per sash (formed by false internal muntins) with similar-type fanlights above. Low stall-riser, central mullion and spandrels are clad in v-jointed wood. At fascia level, simple wooden beam spans from brick pilasters at either side, with modest cornice at upper edge. Sign is narrow painted board attached near mid-span, and drops slightly below soffit of beam. Second floor is built of (painted) brick masonry laid in common bond, and contains two original, tall 2/2 windows with segmental-headed top sashes. Sills are of painted masonry and segmental-arch voussoirs are 1½ bricks high. Ornate cornice is entirely of brick, divided into four bays, each framed by paired corbels, like wooden brackets, set above stringcourse. Between corbels are band of headers with alternate recessed bricks, dog-toothed band, and corbelled course above. Cornice ends with several courses of projecting brickwork built off continuous course of headers. Wall-head is capped with modest, curved metal elements with deep flashing above.

- Comments – Building is generally in good repair, though vinyl shopfront windows are unsuitable. Transom window over doors and accompanying ironwork are, however, most rare. Masonry cracks at beam ends and upper floor voussoirs result from settlement of main beam, which should be monitored. Brickwork should be cleaned of paint, and old windows require repair at bottom rails, and repainting; but these tall beauties should absolutely be retained.

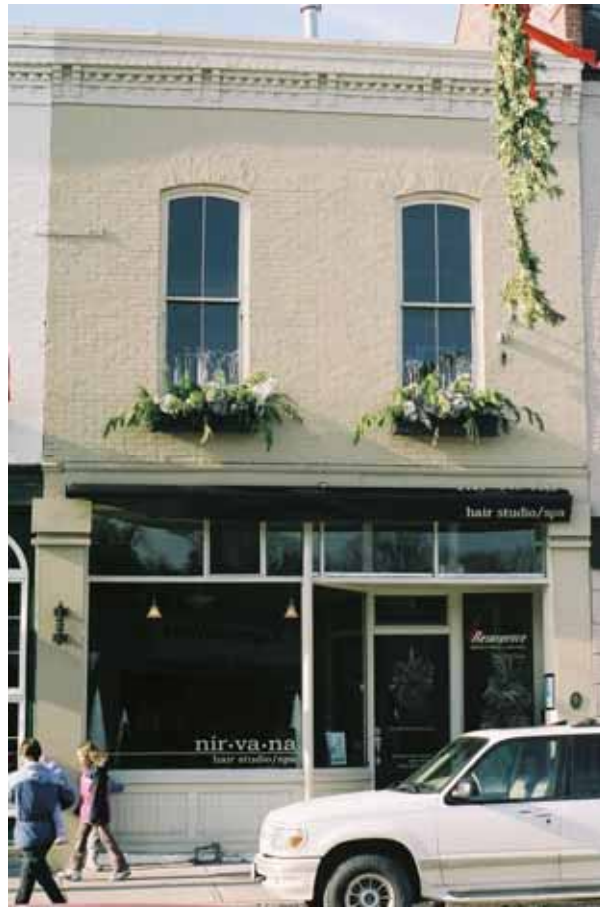
24 Ontario Street

- East Elevation – Imposing, commercial Main Street building is similar to no. 20. to either side, stuccoed brick piers with box-like capitals, frame recent shopfront. Recessed entry at RH side had boarded deck over concrete over limestone blocks, which latter extend across base of building. Door is replacement, ¾ glazed, wooden door with small lower panel. Ceiling above is finished with beaded boards, with two cast-iron vents presumably venting former internal gas lamps. To RH side is large window over vertical, v-jointed boards, in recent frame. Adjacent wall of recess is clad in vertical, v-jointed boards. Transom windows throughout are in same plane as shopfront, and over boarded ceiling. Main shopfront has tall, vertically boarded stall-riser with recent frames, with large pane above and recent, varied fenestration with opening units. Signage is restricted to modern letters in lower shopfront windows, and lettering at RH side of retractable awning. Shallow fascia above has modest upper mouldings only. Second floor is built of (painted) common-bond brick masonry and contains two original, tall 2/2 windows with curved rails at top sashes. Sills are hidden by window-boxes stone, while voussoirs are 1½ bricks high. Cornice is built entirely of brick, divided into four bays by paired corbels similar to wooden brackets, set above stringcourse. Between corbels are band of headers with alternate bricks recessed, dog-toothed band, and additional corbelled course above. Cornice ends with several courses of projecting brickwork built off continuous course of headers. Wall-head is capped with modest, curved metal elements with deep flashing above.

- Comments – Building is generally in good repair, with recent shopfront having older, altered elements at stall-risers, and old cast iron vents at ceiling above. Settlement in masonry at upper floor voussoirs probably results from sagging of main beam, which should be monitored. Paint in this instance is not spalling, but should be carefully removed from old brickwork. Old, sash and case windows seem in good repair, and benefit from recent paint.

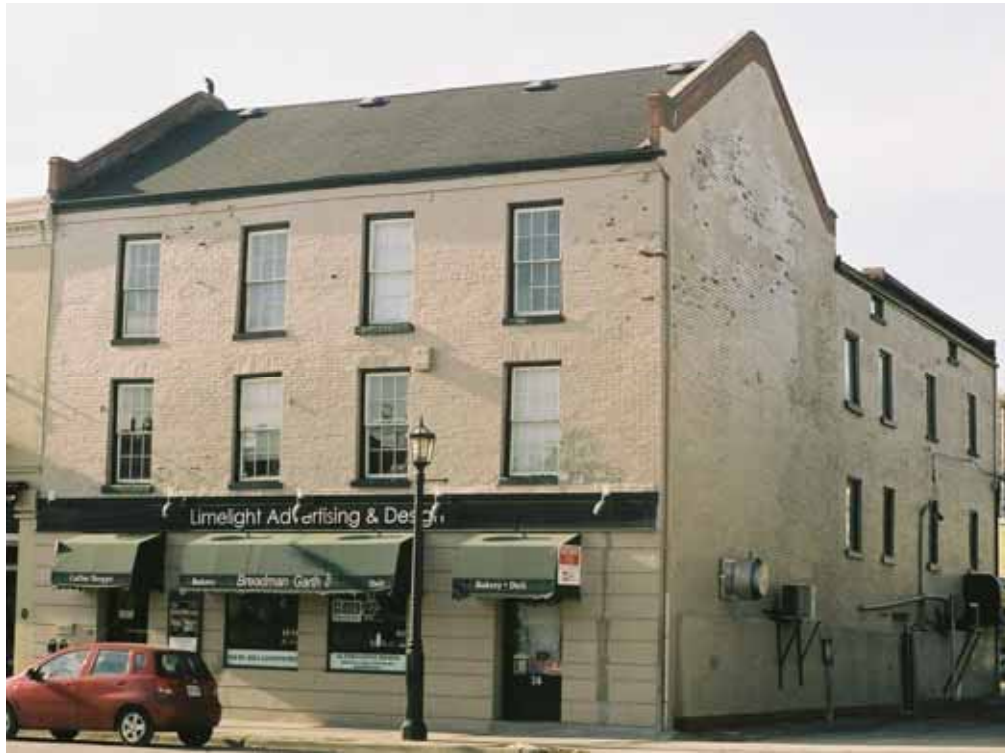
26 Ontario Street

- East Elevation – Tall, symmetrical building is a dignified presence towards the end of Ontario Street. Ground floor appears extensively reworked, having been re-clad in stucco, with bands of rustication in varying widths. Doors at right- and left-hand ends are recent, half-glazed doors with single, horizontal lower panels. Shopfront windows are two large, single-pane, fixed sashes without intrinsic merit. Apertures have half-gambrel-shaped, plastic-clad canopies, and fascia above, with simple signage, consists of strip of painted sheet-metal top-lit by 5 spun-metal light-fixtures. Second and third floors are of painted brickwork (assumed to be monochromatic red) with header courses typically every sixth course. Windows at both levels are four, uniformly spaced, old 6/6 units, some with stone sills but most with later concrete sills, and with flat-arches formed by single course of brick soldiers (rebuilt with steel angles at second floor, nos. 1, 2 and 4). There is evidence of settlement throughout façade. At wall-head, masonry corbels out slightly below top three courses, and modest wooden fascia is hidden by K-type aluminum gutter with modern downpipe to north. Roof is framed by parapet walls built of sloping-course masonry which rises well above roof-line and has flattened portion adjacent ridge. Masonry stumps visible within parapets indicate location of former chimneys at front and rear pitches. Roof is clad in black asphalt shingles.

- Comments – Building is in fair repair, with recent ground-floor stucco and shopfronts being foreign to original. Recent interventions should be reconsidered, and restoration might be suitable both to commercial needs and to character of original building. Paint should be carefully removed from brickwork. Four chimneys, once major and significant features, should be rebuilt to period details; and ideally a cedar-shingle roof should be installed, at least at front pitch. At Maitland Street, paint should be removed, vents and AC relocated, and a 3rd floor wood lintel seems to be failing. An open, commercial presence here would enliven lane.

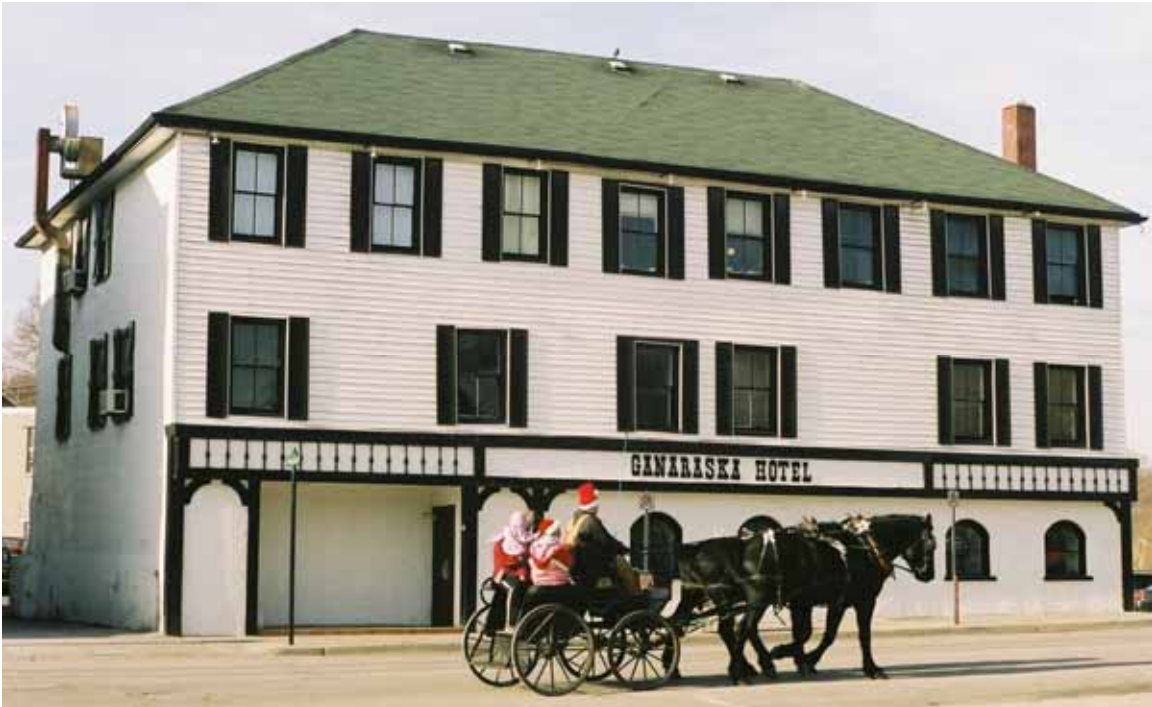
30 Ontario Street

- Comments – Old building combines interesting old features and less suitable recent elements. Although current aspect is one of an “olde” hotel, south elevation shows nature of original wall materials and these should be revealed, repaired and reinstated/replicated as appropriate. Thus aluminum and vinyl elements should be removed, render repaired, and ground floor altered to reflect either original configuration, or to a type more suitable to age and character of hotel. Diagonal line in front roof suggests presence of former hip, which is interesting, if only to the observant and curious historian. Hotel is well-placed next to Ganaraska River and holds various opportunities for outdoor terraces to north, to west and on Maitland Street to south. For possible future buildings on lots to west and north, see the Guidelines.

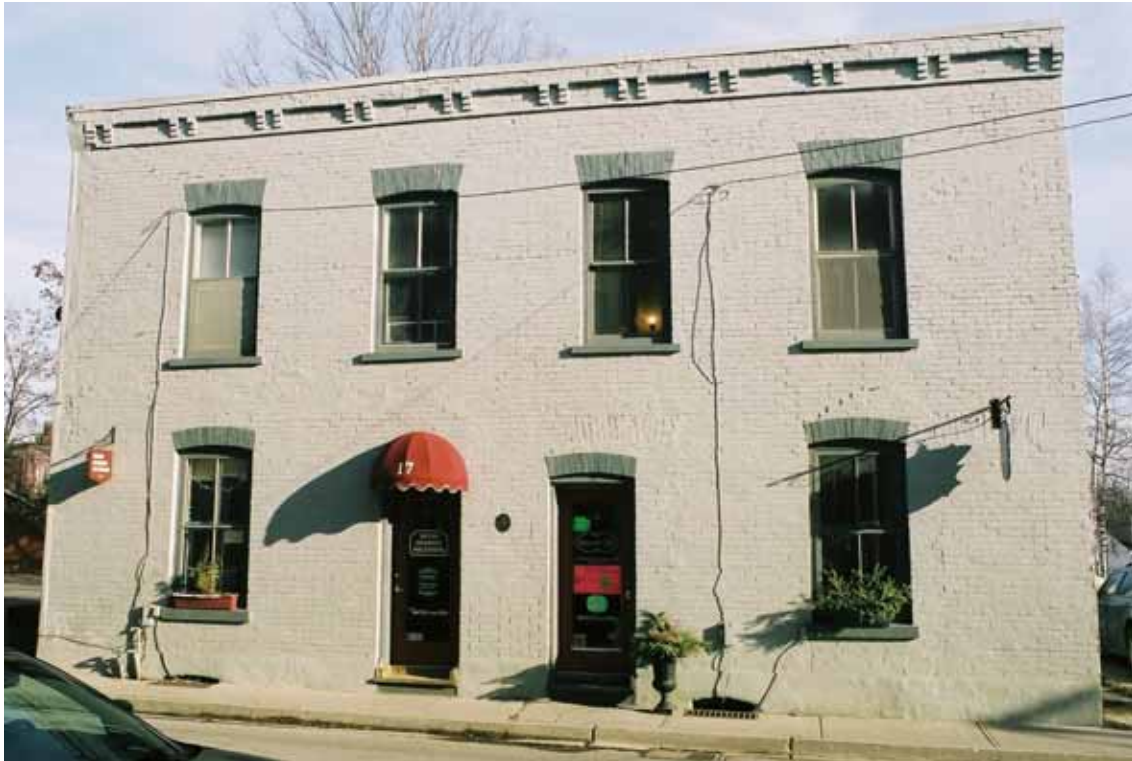
17 and 19 John Street

- Comments – Brick houses are in good condition and retaining old windows, though locations are altered at ground floor, which may account for painted masonry. Evidence of rebuilding at lower level includes altered masonry and simpler voussoirs. Brick is assumed to be red brick throughout and if so, should be painted a similar colour. Parapet seems to have been reduced – historic photos may confirm this – and if so, rebuilding is to be encouraged. Wooden storm doors and one lower wooden storm window have recently disappeared. For possible development of parking lot to north, see the Guidelines.

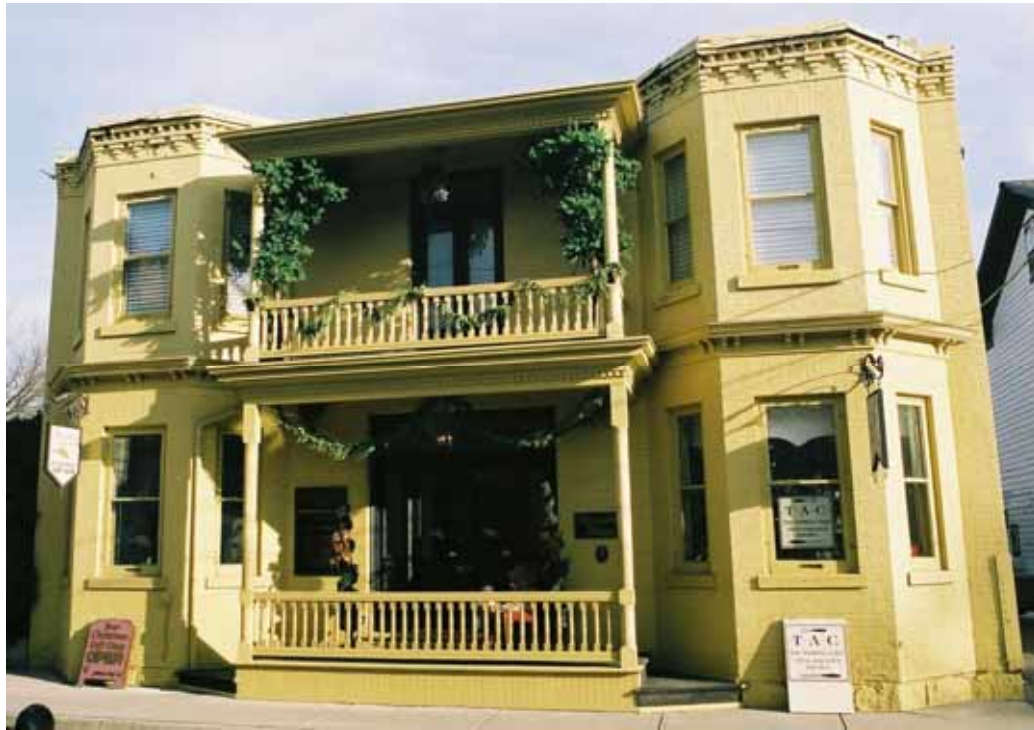
25 John Street

- Comments – Dignified building is assumed to been restored. Brick colour gives rather lively presence on John Street. Current situation at parapet compromises appearance, and this aspect should be remedied, replicating period details as closely as possible. At rear, one-storey, painted brick structure adjacent to Lent Lane has various settlement cracks and needs attention. For possible development of parking lot to north, see the Guidelines.

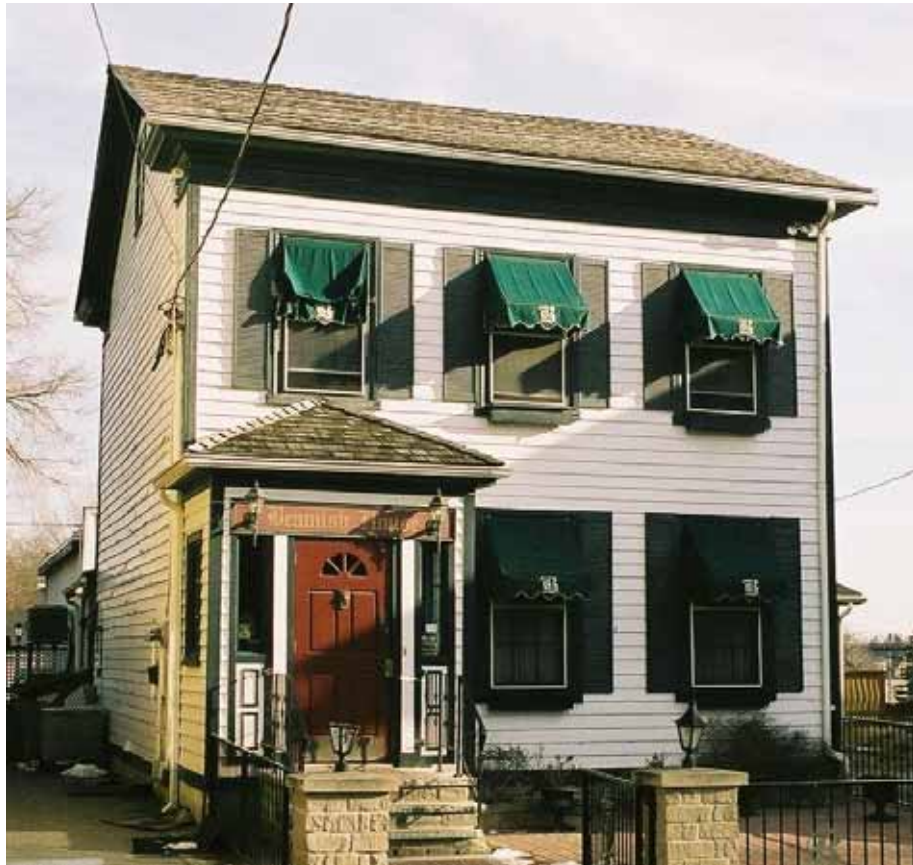
27 John Street

- Comments – An attractive house successfully adapted to use as pub restaurant. Front door is modern and suburban and should be replaced with suitable, panelled or half-glazed and panelled door; and shutters and canopies are out of keeping with original building. Lanterns at north rear terrace might be replaced with discreetly modern units, and railing at south terrace should be painted as at north terrace. Clapboard at north elevation needs repair and painting, and a suitable brick would enhance period aspect of building.

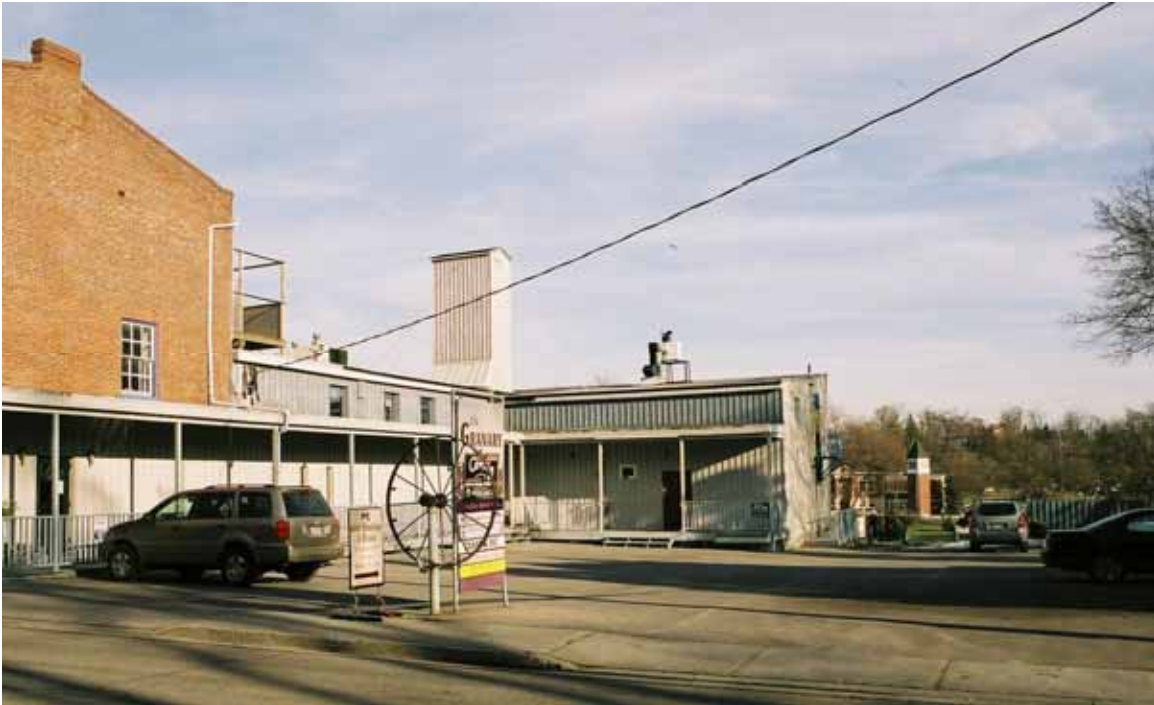
**41 John Street** (continued)

- Comments – An attractive building, though with a number of recent elements. Shopfront, doors and transom window are obviously modern and could be more to heritage norms (especially doors), but are generally attractive. Shopfront pilasters and fascia lack suitable ornament and detail. Thickness of muntins in new 6/6 windows is somewhat noticeable, and metal frames of individual thermopanes tend to catch the light. See the Guidelines for comments on replacement windows. Window arches are generally sagging and may require support by concealed angle-iron. At rear addition, tower (assumed to have former industrial purpose, as would be fitting adjacent former railway line) and old Coca Cola sign at north wall are valuable heritage elements and should be conserved. For any proposed development of the large parking lot to the south, see the Guidelines. Note that this three-storey Georgian building is the last of its kind as one heads south on John Street and so marks the ultimate point of transition between Original Commercial Sector and Transitional Residential Sector.

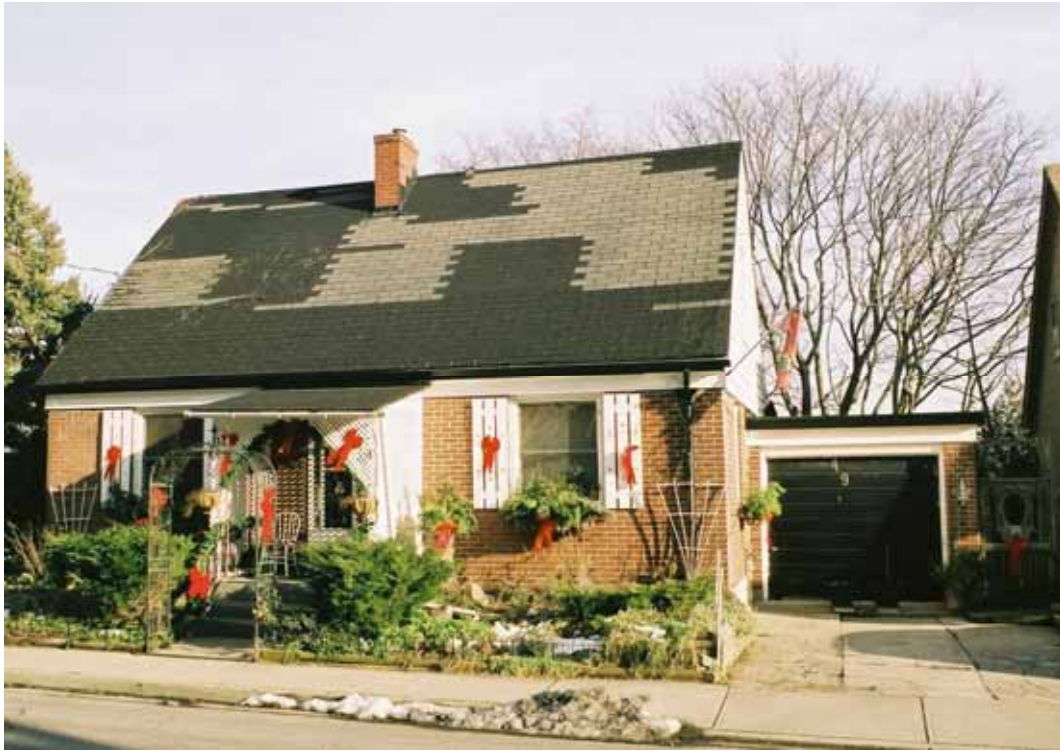
**49 John Street**

- Symmetrical, 1½ storey, red-brick Cape Cod house with flat-roofed garage (c. 1950).
- Description – Ground floor masonry is of common-bond red brick over roughly formed, cast-in-situ concrete foundation. Modest lean-to porch with over small landing is enclosed at sides and part of front by painted lattice-work. Old front door has four vertical lower panels with attractive multiple-pane glazing above (behind glazed storm door). Windows at either side are wide, 1/1 units (behind metal storms) framed by later, plank-type shutters. Sills are canted rowlock headers and lintels are concealed by aluminum siding below eaves. Soffits are minute and aluminum-clad, as is fascia. Unusual metal hopper exists at RH side, feeding corrugated metal downspout. Steeply pitched roof is clad in black asphalt shingles, with various areas repaired with light-grey shingles. Garage at south side has flat roof and is apparently a later addition, built also of red brick, with single-car door formed of nine full-width metal panels. Gable walls have windows and sills etc. as described (behind metal storms) at ground and second floor levels. Gables are clad in textured vinyl siding, presumably over clapboard, with small moulding at eaves.

- Comments – Modest house is later than majority of structures within block, but still has traditional elements of pitched roof, red brick masonry and double-hung windows. Front door is surprisingly ornate. Removal of recent, textured siding at gables is encouraged, assuming that wood siding in good repair exists beneath. Flat-roof garage is a foreign addition, though not unacceptably so. Extensive plantings of front garden is unusual in the Heritage District, but not unsuitable given more recent and suburban nature of this house.

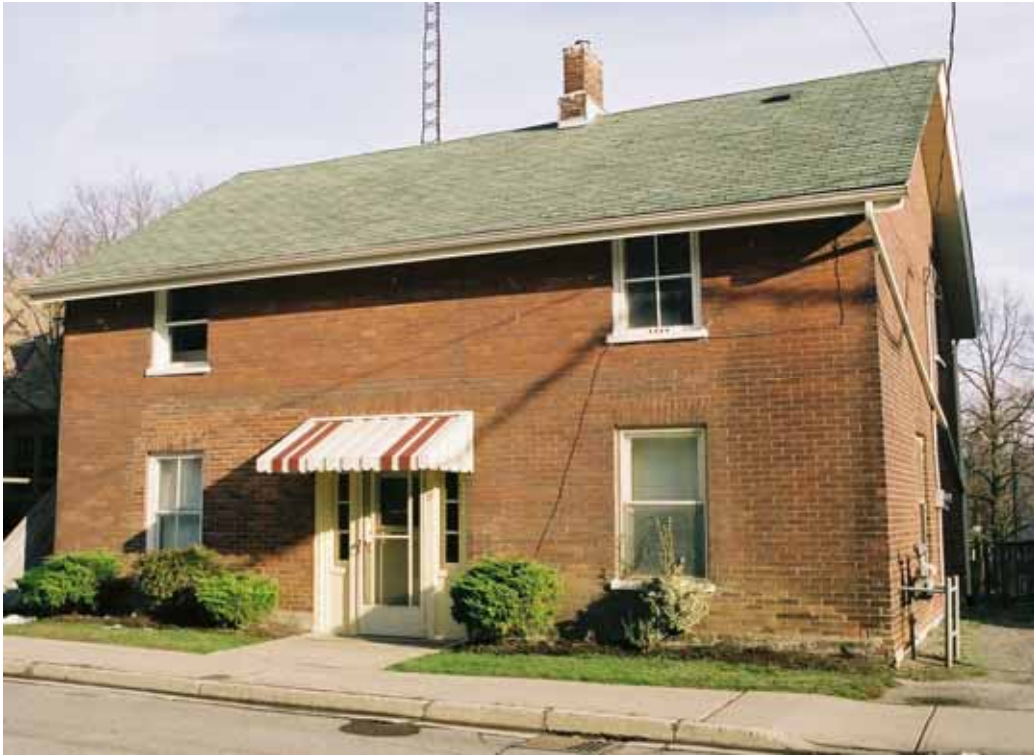
**57 John Street**

- Georgian, pitched-roof, two-storey red-brick house with period front doorway (c.1865).
- **Description** – Long, gabled house has unusual aspect, with widely spaced windows, particularly at upper floor. Masonry is unornamented, common-bond red brick throughout, built off typical, rubble limestone foundation. Rebuilt brickwork at LH side suggests alterations in this area, although not readily comprehensible from exterior. Central **front doorway** comprises old, half-glazed door with single lower panel (behind metal storm door), set between four-pane sidelights with plain boards in lower regions, now partly hidden in concrete slab. Transom window is small, three-pane unit with broad mullions at either side, with very wide, flat-arch above. Modern, two-tone metal canopy over doorway obscures both arch and transom, and is an unsuitable later addition. **Windows** to either side are later, 1/1 units with original, narrow wooden sills (with period 4-pane storm at left and metal storm at right). Flat arches above contain stretcher and header voussoirs, and rise uniformly to joint-line four bricks above. At **upper floor**, low 1/1 windows (with 4-pane storm at RH unit) are set tight against eaves, with narrow wooden sills as at ground floor. **South elevation** is brick, with two 6/6 windows (with metal storms at ground floor), while north elevation is clad in textured vinyl siding, also with 6/6 windows. Soffits and fascias are aluminum-clad and rainwater goods are conventional aluminum profiles. **Pitched roof** has green asphalt shingles, and a single chimney, on older base, exists at unusual location near center of ridge.

- **Comments** – Parsonage is apparently Georgian but with unusual features, such as 1/1 ground floor and small, upper-level windows; unlike 6/6 windows at end walls. These presumably indicate changes over the years and should be retained. Building is in good repair, though metal canopy over front door and aluminum cladding at soffits and eaves should be removed. Metal storm door is also unsuitable and removal would improve appearance. Chimney requires repointing, and should be rebuilt in upper portions to suitable period details; though older chimneys may have existed elsewhere, as should be apparent from internal roof structure or sheathing. Restoration of such aspects, and installation of a period roofing material (i.e. wood shingles) would enhance appearance of interesting and attractive house.
