## Arborist Report

Tree Inventory and Assessment Report

ONroute Port Hope

BRM-22021342-E0

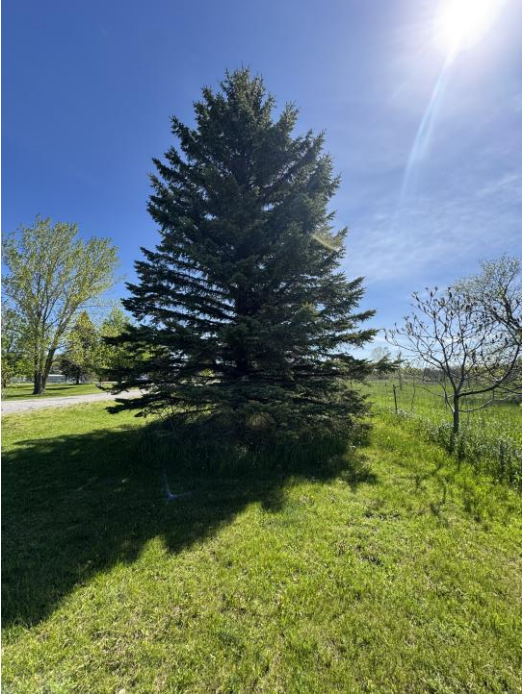
Image 1. Tree 1

| Tree ID # | Species | | DBH | mTPZ | DL | TI | CS | CV | CDB | Comments | Action | Compensation |
|---|---|---|---|---|---|---|---|---|---|---|---|---|
| 1 | <i>Picea pungens</i> | Blue Spruce | 37 | 2.4 | 4 | G | G | G | | | Preserve | |

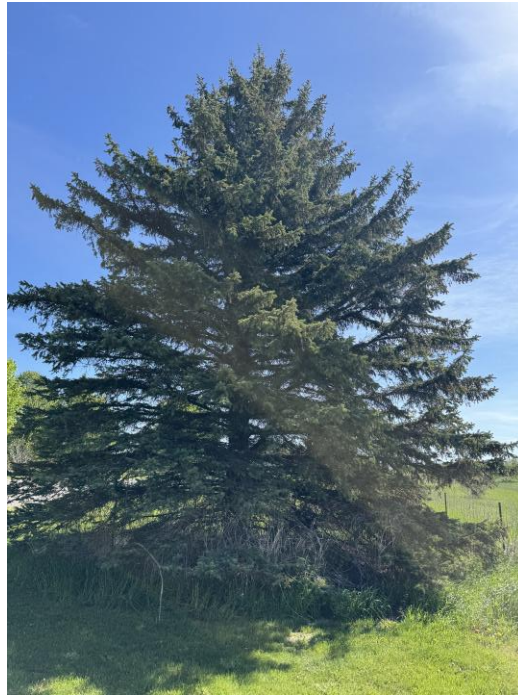
Image 2. Tree 2

The removal of seven (7) trees will be required to accommodate the proposed development. Trees 8, 9, and 16-19 directly conflict with the proposed parking lot. Significant encroachment into the minimum tree protection zone (mTPZ) of Tree 2 is required to accommodate proposed re-grading such that the tree would not be expected to tolerate the resulting injury.

| Tree ID # | Species | | DBH | mTPZ | DL | TI | CS | CV | CDB | Comments | Action | Compensation |
|---|---|---|---|---|---|---|---|---|---|---|---|---|
| 2 | <i>Picea pungens</i> | Blue Spruce | 45 | 3 | 5 | G | G | G | | | Remove | 3 |

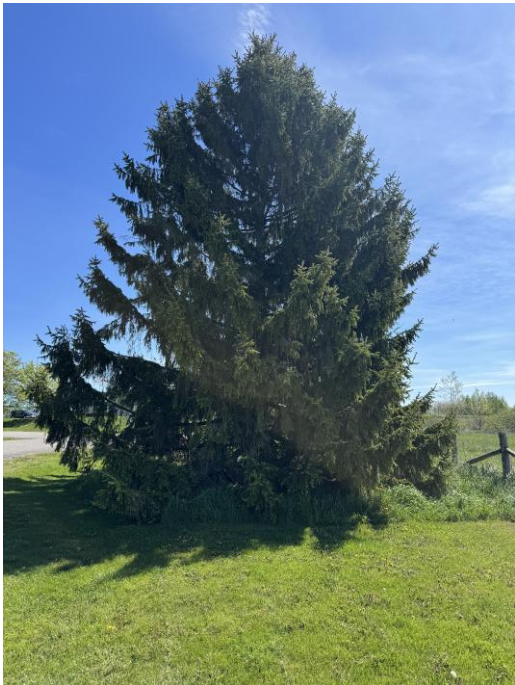
Image 3. Tree 3

| Tree ID # | Species | | DBH | mTPZ | DL | TI | CS | CV | CDB | Comments | Action | Compensation |
|---|---|---|---|---|---|---|---|---|---|---|---|---|
| 3 | <i>Picea abies</i> | Norway Spruce | 70 | 4.2 | 5 | G | G | G | | | Preserve | |

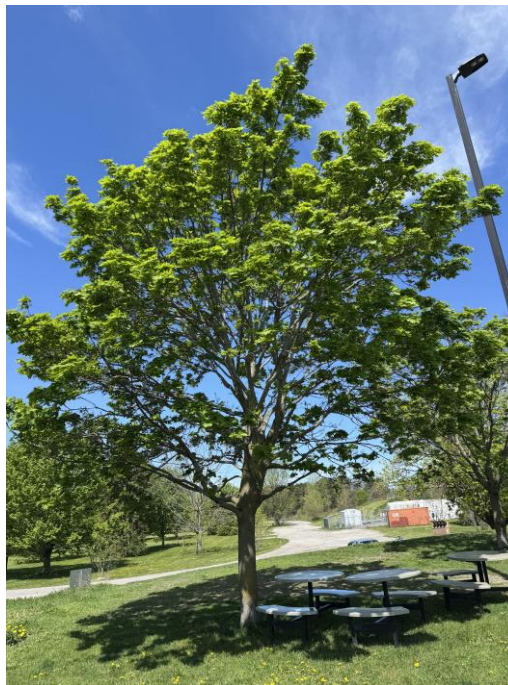
Image 4. Tree 4

| Tree ID # | Species | | DBH | mTPZ | DL | TI | CS | CV | CDB | Comments | Action | Compensation |
|---|---|---|---|---|---|---|---|---|---|---|---|---|
| 4 | <i>Acer platanoides</i> | Norway Maple | 24 | 1.8 | 4.5 | G | G | G | | | Preserve | |

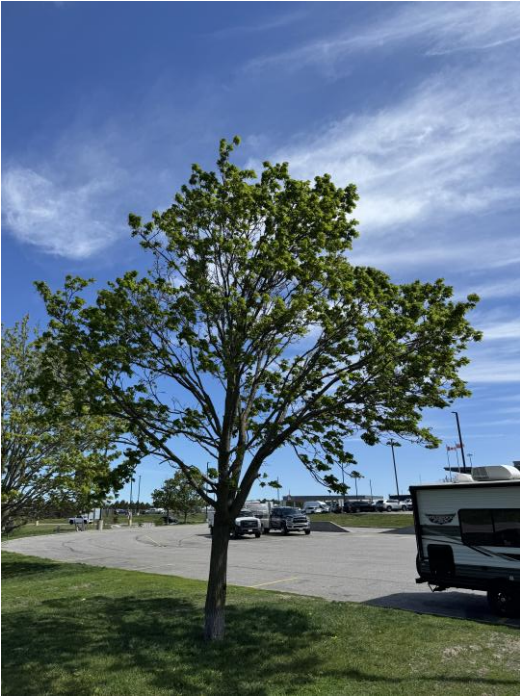
Image 5. Tree 5

| Tree ID # | Species | | DBH | mTPZ | DL | TI | CS | CV | CDB | Comments | Action | Compensation |
|---|---|---|---|---|---|---|---|---|---|---|---|---|
| 5 | <i>Acer platanoides</i> | Norway Maple | 22 | 1.8 | 5 | G | G | G-F | 15 | | Preserve | |

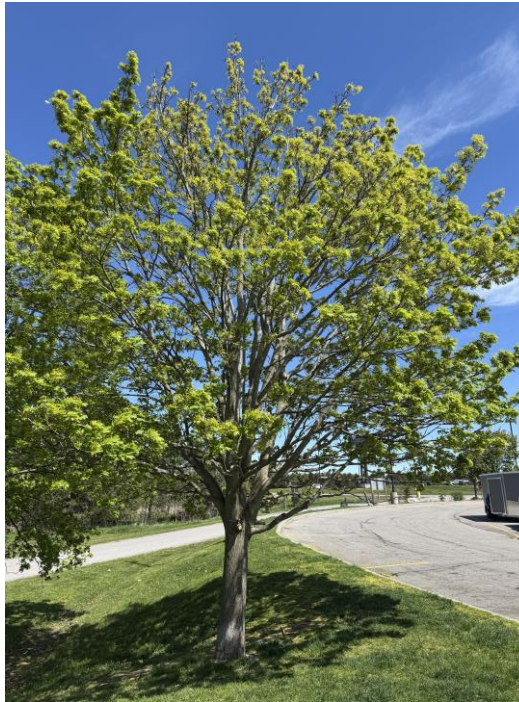
Image 6. Tree 6

| Tree ID # | Species | | DBH | mTPZ | DL | TI | CS | CV | CDB | Comments | Action | Compensation |
|---|---|---|---|---|---|---|---|---|---|---|---|---|
| 6 | <i>Acer platanoides</i> | Norway Maple | 28 | 1.8 | 5 | G | G | G | | | Preserve | |

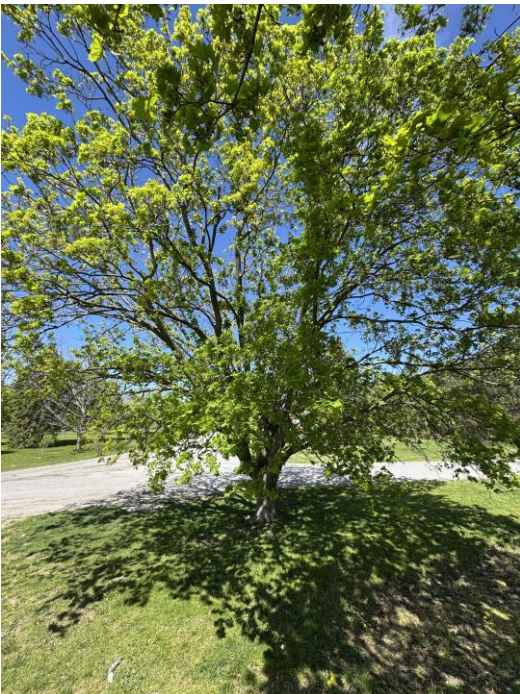
Image 7. Tree 7

| Tree ID # | Species | | DBH | mTPZ | DL | TI | CS | CV | CDB | Comments | Action | Compensation |
|---|---|---|---|---|---|---|---|---|---|---|---|---|
| 7 | <i>Acer platanoides</i> | Norway Maple | 66 | 4.2 | 7 | G | F | G | | Codominant at 1.4m | Preserve | |

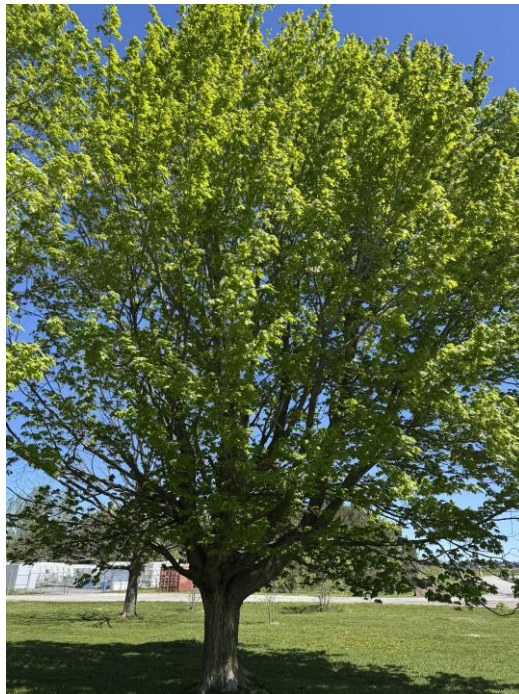
Image 8. Tree 8

| Tree ID # | Species | | DBH | mTPZ | DL | TI | CS | CV | CDB | Comments | Action | Compensation |
|---|---|---|---|---|---|---|---|---|---|---|---|---|
| 8 | <i>Acer saccharum</i> | Sugar Maple | 56 | 3.6 | 8 | G | G | G | | | Remove | 4 |

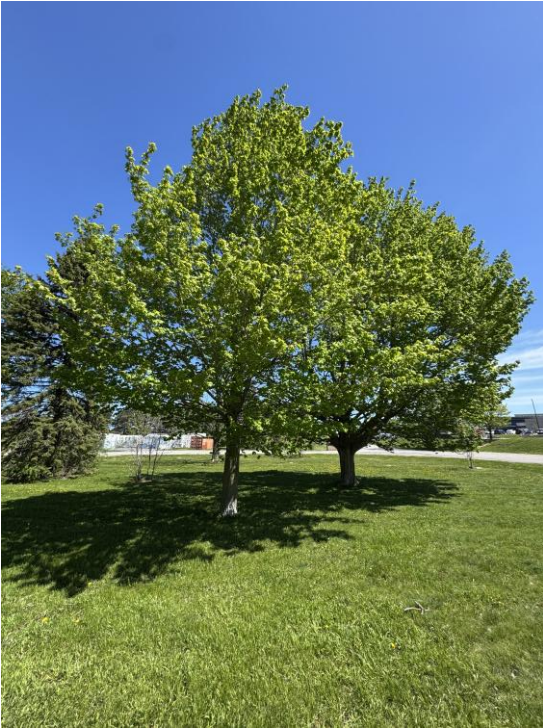
Image 9. Tree 9

| Tree ID # | Species | | DBH | mTPZ | DL | TI | CS | CV | CDB | Comments | Action | Compensation |
|---|---|---|---|---|---|---|---|---|---|---|---|---|
| 9 | <i>Acer saccharum</i> | Sugar Maple | 32 | 2.4 | 5 | G | G | G | | | Remove | 2 |

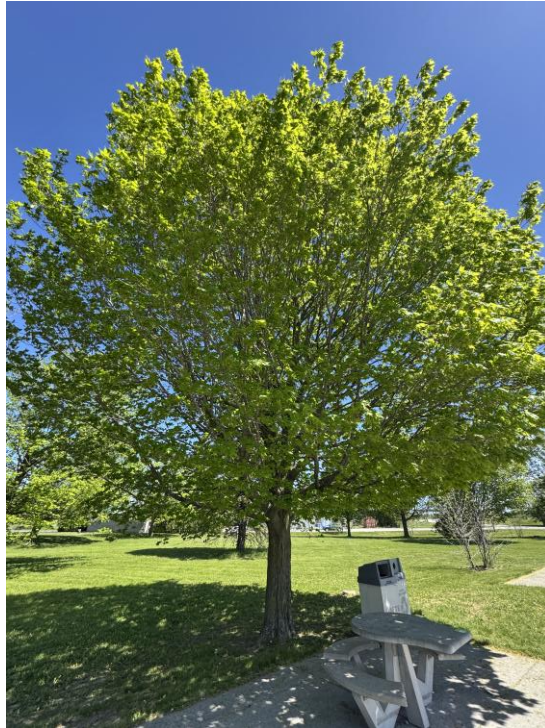
Image 10. Tree 10

| Tree ID # | Species | | DBH | mTPZ | DL | TI | CS | CV | CDB | Comments | Action | Compensation |
|---|---|---|---|---|---|---|---|---|---|---|---|---|
| 10 | <i>Acer saccharum</i> | Sugar Maple | 40 | 2.4 | 6 | G | G | G | | | Preserve | |

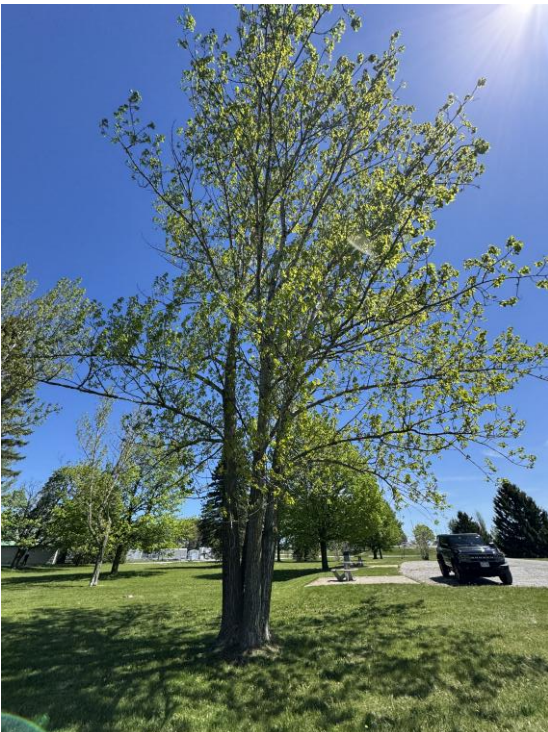
Image 11. Tree 11

| Tree ID # | Species | | DBH | mTPZ | DL | TI | CS | CV | CDB | Comments | Action | Compensation |
|---|---|---|---|---|---|---|---|---|---|---|---|---|
| 11 | <i>Populus deltoides</i> | Eastern Cottonwood | 27,30,31,35 | 4.2 | 9 | G-F | F | G-F | | Codominant at base | Preserve | |

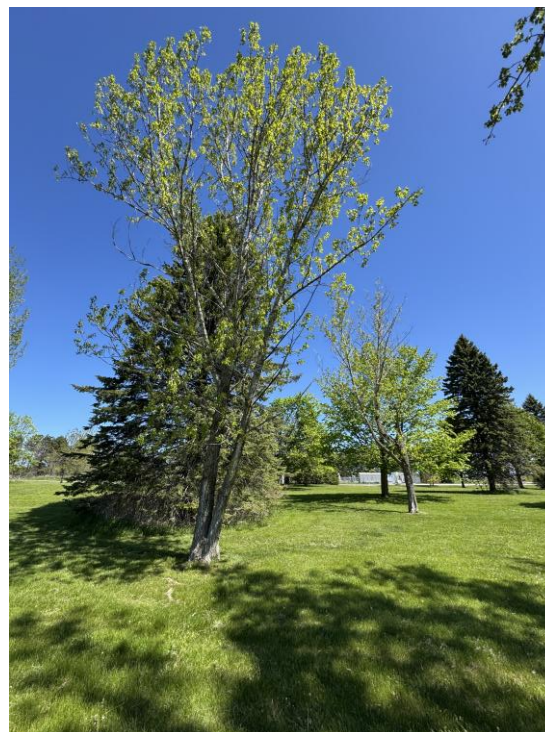
Image 12. Tree 12

| Tree ID # | Species | | DBH | mTPZ | DL | TI | CS | CV | CDB | Comments | Action | Compensation |
|---|---|---|---|---|---|---|---|---|---|---|---|---|
| 12 | <i>Populus deltoides</i> | Eastern Cottonwood | 20,28 | 2.4 | 6 | F | F | F | 15 | Codominant at base | Preserve | |

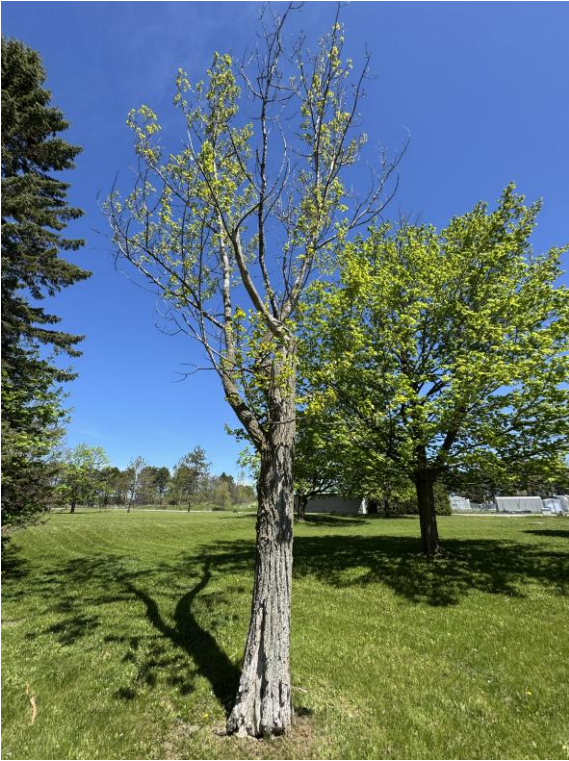
Image 13. Tree 13

| Tree ID # | Species | | DBH | mTPZ | DL | TI | CS | CV | CDB | Comments | Action | Compensation |
|---|---|---|---|---|---|---|---|---|---|---|---|---|
| 13 | <i>Populus deltoides</i> | Eastern Cottonwood | 31 | 2.4 | 4 | F | F-P | F-P | 40 | Asymmetrical crown (M), poor form (H) | Preserve | |

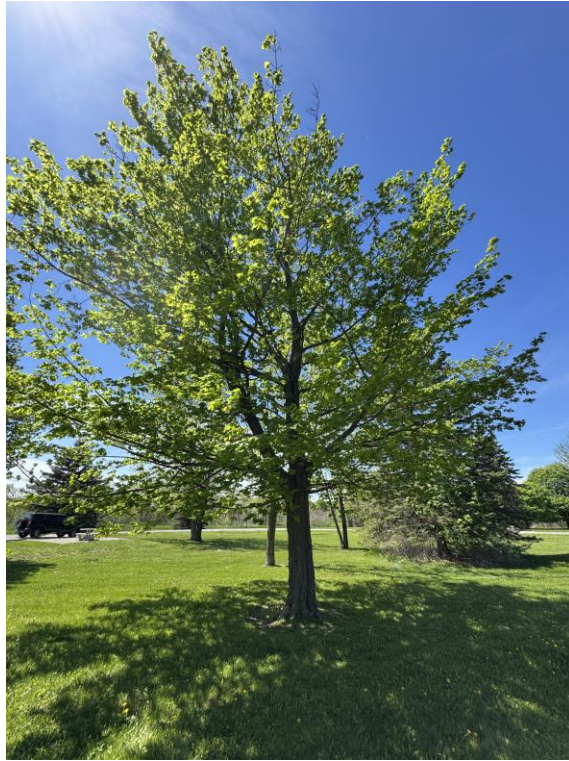
Image 14. Tree 14

| Tree ID # | Species | | DBH | mTPZ | DL | TI | CS | CV | CDB | Comments | Action | Compensation |
|---|---|---|---|---|---|---|---|---|---|---|---|---|
| 14 | <i>Acer saccharum</i> | Sugar Maple | 40 | 2.4 | 6 | G | G | G | | | Preserve | |

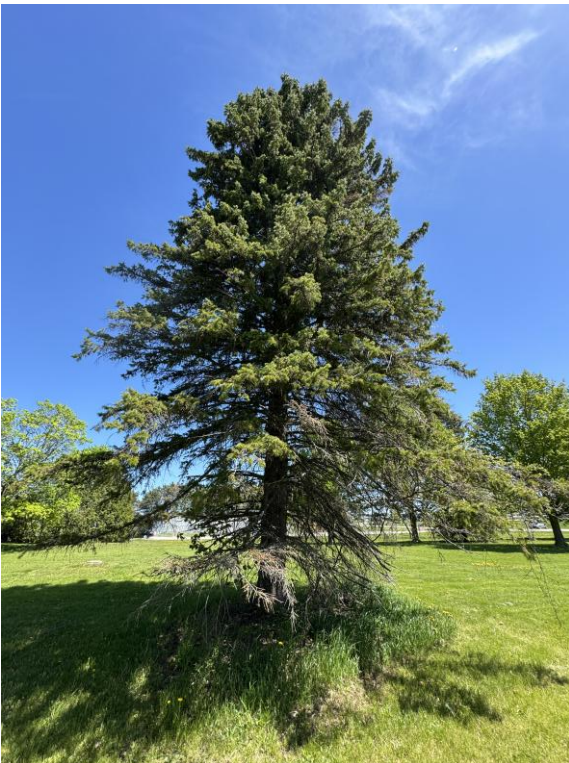
Image 15. Tree 15

| Tree ID # | Species | | DBH | mTPZ | DL | TI | CS | CV | CDB | Comments | Action | Compensation |
|---|---|---|---|---|---|---|---|---|---|---|---|---|
| 15 | <i>Picea pungens</i> | Blue Spruce | ~51 | 3.6 | 5 | G | G | F | 20 | | Preserve | |

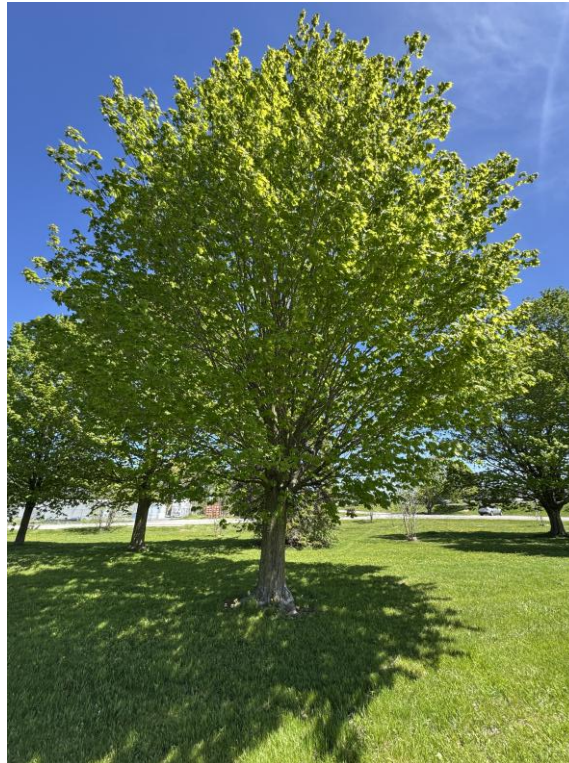
Image 16. Tree 16

| Tree ID # | Species | | DBH | mTPZ | DL | TI | CS | CV | CDB | Comments | Action | Compensation |
|---|---|---|---|---|---|---|---|---|---|---|---|---|
| 16 | <i>Acer platanoides</i> | Norway Maple | 40 | 2.4 | 6.5 | G | G | G | | | Remove | 3 |

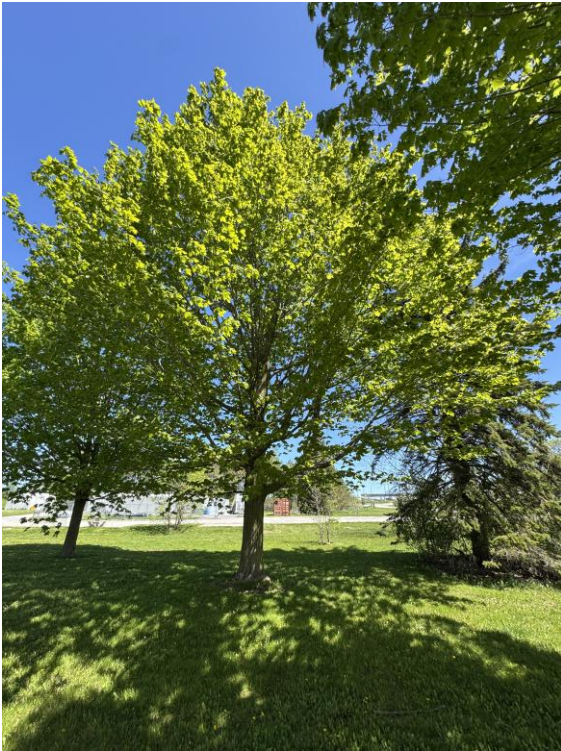
Image 17. Tree 17

| Tree ID # | Species | | DBH | mTPZ | DL | TI | CS | CV | CDB | Comments | Action | Compensation |
|---|---|---|---|---|---|---|---|---|---|---|---|---|
| 17 | <i>Acer saccharum</i> | Sugar Maple | 44 | 3 | 6.5 | G | G | G | | | Remove | 3 |

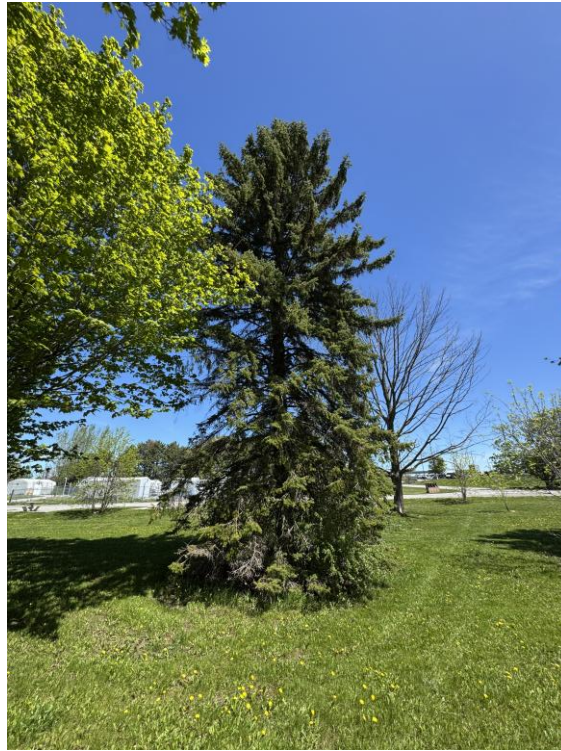
Image 18. Tree 18

| Tree ID # | Species | | DBH | mTPZ | DL | TI | CS | CV | CDB | Comments | Action | Compensation |
|---|---|---|---|---|---|---|---|---|---|---|---|---|
| 18 | <i>Picea pungens</i> | Blue Spruce | 43 | 3 | 5 | G | G | G | | | Remove | 3 |

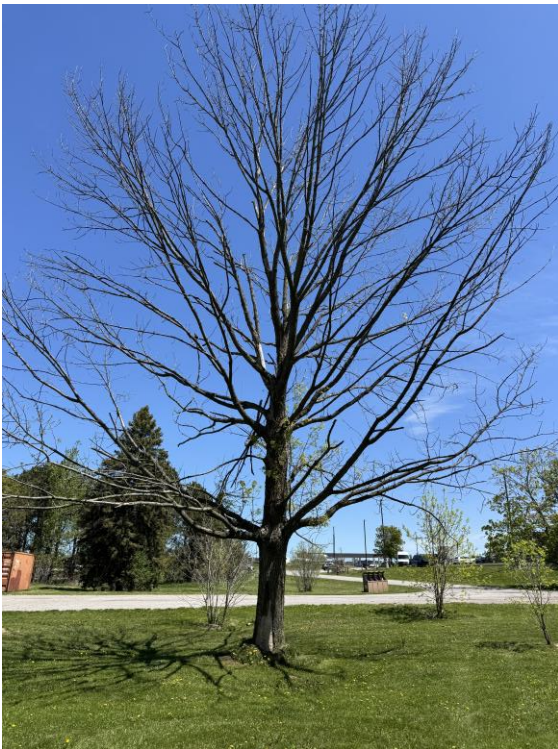
Image 19. Tree 19

| Tree ID # | Species | | DBH | mTPZ | DL | TI | CS | CV | CDB | Comments | Action | Compensation |
|---|---|---|---|---|---|---|---|---|---|---|---|---|
| 19 | <i>Fraxinus pennsylvanica</i> | Green Ash | 46 | 3 | 7 | F | F | P | 90 | Emerald ash borer (H), epicormic branching (H) | Remove | 0 |

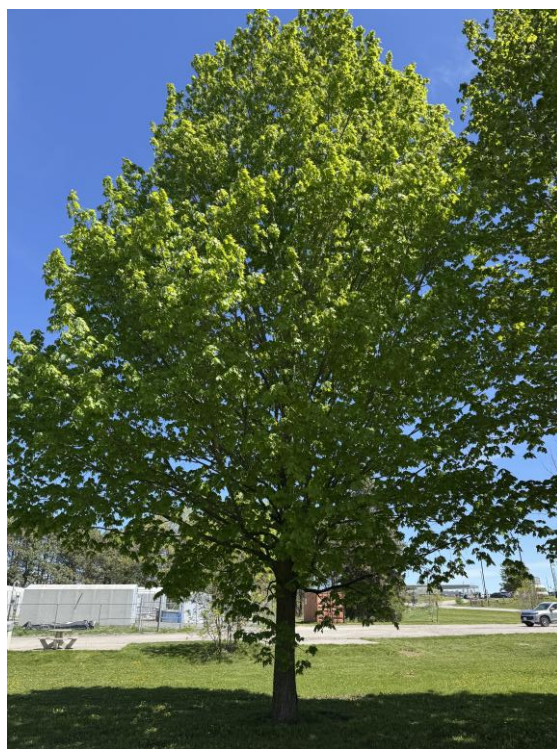
Image 20. Tree 20

| Tree ID # | Species | | DBH | mTPZ | DL | TI | CS | CV | CDB | Comments | Action | Compensation |
|---|---|---|---|---|---|---|---|---|---|---|---|---|
| 20 | <i>Acer platanoides</i> | Norway Maple | 21 | 1.8 | 6.5 | G | G | G | | | Remove | 1 |

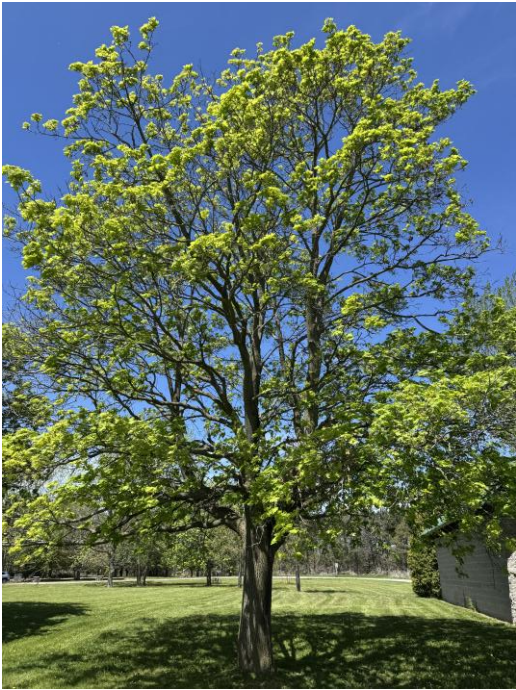
Image 21. Tree 21

| Tree ID # | Species | | DBH | mTPZ | DL | TI | CS | CV | CDB | Comments | Action | Compensation |
|---|---|---|---|---|---|---|---|---|---|---|---|---|
| 21 | <i>Acer platanoides</i> | Norway Maple | 44 | 3 | 6.5 | G | G | G | | | Preserve | |

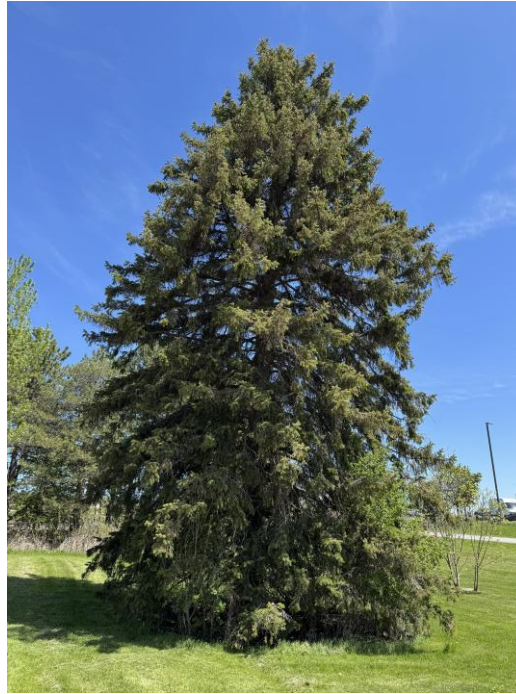
Image 22. Tree 22

| Tree ID # | Species | | DBH | mTPZ | DL | TI | CS | CV | CDB | Comments | Action | Compensation |
|---|---|---|---|---|---|---|---|---|---|---|---|---|
| 22 | <i>Picea glauca</i> | White Spruce | 56 | 3.6 | 5 | G | G | G | | | Preserve | |
