**PHASE II ENVIRONMENTAL
SITE ASSESSMENT REPORT
EXISTING VACANT PROPERTY
CROFT STREET,
PORT HOPE, ONTARIO
PROJECT NO. G022881E1**

Roseglen Village For Seniors Inc.
53 Wellington Street
Port Hope, ON
L1A 2M5

GEO-LOGIC INC.

APRIL 2010

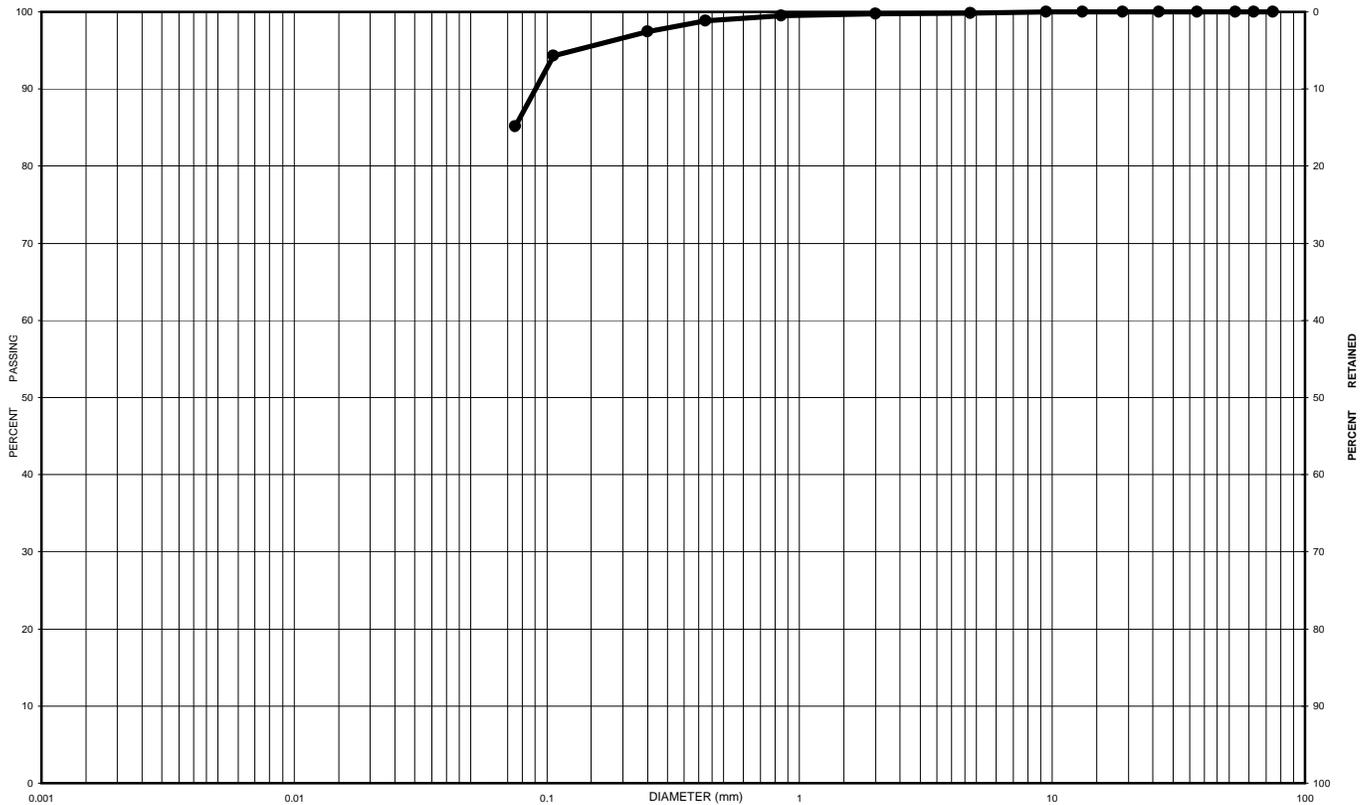
Client:	Roseglen	Ref No.:	G022881E1
Project:	ESA	Location:	53 Wellington, Port Hope
Borehole No.:	TP9	Sample No.:	1
Depth:	18"	Enclosure:	F-13

Sample No.	Depth	Description	Gravel	Sand	Silt	Clay	Class.
TP9, 1	18"		0	15	85

analysis. The results of the testing indicate a soil distribution of 0 to 3 percent gravel, 18 to 24 percent sand, 76 to 82 percent silt and clay sized particles by weight.
