**Heritage Impact Assessment
86 John Street
Municipality of Port Hope
County of Northumberland
Lot 6, Concession 1
Geographic Township of Hope
Former Durham County**

Project # 2021-0636

**Original
20/02/2025**

**Revised
15/08/2025**

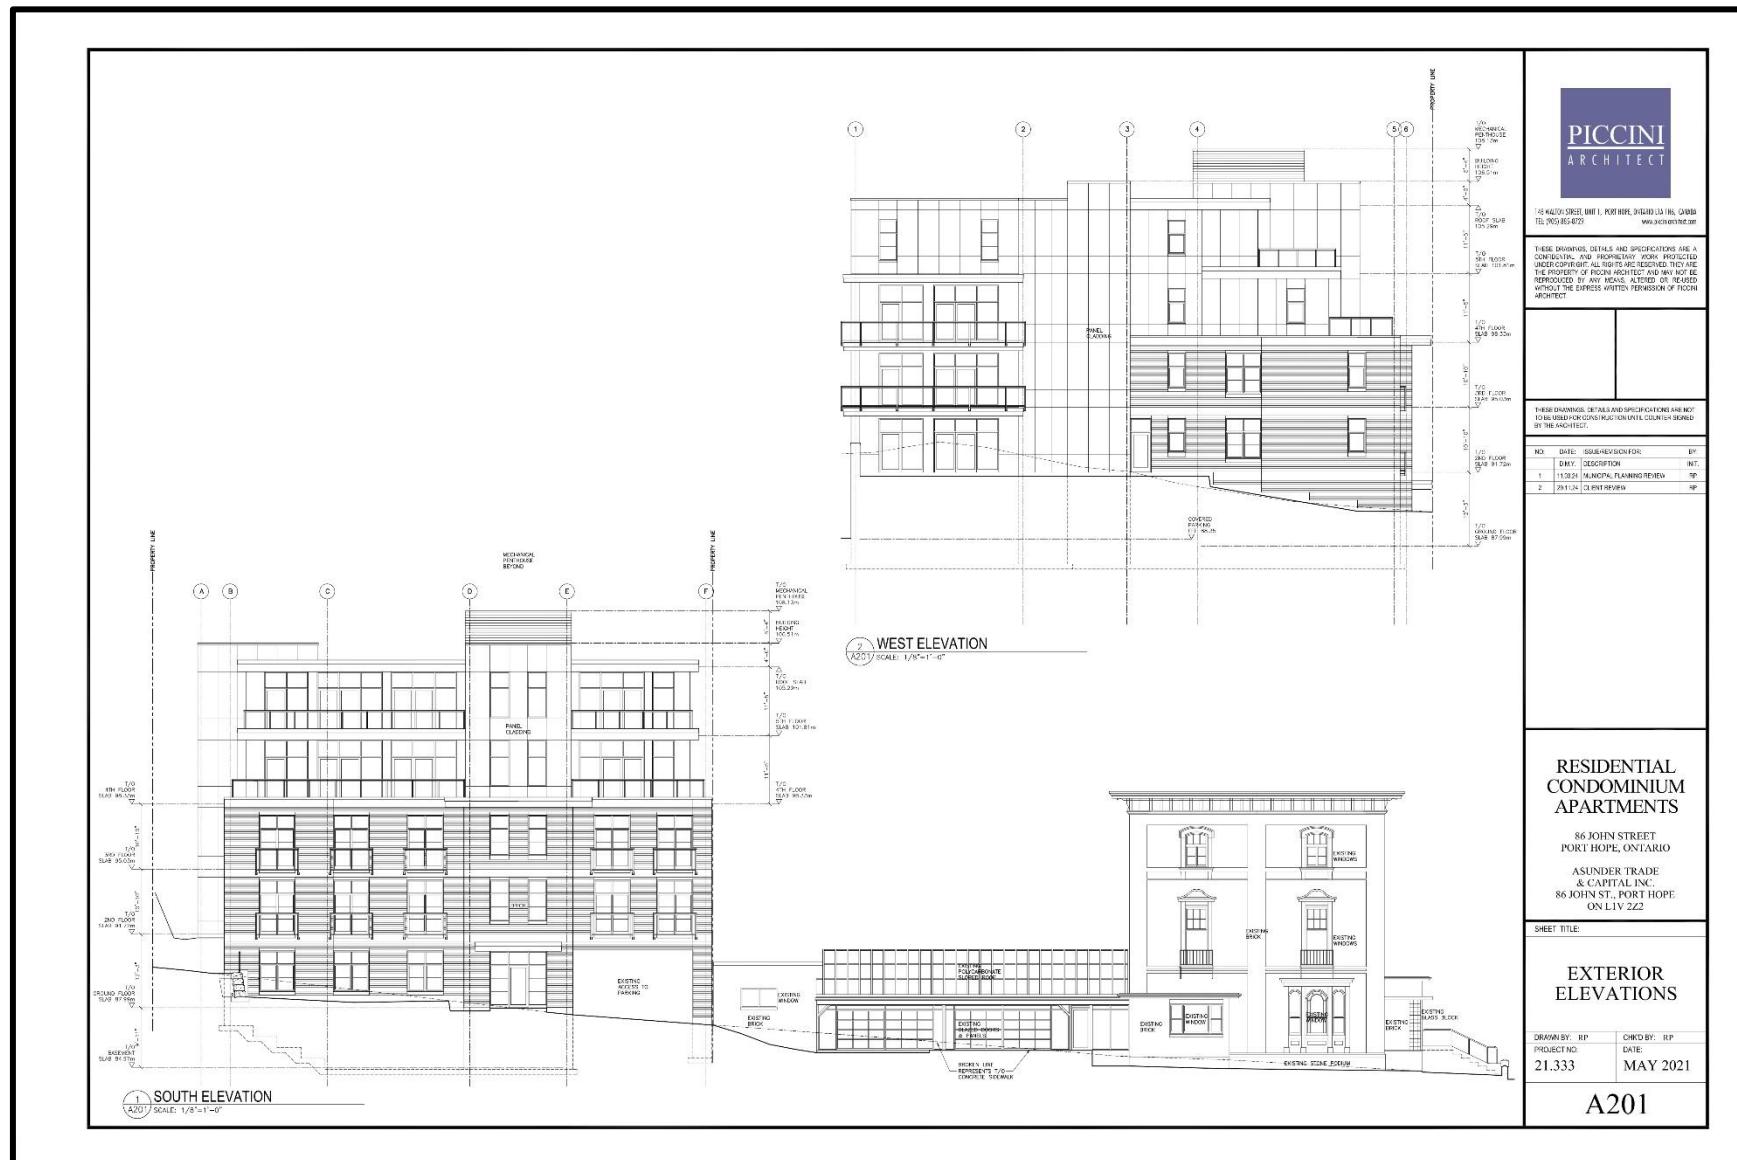
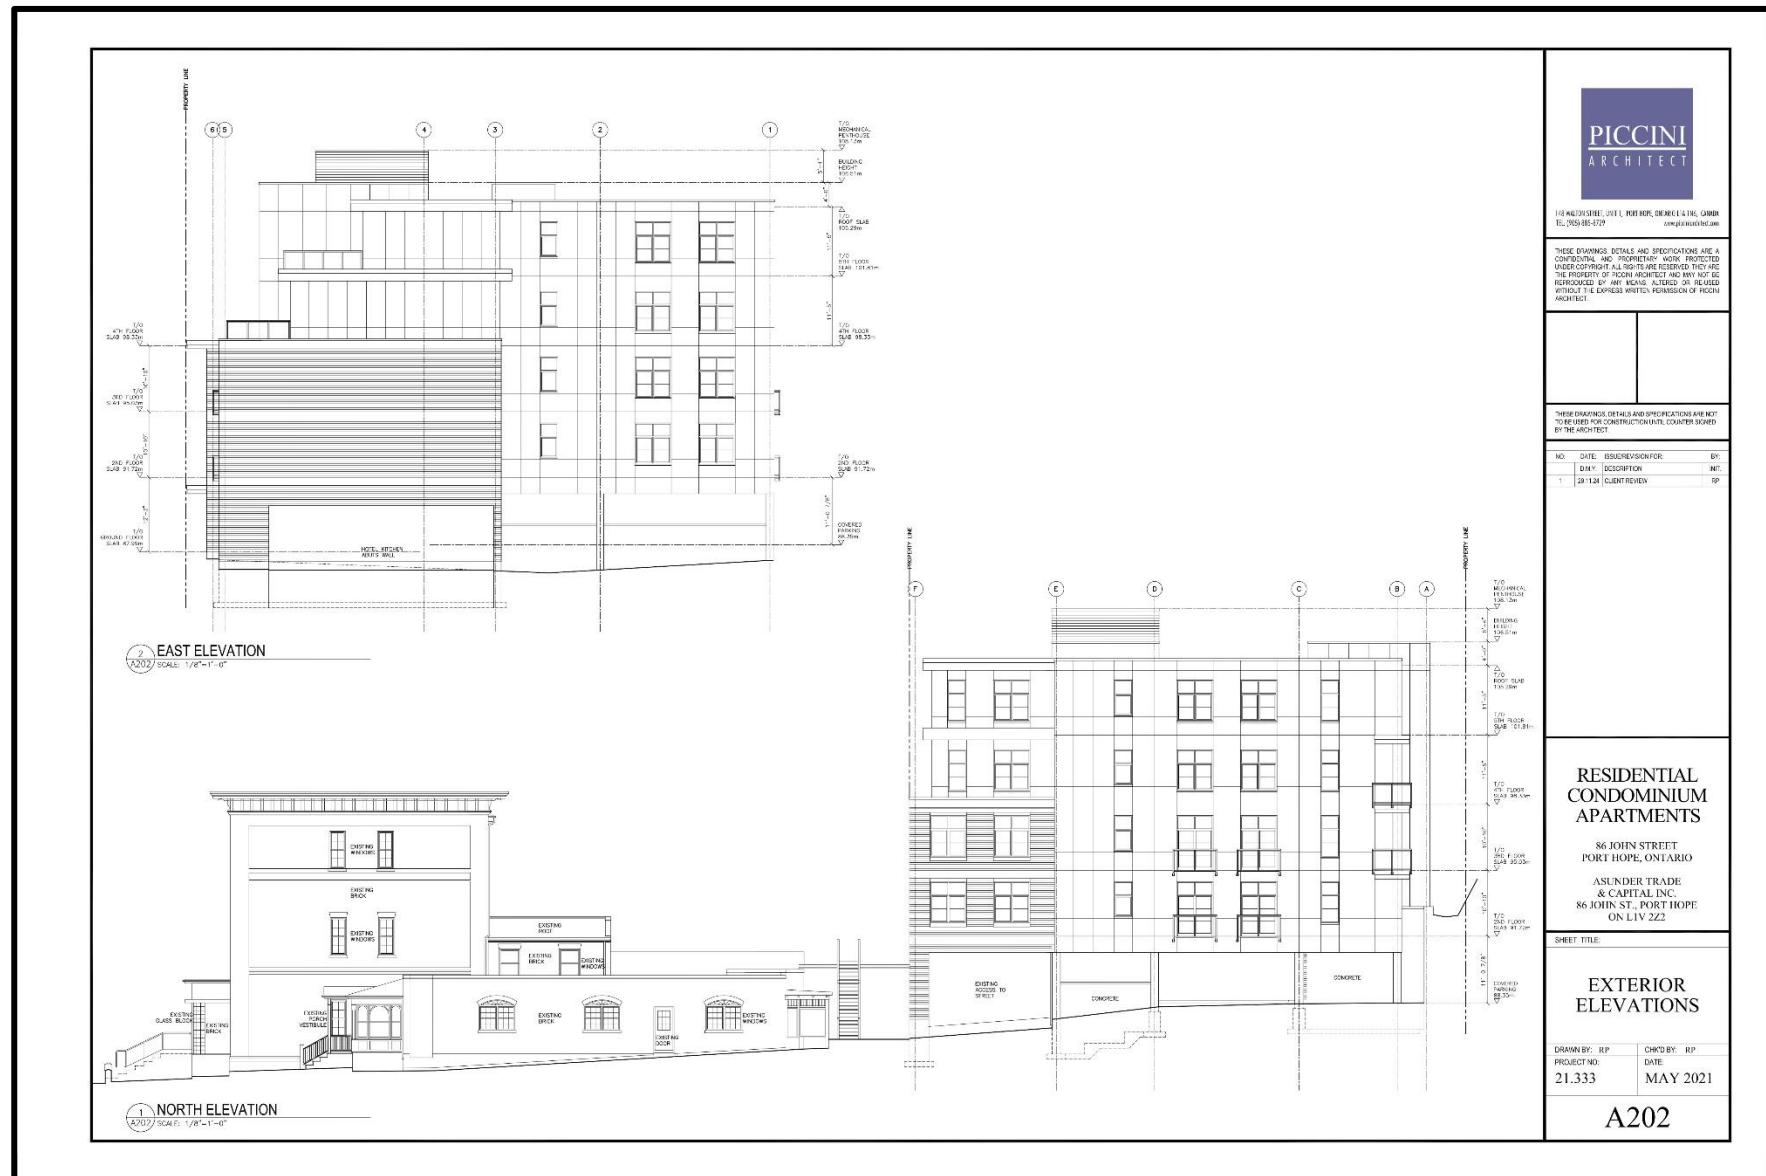
Figure 4: Proposed Development – Exterior Elevations
(Piccini Architect 2021)

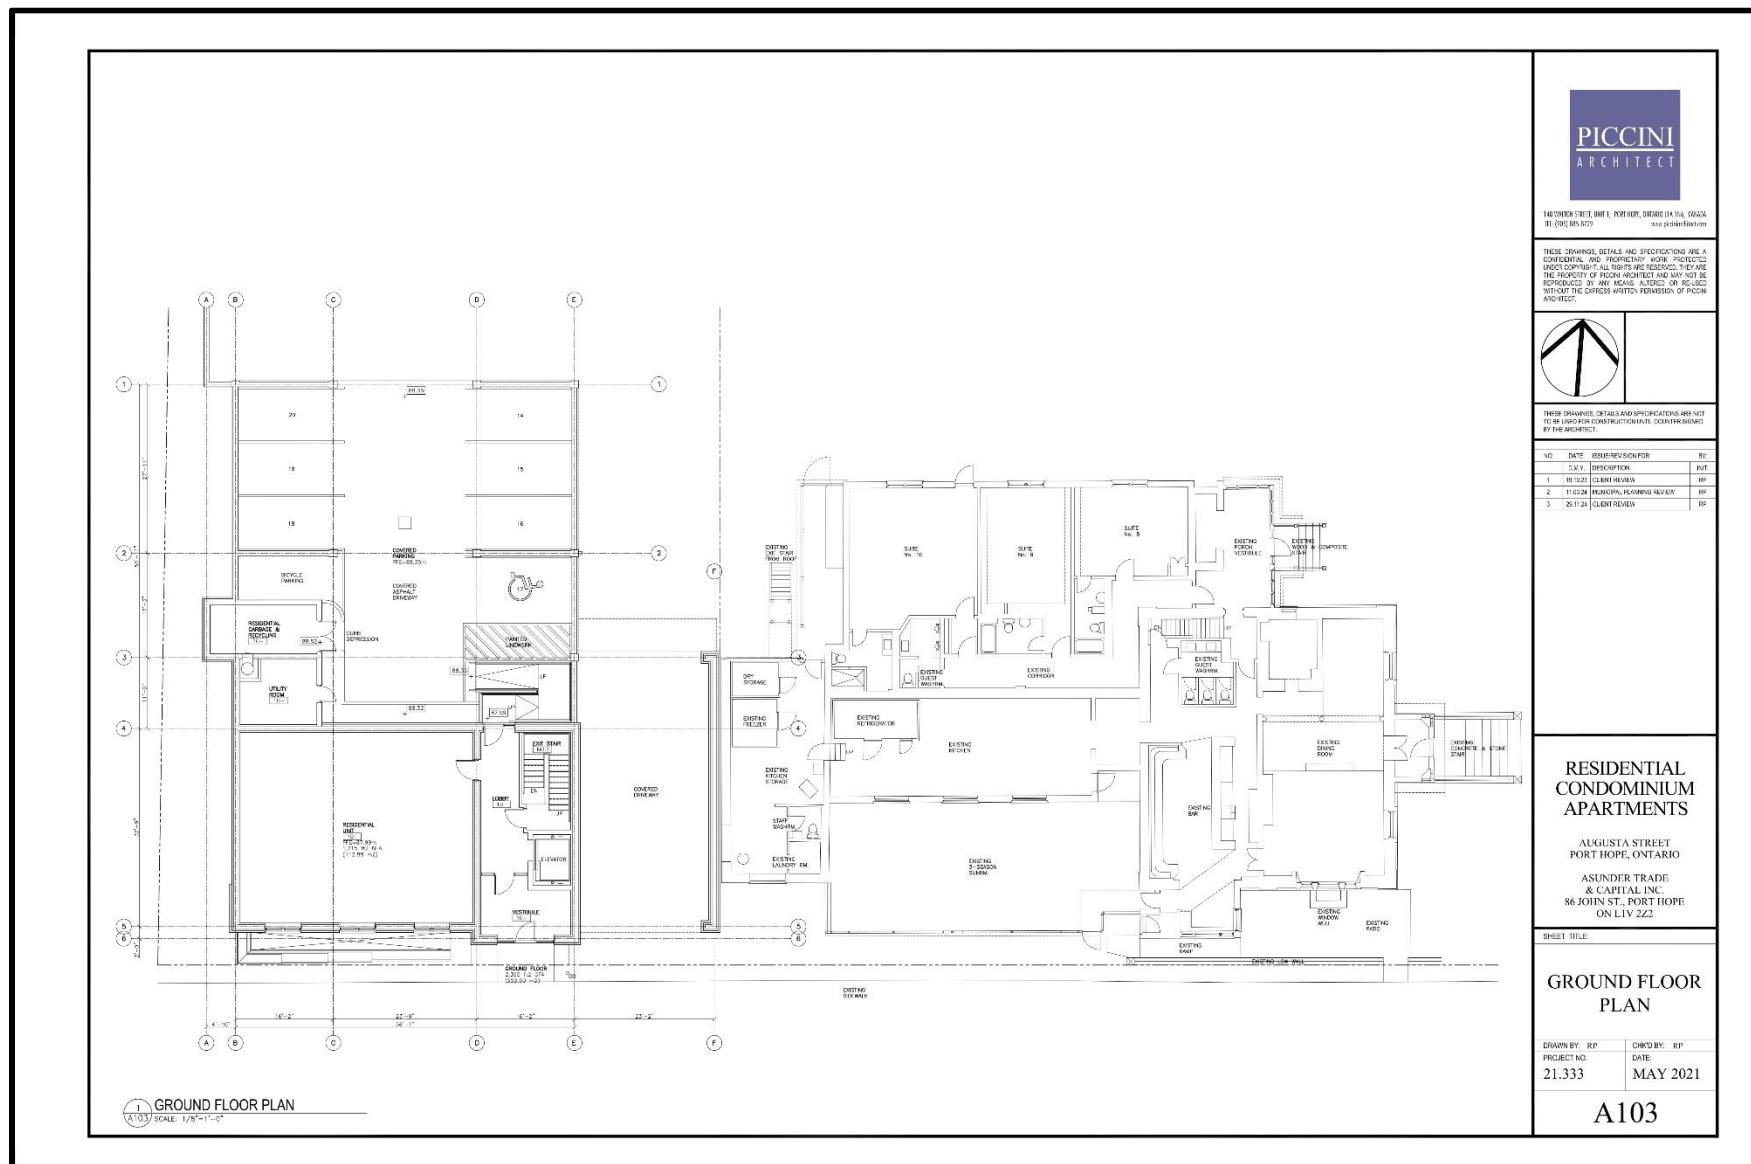
**Figure 5: Proposed Development – Ground Floor Plan
(Piccini Architect 2021)**

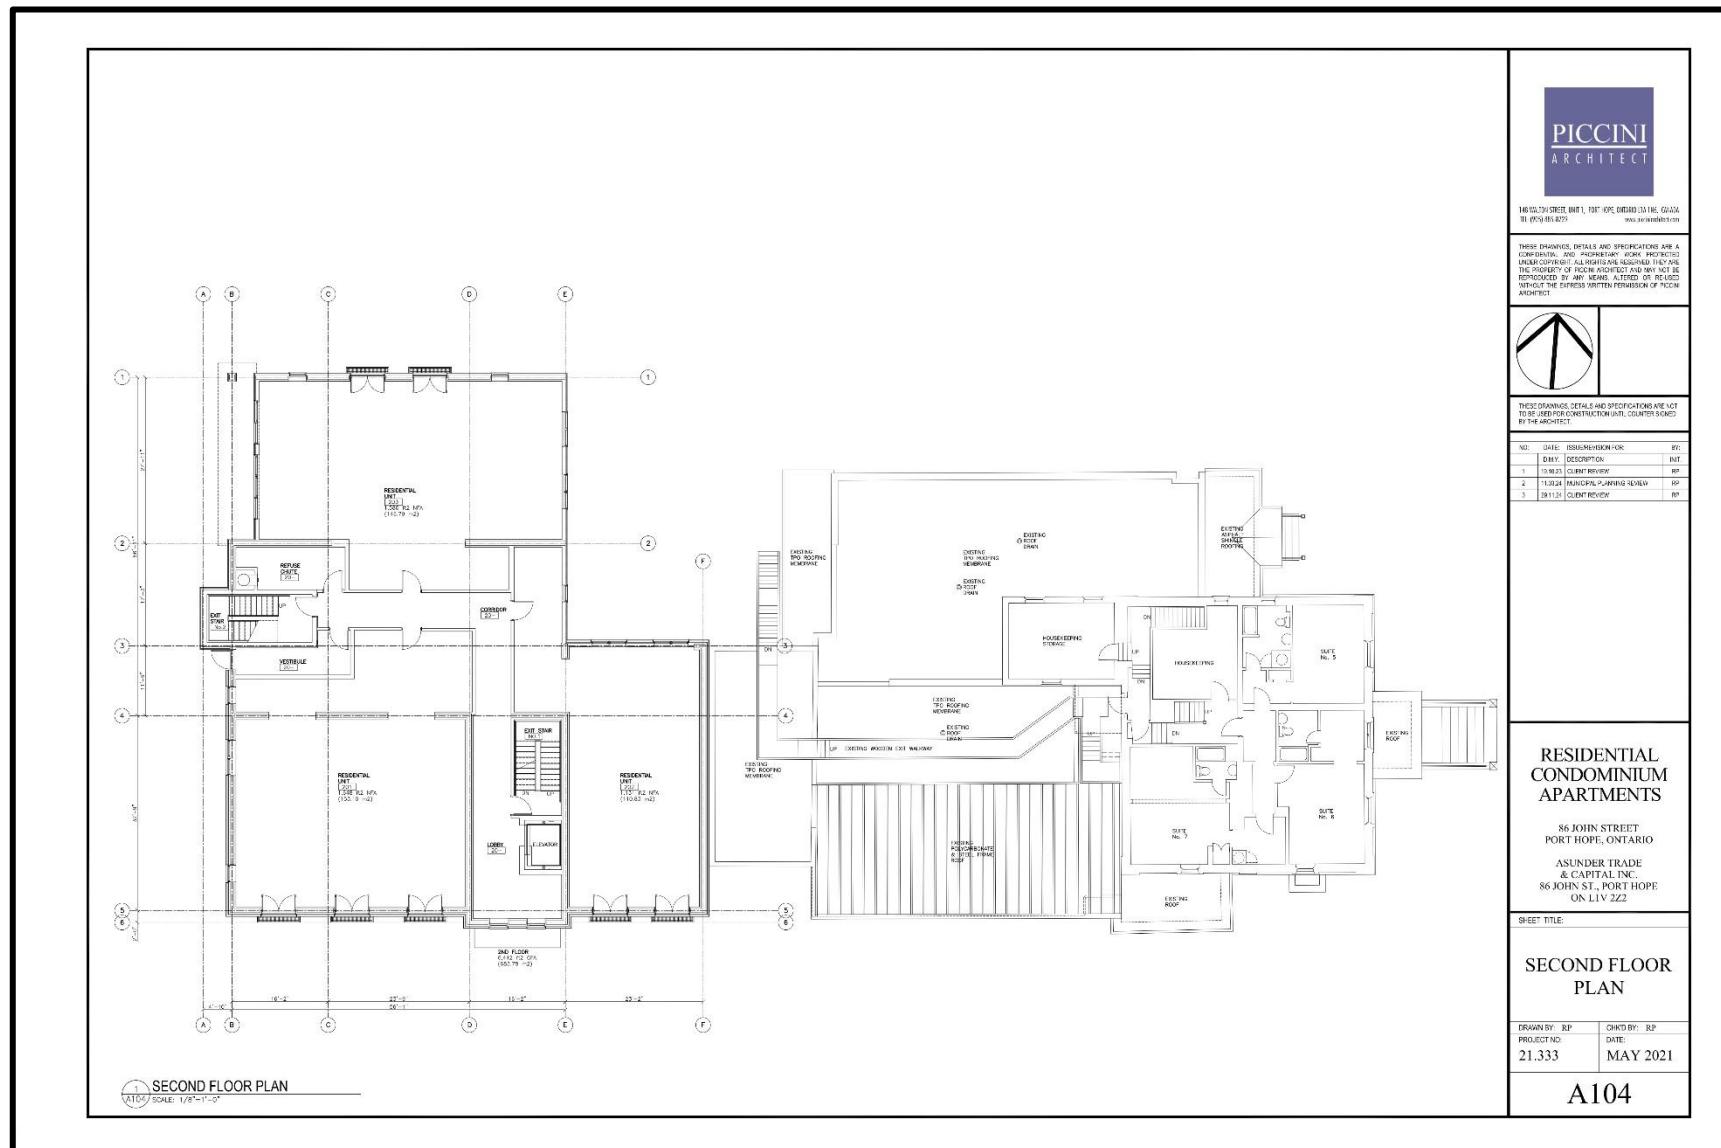
Figure 6: Proposed Development – Second Floor Plan
(Piccini Architect 2021)

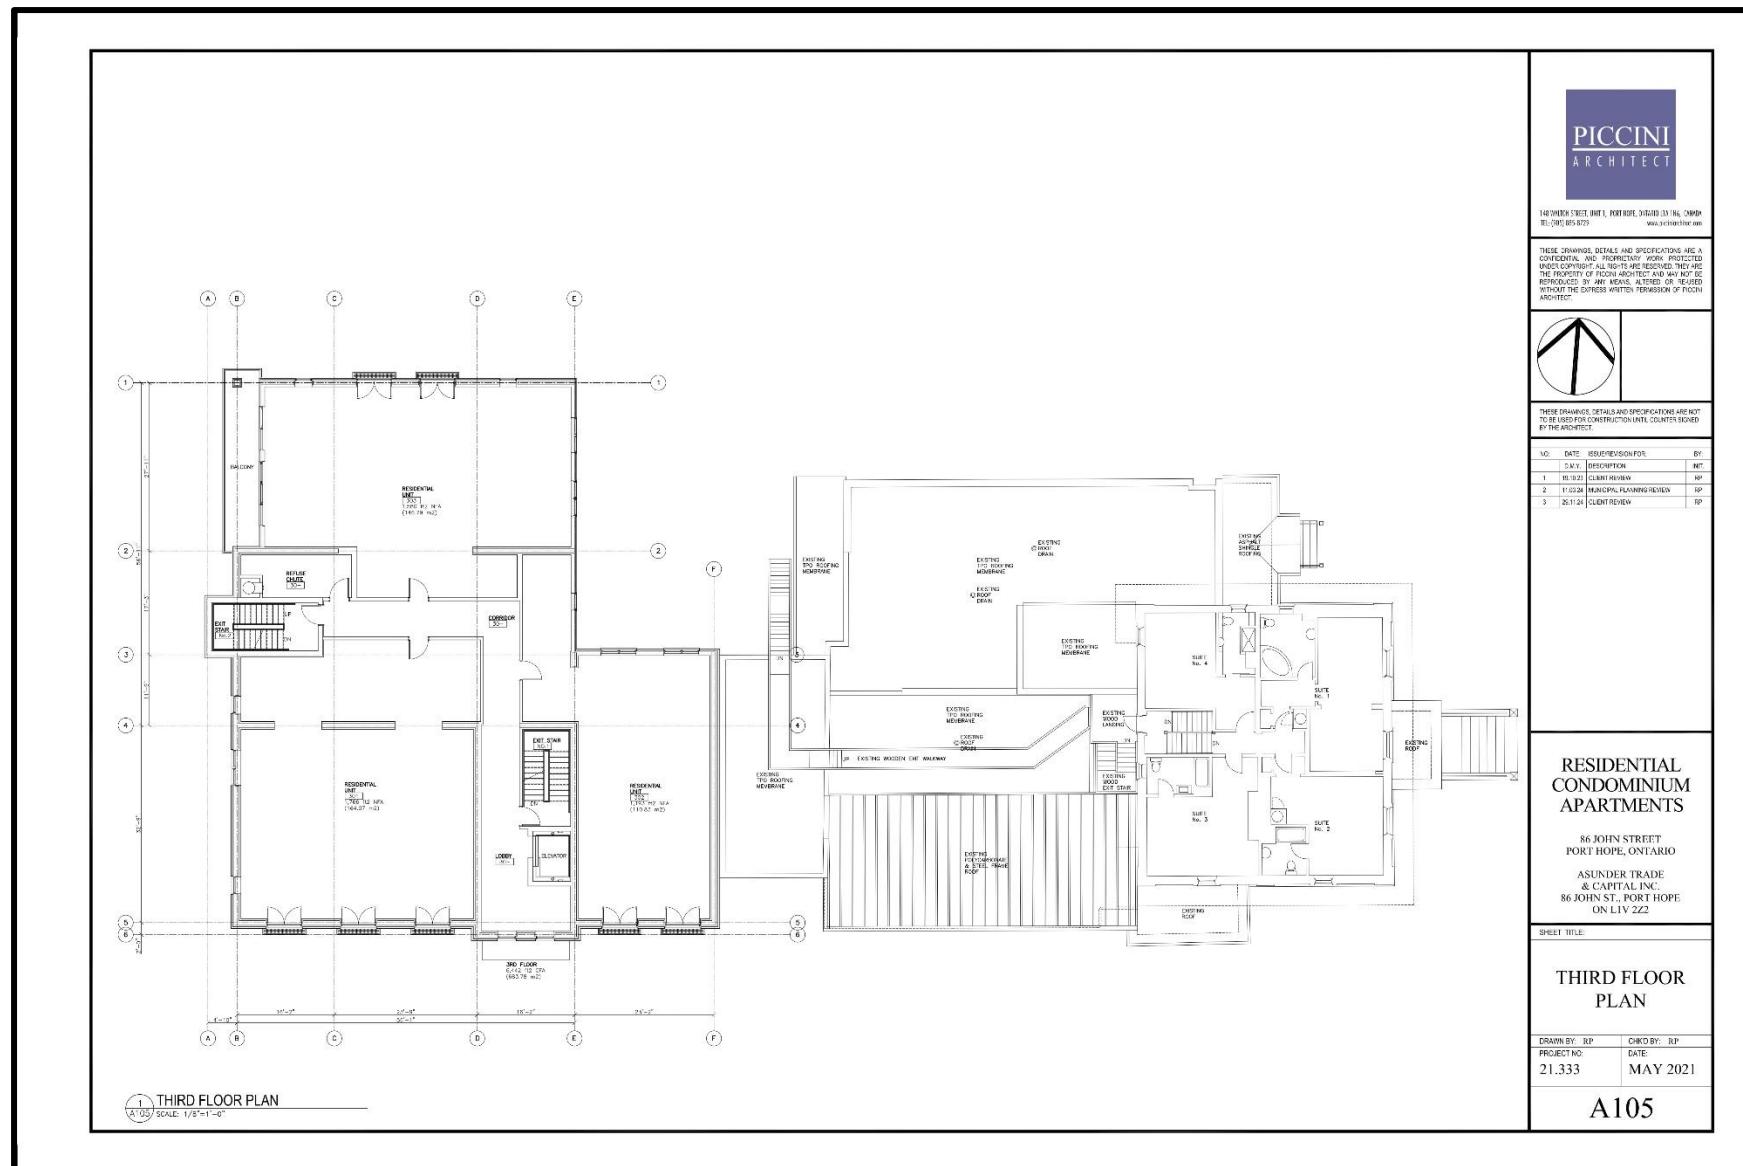
Figure 7: Proposed Development – Third Floor Plan
(Piccini Architect 2021)

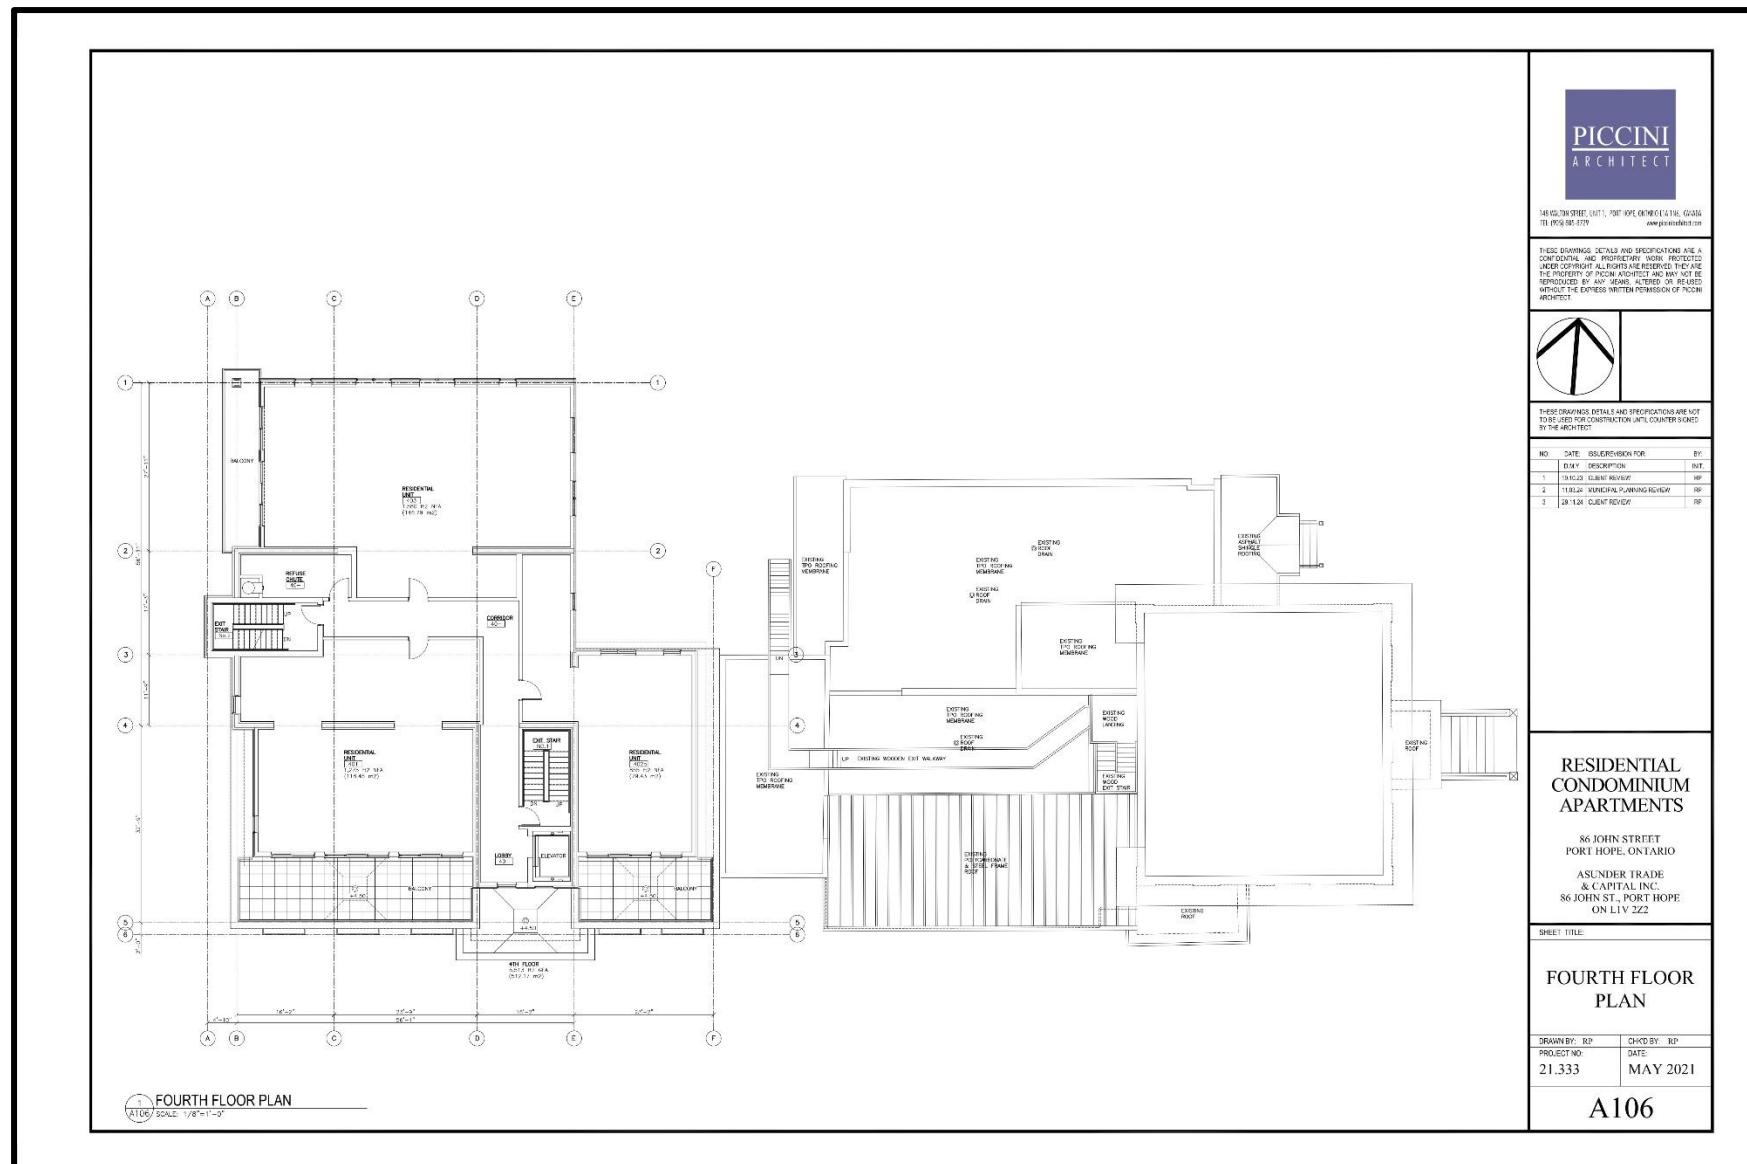
Figure 8: Proposed Development – Fourth Floor Plan
(Piccini Architect 2021)

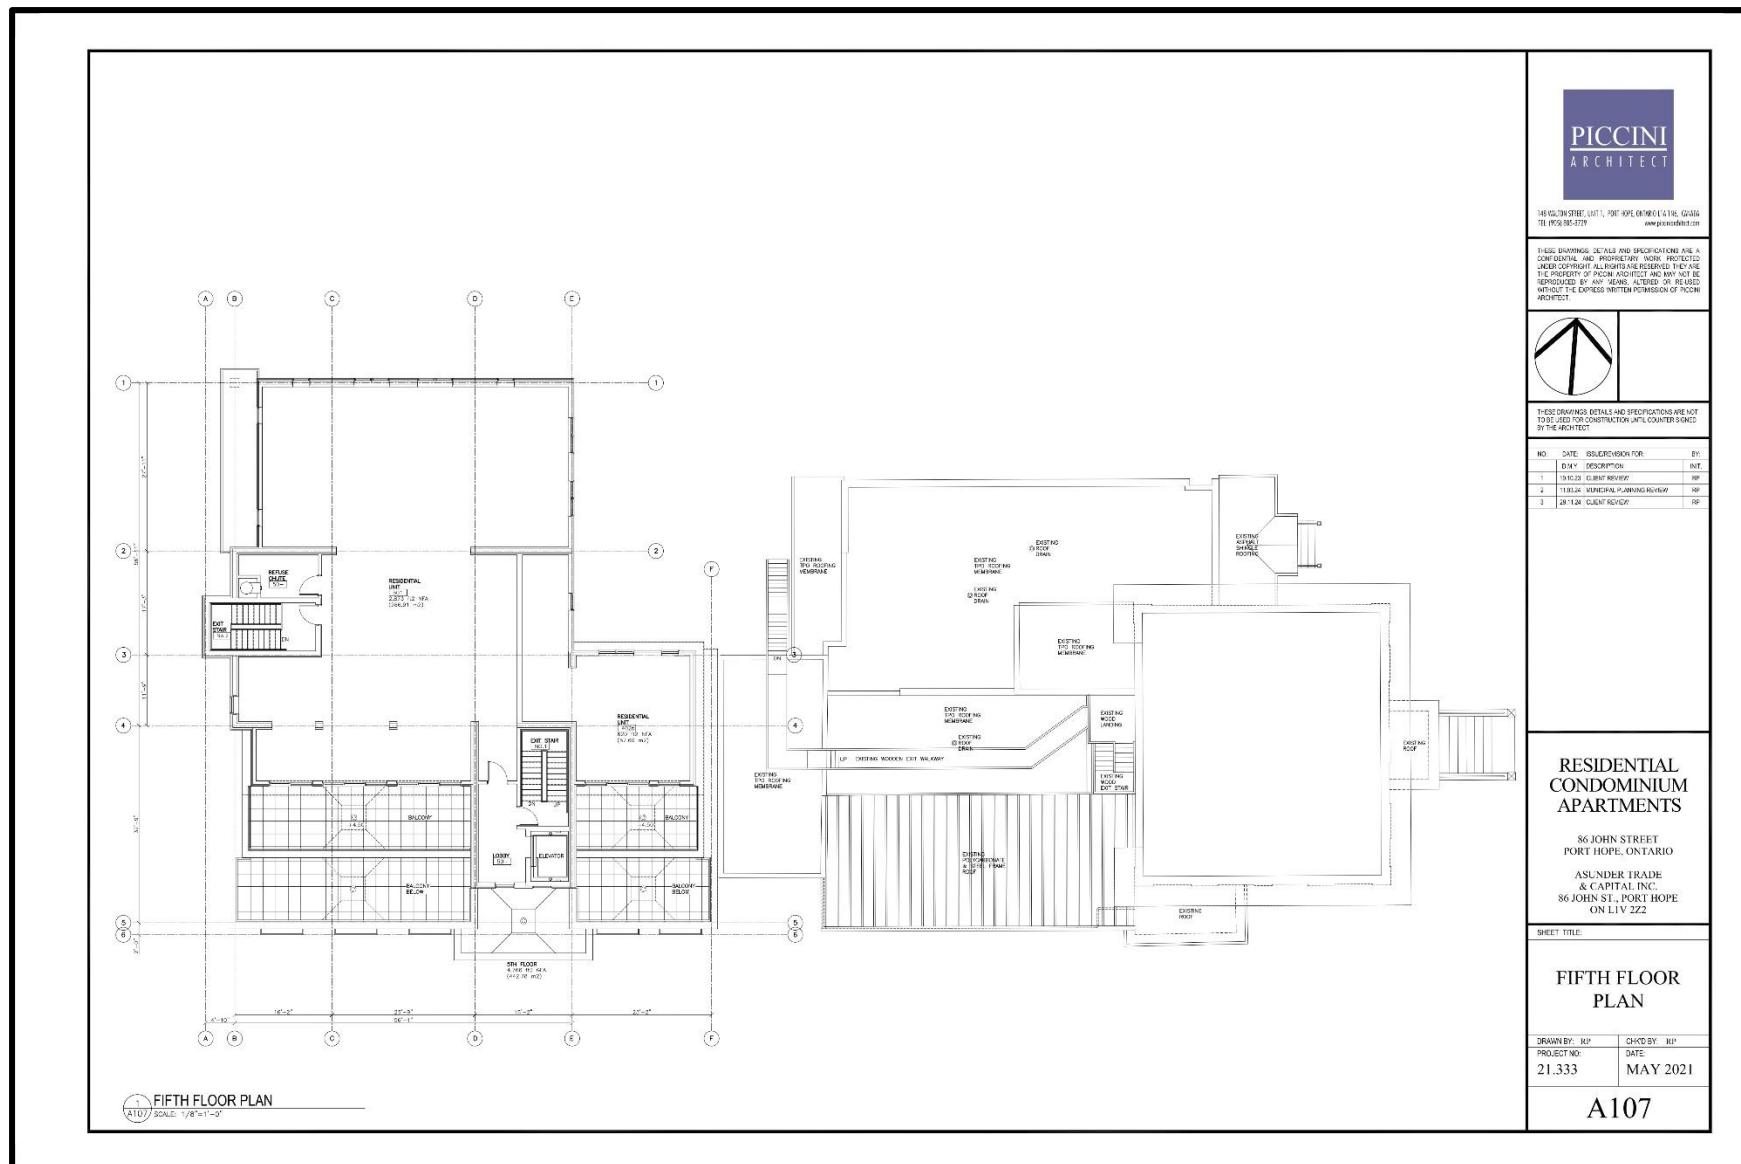
**Figure 9: Proposed Development – Fifth Floor Plan
(Piccini Architect 2021)**

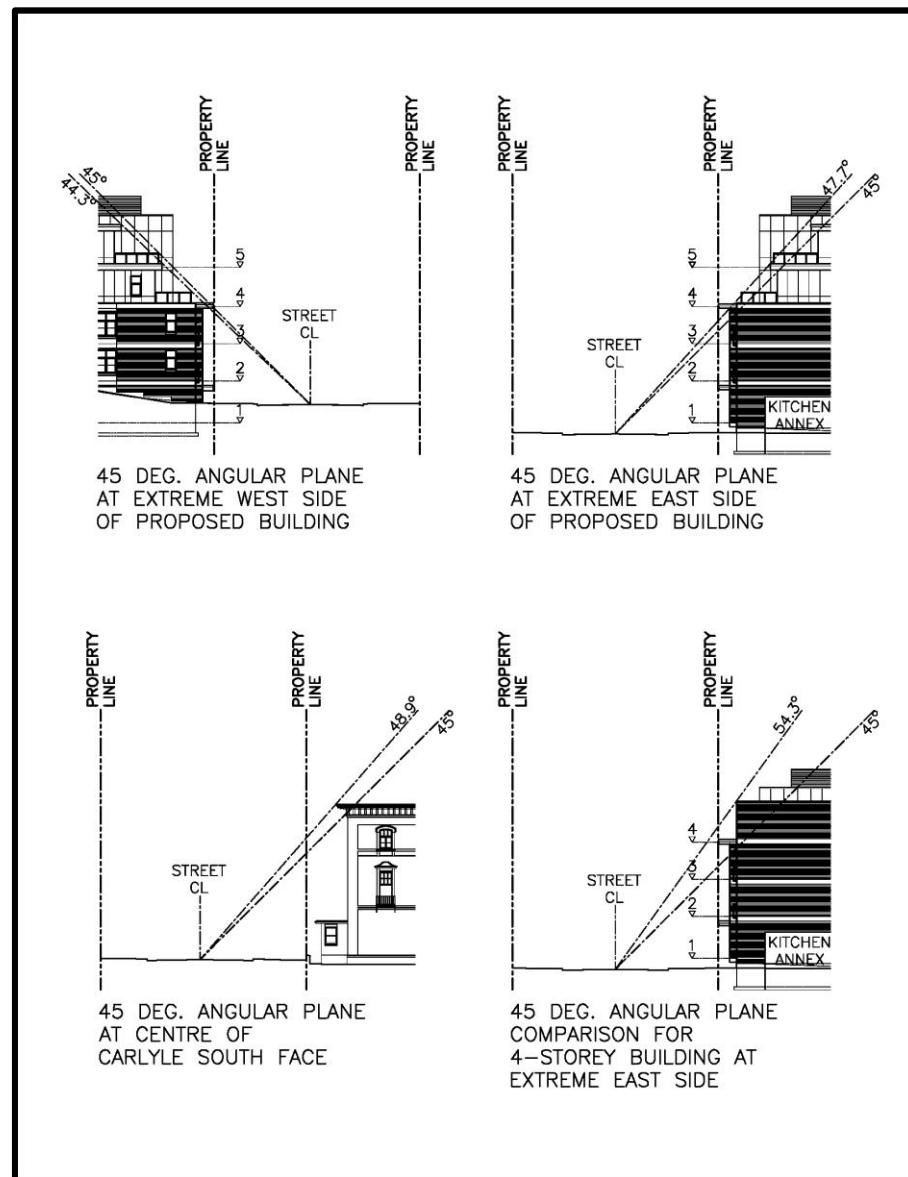
Figure 15: Proposed Development – Angular Plane of Proposed Design and 4-Storey Building
(Piccini Architect 2025)

The angular plane diagrams of the proposed 5-storey building show how the 3-storey base and terraced setbacks of the 4th and 5th floors help to maintain a consistent streetscape with respect to the existing hotel and heavily treed lot to the west. This is in keeping with the commercial nature of Augusta Street, east of the Pine Street intersection, and an appropriate development for the southernmost boundary of the John, Ontario, Queen Streets Heritage Conservation District (JOQSHCD).

These images can be found in Figure 15.
