Our ref: 11216754-01

**Re: Evaluation of ANSI Pitted Outwash Plain in Proposed Rural Subdivision  
Garden Hill, Cobourg, Ontario**

**Outwash Plain Investigation  
SITE LOCATION PLAN**

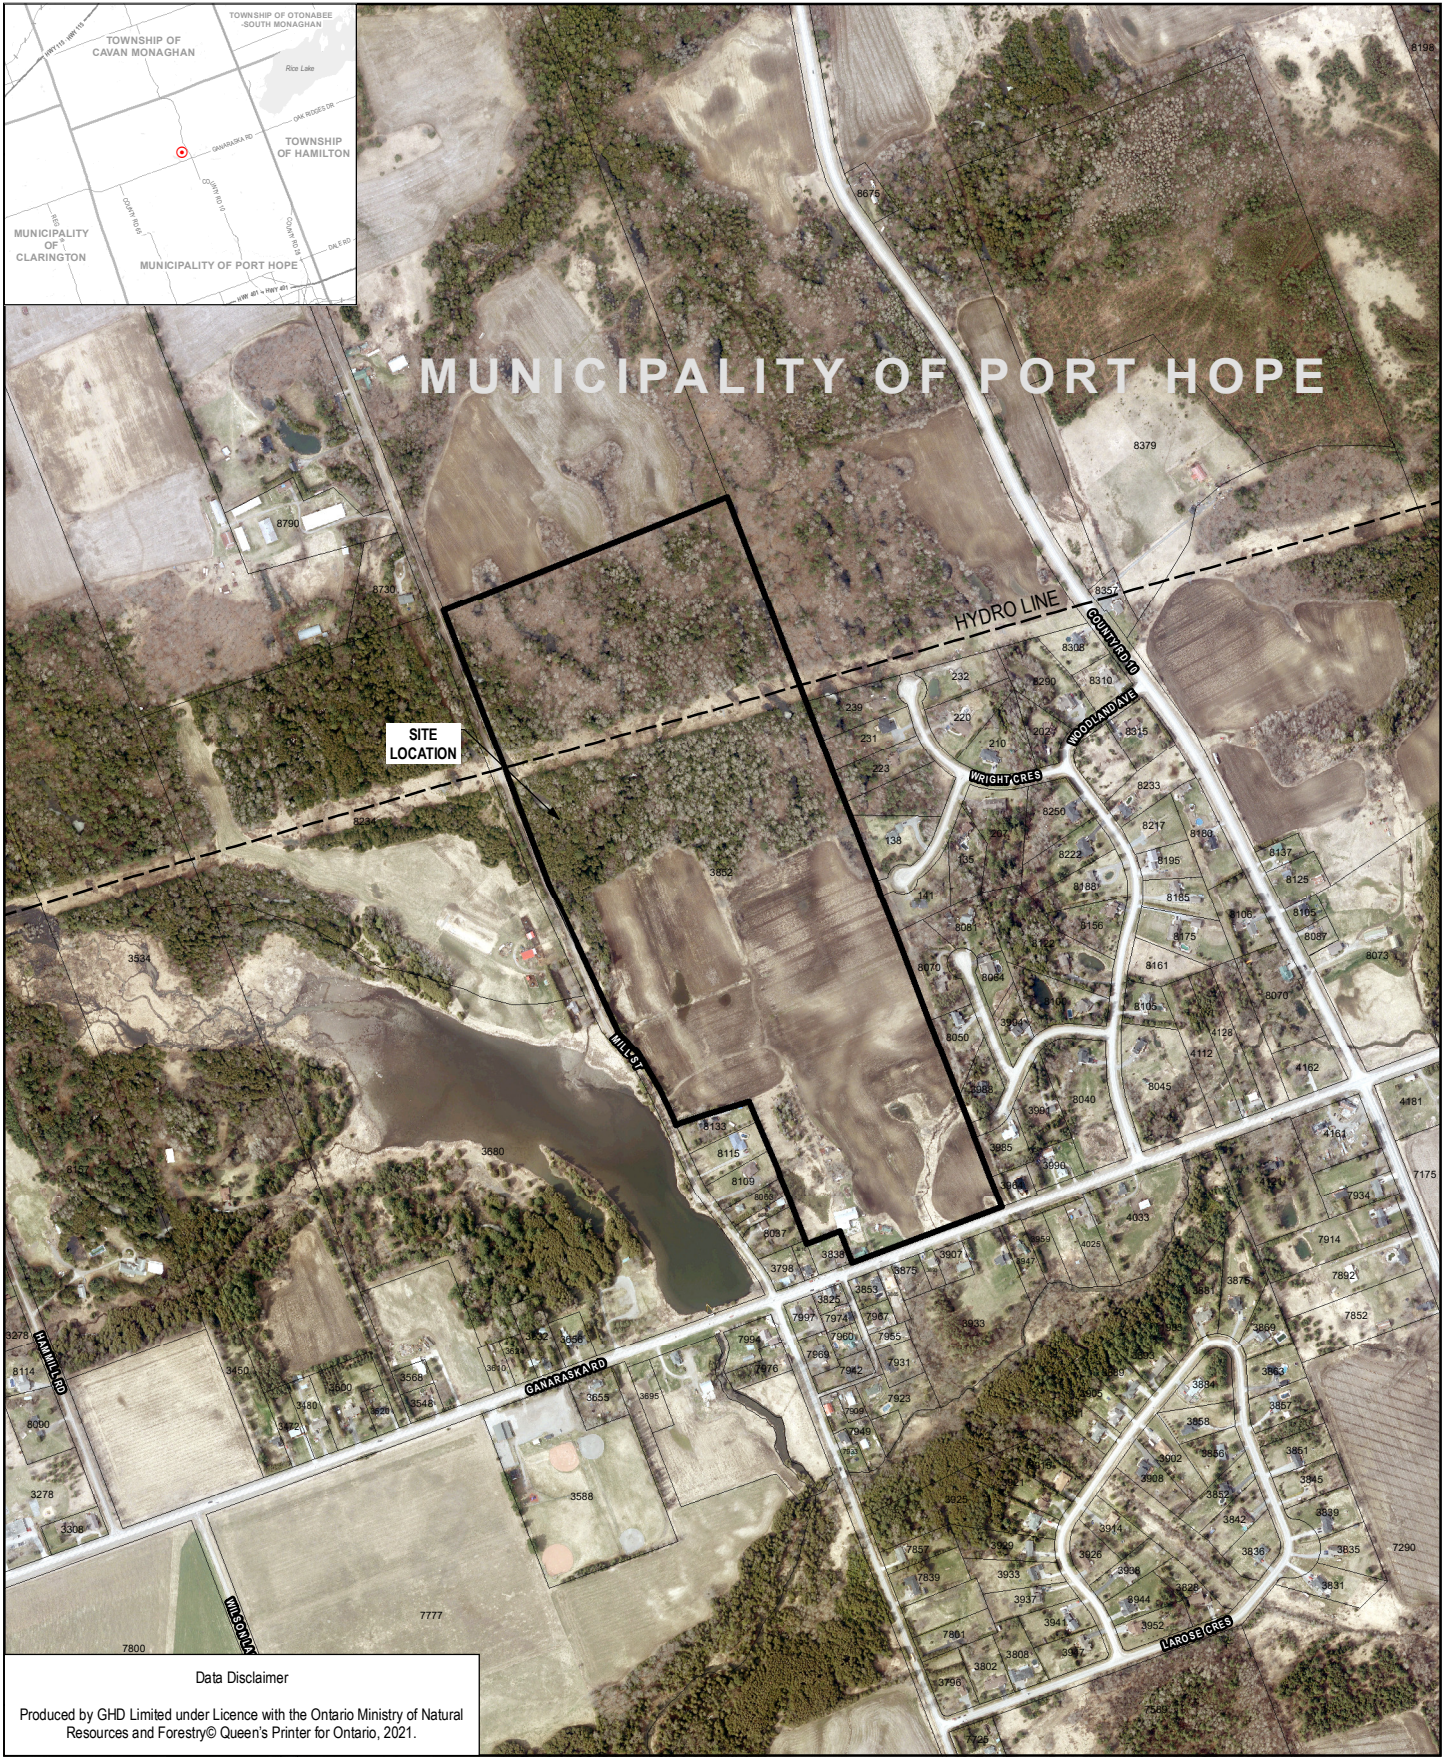
# MUNICIPALITY OF PORT HOPE

The physiography for the site is shown on Figure 2 in the enclosures and indicates the site is in a sand plain in the South Slope but is close to a contact point with the the Oak Ridges Moraine just to the north of the site. The Ontario Department of Mines and Northern Affairs mapping show the woodlot area containing kame moraine deposits with dissected terrain present. The Surficial Geology of Southern Ontario from the Ministry of Natural Resources indicates the site soil deposits in the woodlot consist of modern alluvial deposits as shown in Figure 3 of the enclosures.

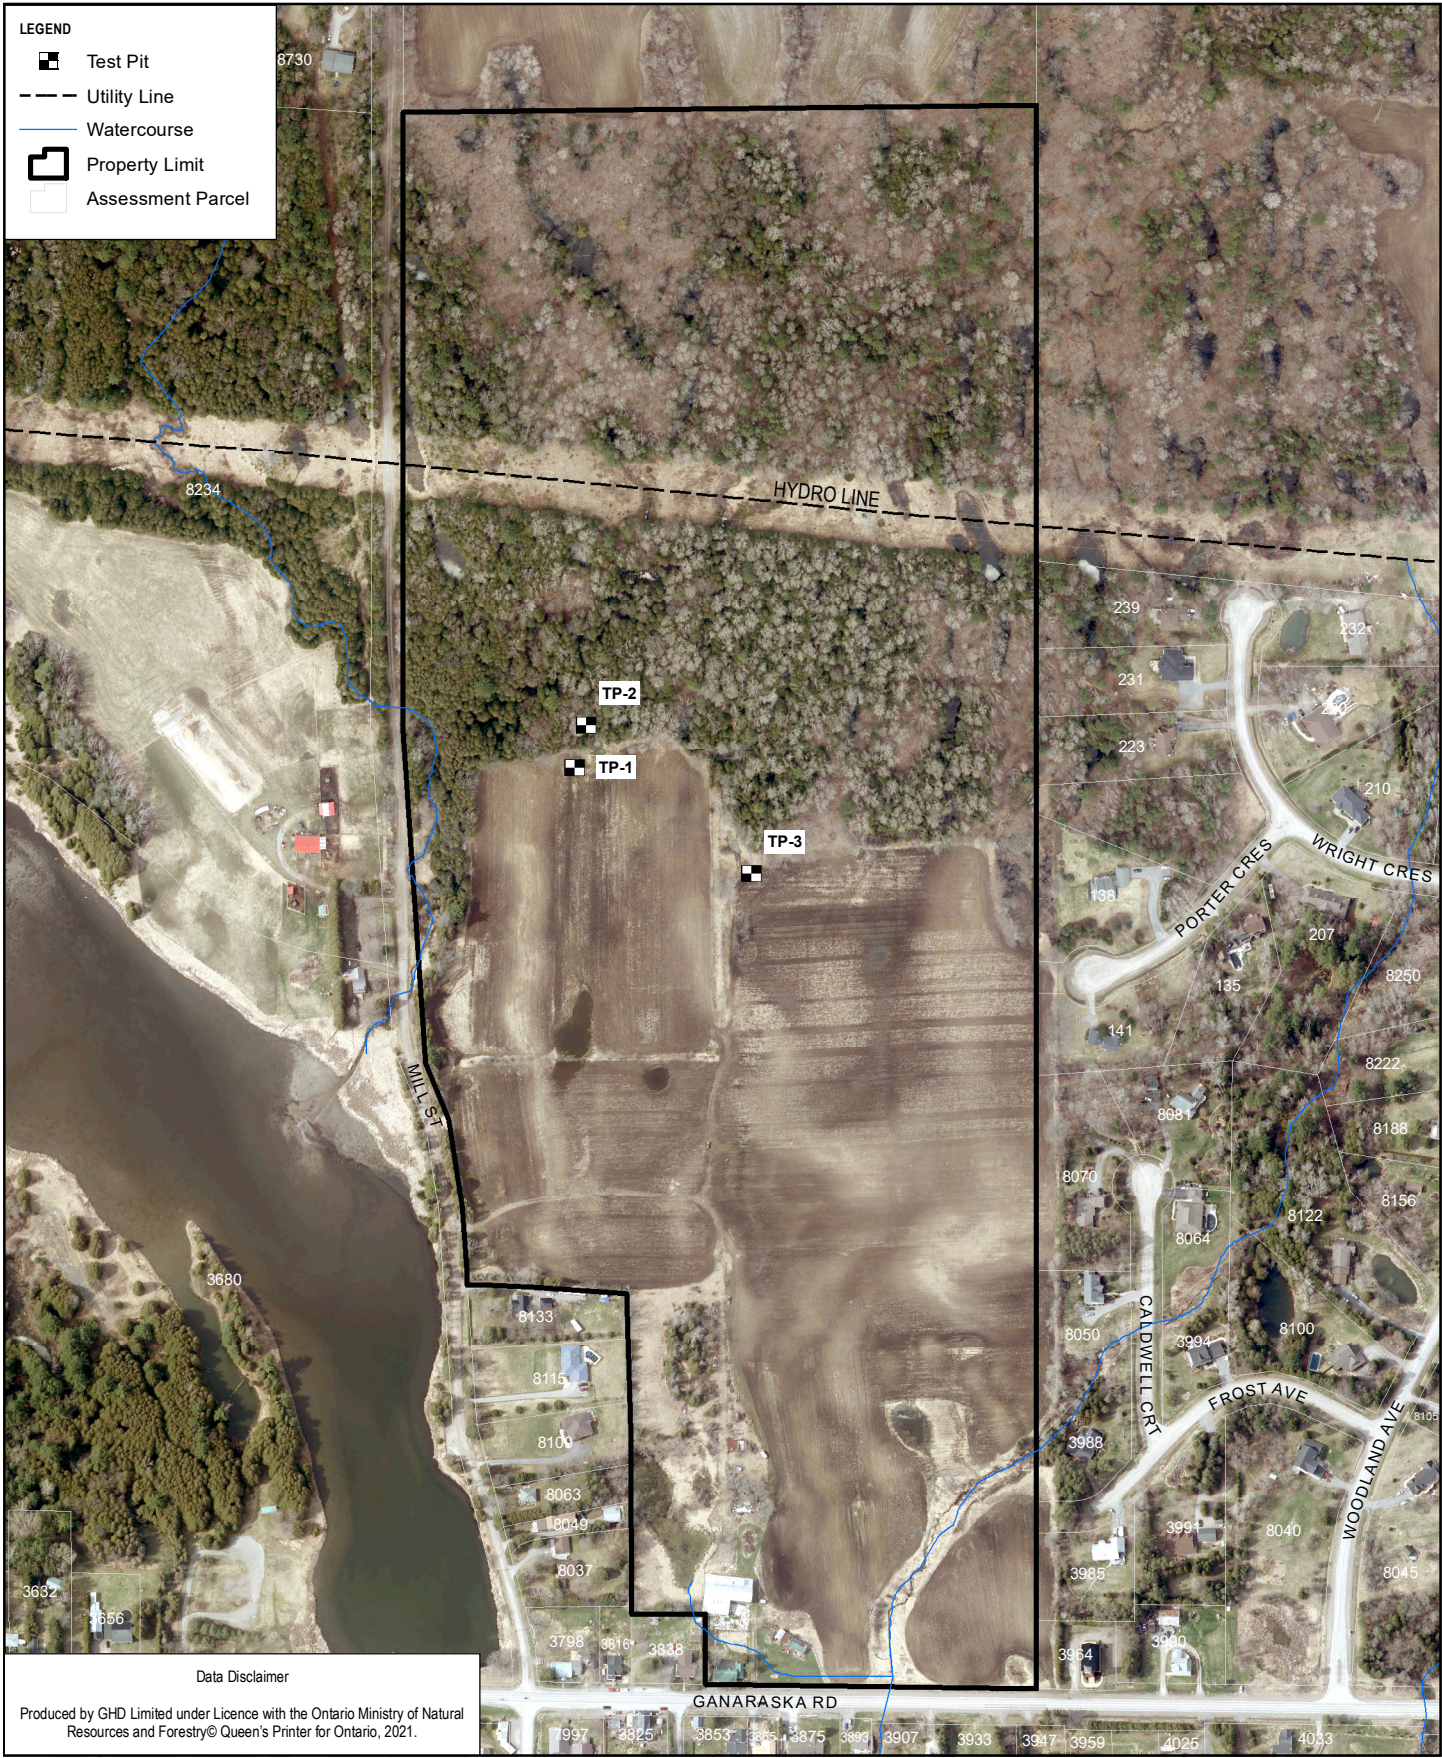
**FIGURE 4**

The site geology was further investigated with three test holes advanced to depths ranging from 1.2 to 1.5 m (see Figure 4 for locations and Appendix A for logs). Two of the test pits were

excavated at the base of a draw feature on the west side of the woodlot. The first was at the dripline from the tree cover of the wood lot and the second was about 10m north of the first test pit. The third test pit was located just to the east of a fence line present to the south of the woodlot which is at the midpoint of the property in an east west direction. The test pit was in a slight depression topographically.

**HYDROGEOLOGICAL INVESTIGATION  
TEST HOLE LOCATIONS**

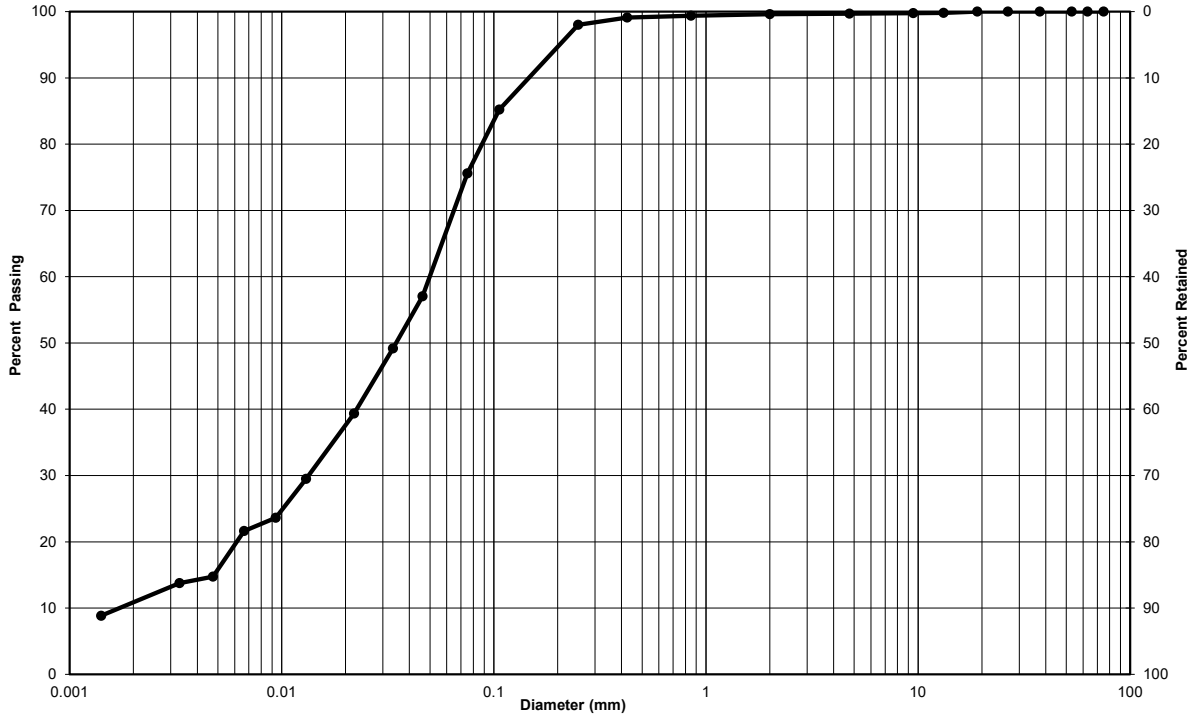
<b>Borehole no.:</b>	TP1	<b>Sample no.:</b>	
<b>Depth:</b>	5'	<b>Enclosure:</b>

The test holes on the west side encountered surficial topsoil underlain by a poorly differentiated sandy silt to silty sand that was in turn underlain by peat. Below the peat layer, interbedded silts and sands were encountered with occasional gravel layers. A sample taken at a 1.2 to 1.5 m depth in Test Pit 1 and tested for gradation indicated the soil was made up of 5% gravel; 19% sand sized particles, 66% silt sized particles and 10% clay sized particles in the interbedded deposit (see Appendix B for Gradation Results). A sample taken at a 1.0 to 1.2 m depth in Test Pit 2 and tested for gradation indicated the soil was made up of 14% gravel, 58% sand sized particles, 25% silt sized particles and 3% clay sized particles in the interbedded deposit.

**Particle-Size Analysis of Soils (Geotechnical)  
(USCS) (ASTM D422)**

Soil Description	Gravel (%)	Sand (%)	Clay & Silt (%)
Silt with sand (ML)	0	24	76
<b>Silt-size particles (%):</b>	66		
<b>Clay-size particles (%) (&lt;0.002mm):</b>	10

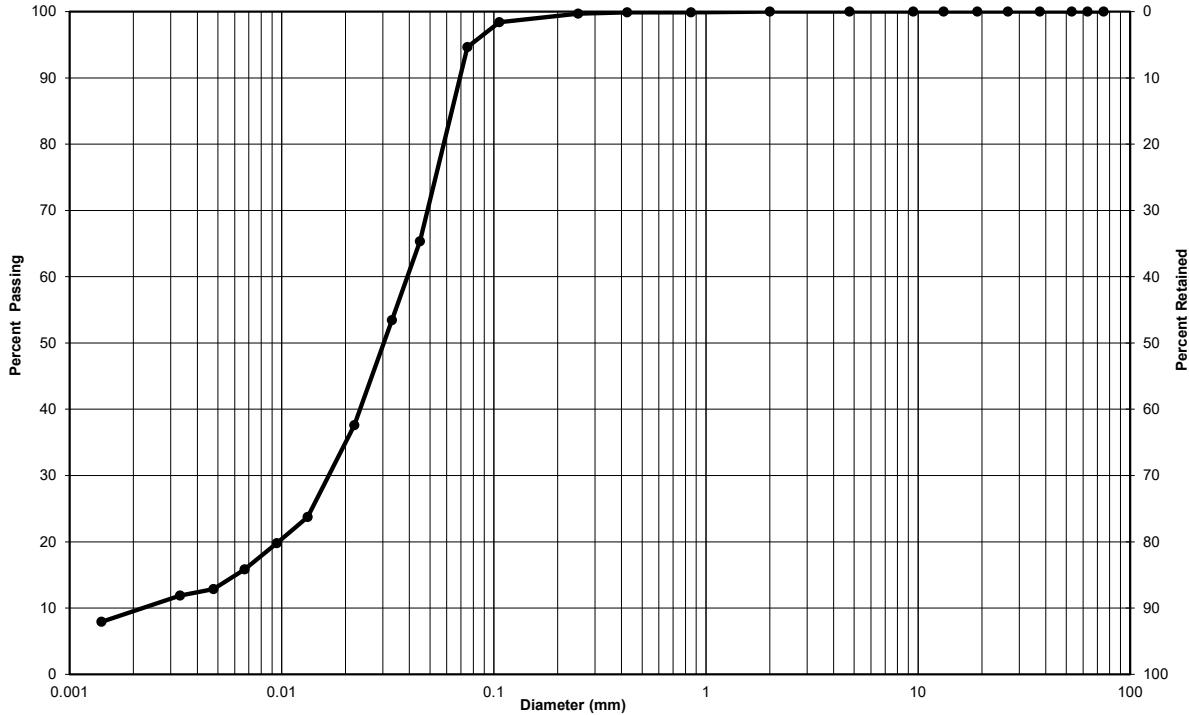
Borehole no.:	TP3	Sample no.:	
Depth:	5'	Enclosure:

The third test hole was located in a slight depression on the east side of the woodlot and was moved about 10 m east after intercepting a tile drain which was water bearing. The test hole encountered surficial topsoil to a 0.6 m depth underlain by a bedded sand, silt and clay soil with occasional gravel layers. A sample taken at a 1.2 to 1.5 m depth in Test Pit 3 and tested for gradation indicated the soil was made up of 5% sand sized particles, 86% silt sized particles and 9% clay sized particles in the interbedded deposit.

**Particle-Size Analysis of Soils (Geotechnical)  
(USCS) (ASTM D422)**

Soil Description	Gravel (%)	Sand (%)	Clay & Silt (%)
Silt (ML)	0	5	95
<b>Silt-size particles (%):</b>	86		
<b>Clay-size particles (%) (&lt;0.002mm):</b>	9

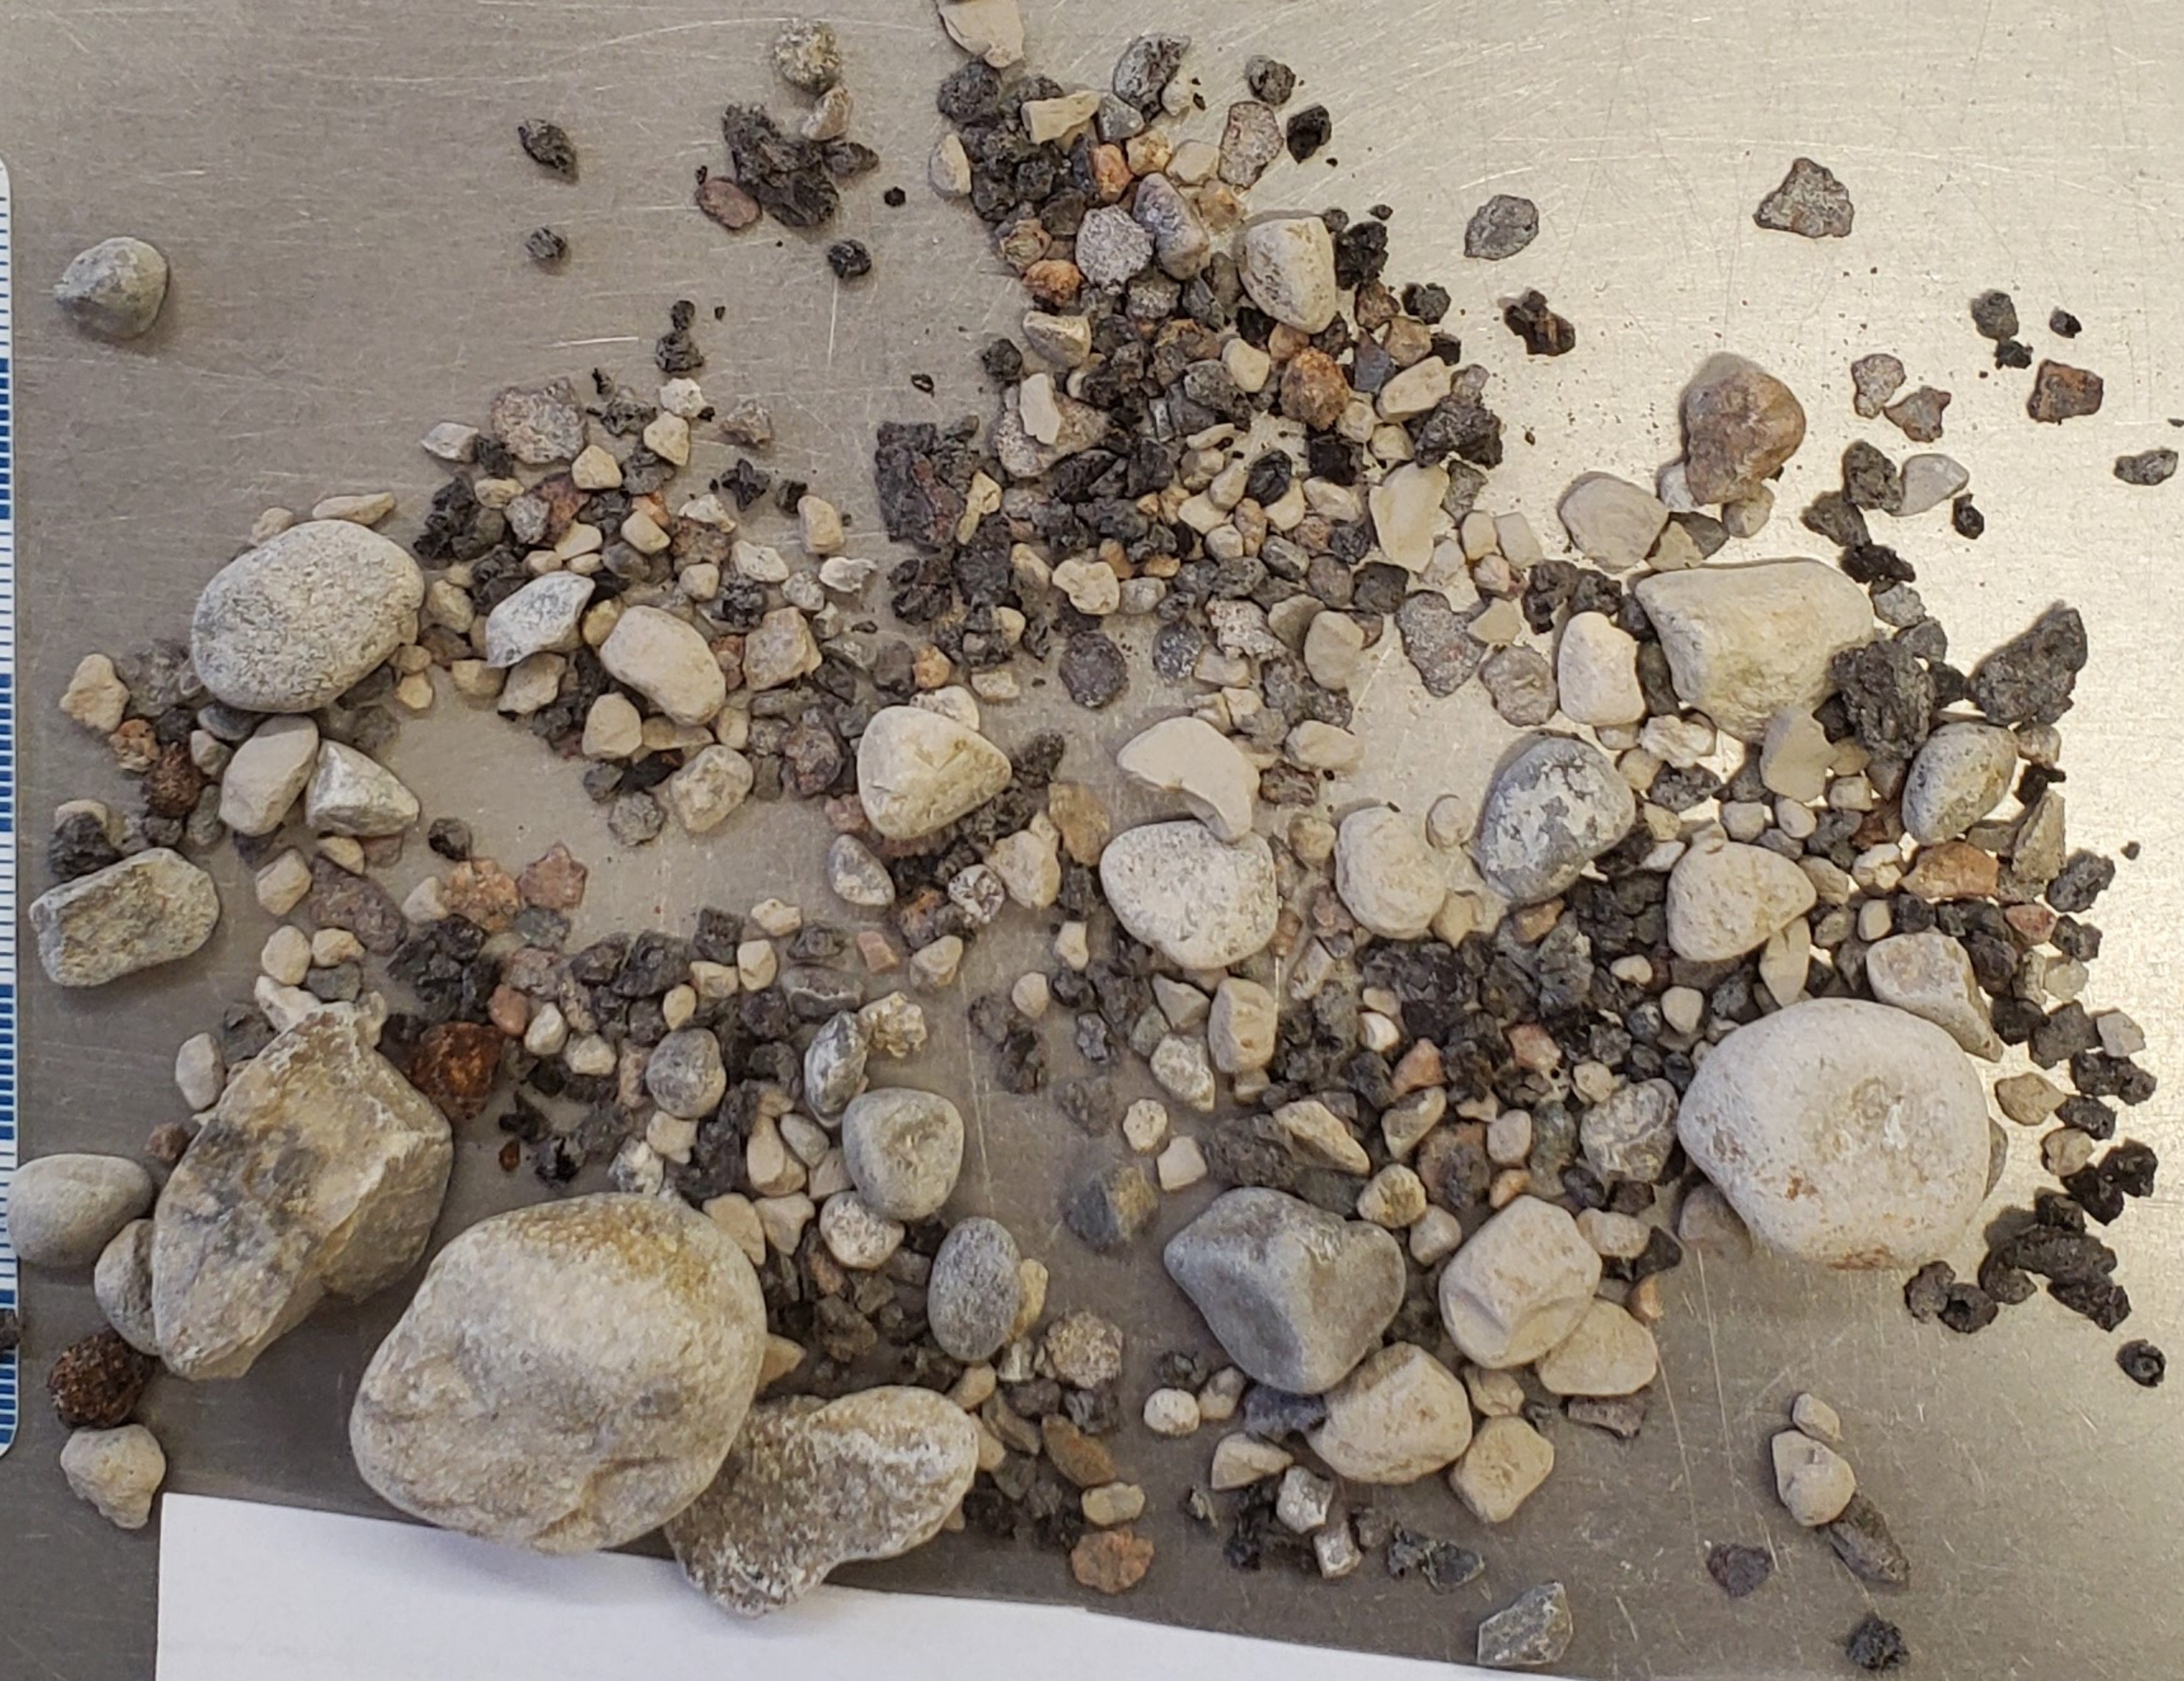
TP 1  
+2.00mm

An examination of the aggregate from the samples taken in the test holes (see photos in Appendix B) indicated that the rock had 30% to 50% igneous and metamorphic rock content with corner rounding evident but not the total rounding associated with near shore deposition (See photo in Appendix B of typical rock deposits from a kame deposit vs rocks found on the Lake Ontario shoreline).

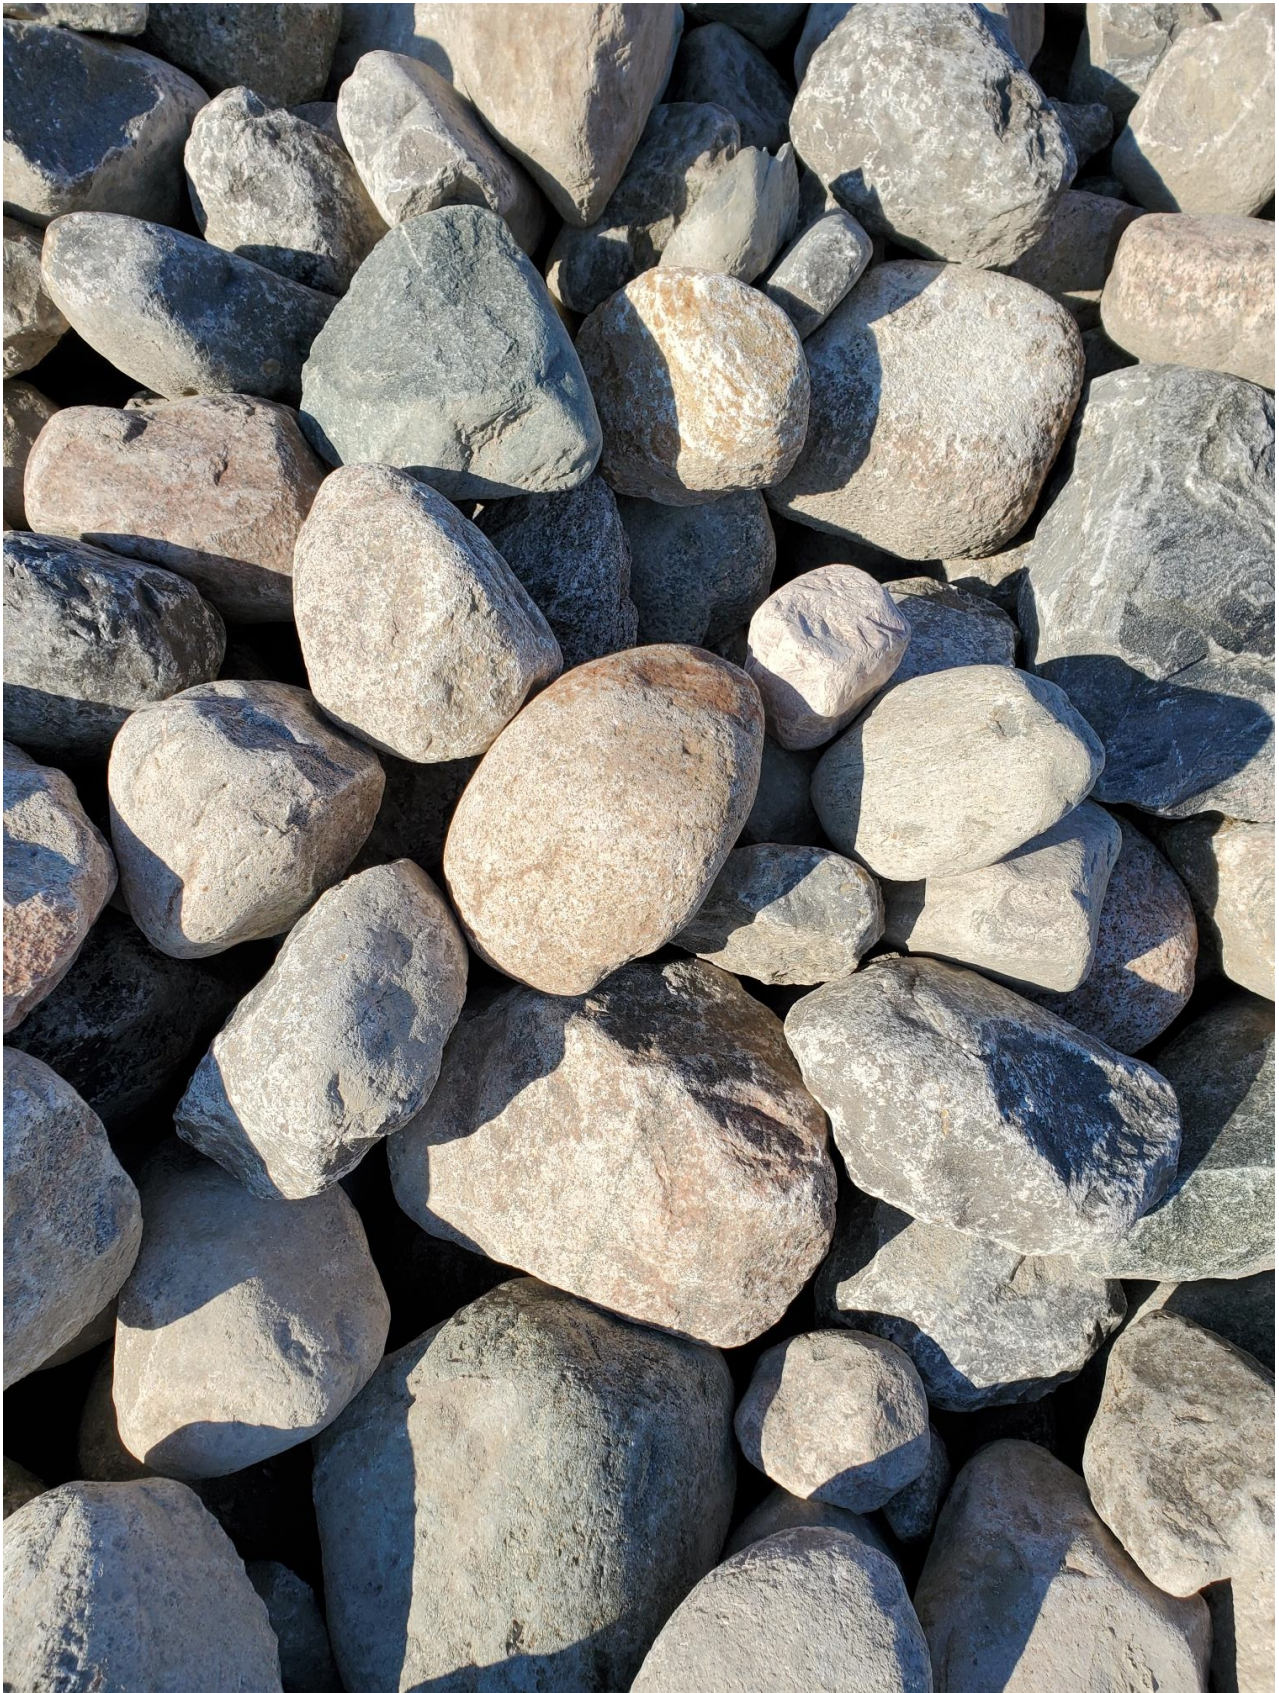
Typical Kame Aggregate Finlays Beaver Meadow Road Pit Hamilton Township

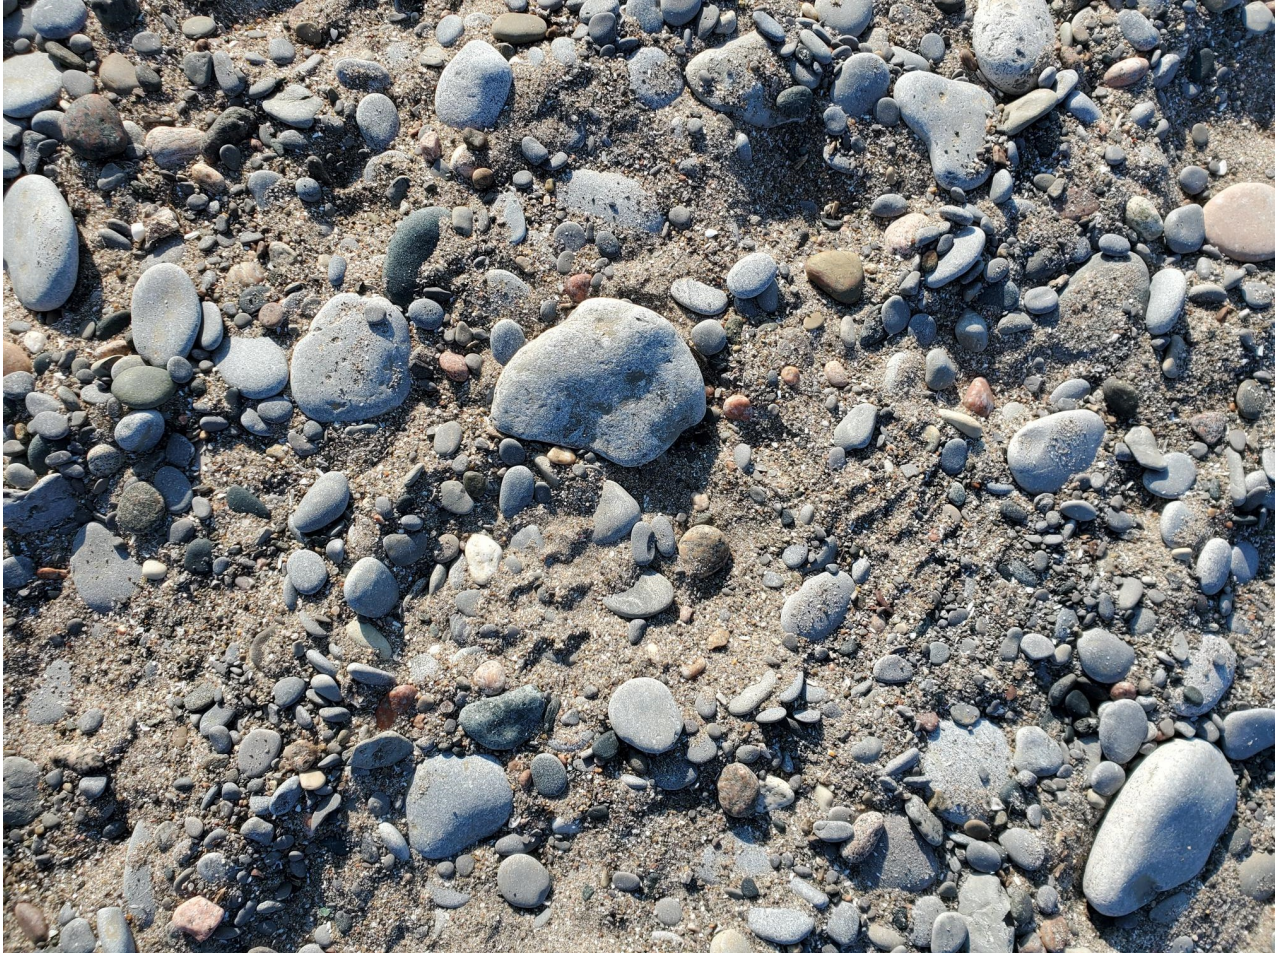
Typical South Slope aggregate Finlays Van Luven Road Pit Hamilton Township
