**ARBORIST REPORT
&
TREE PROTECTION PLAN**

39 PINE STREET

Port Hope, ON,
L1A 3G5

Date: July 2, 2024

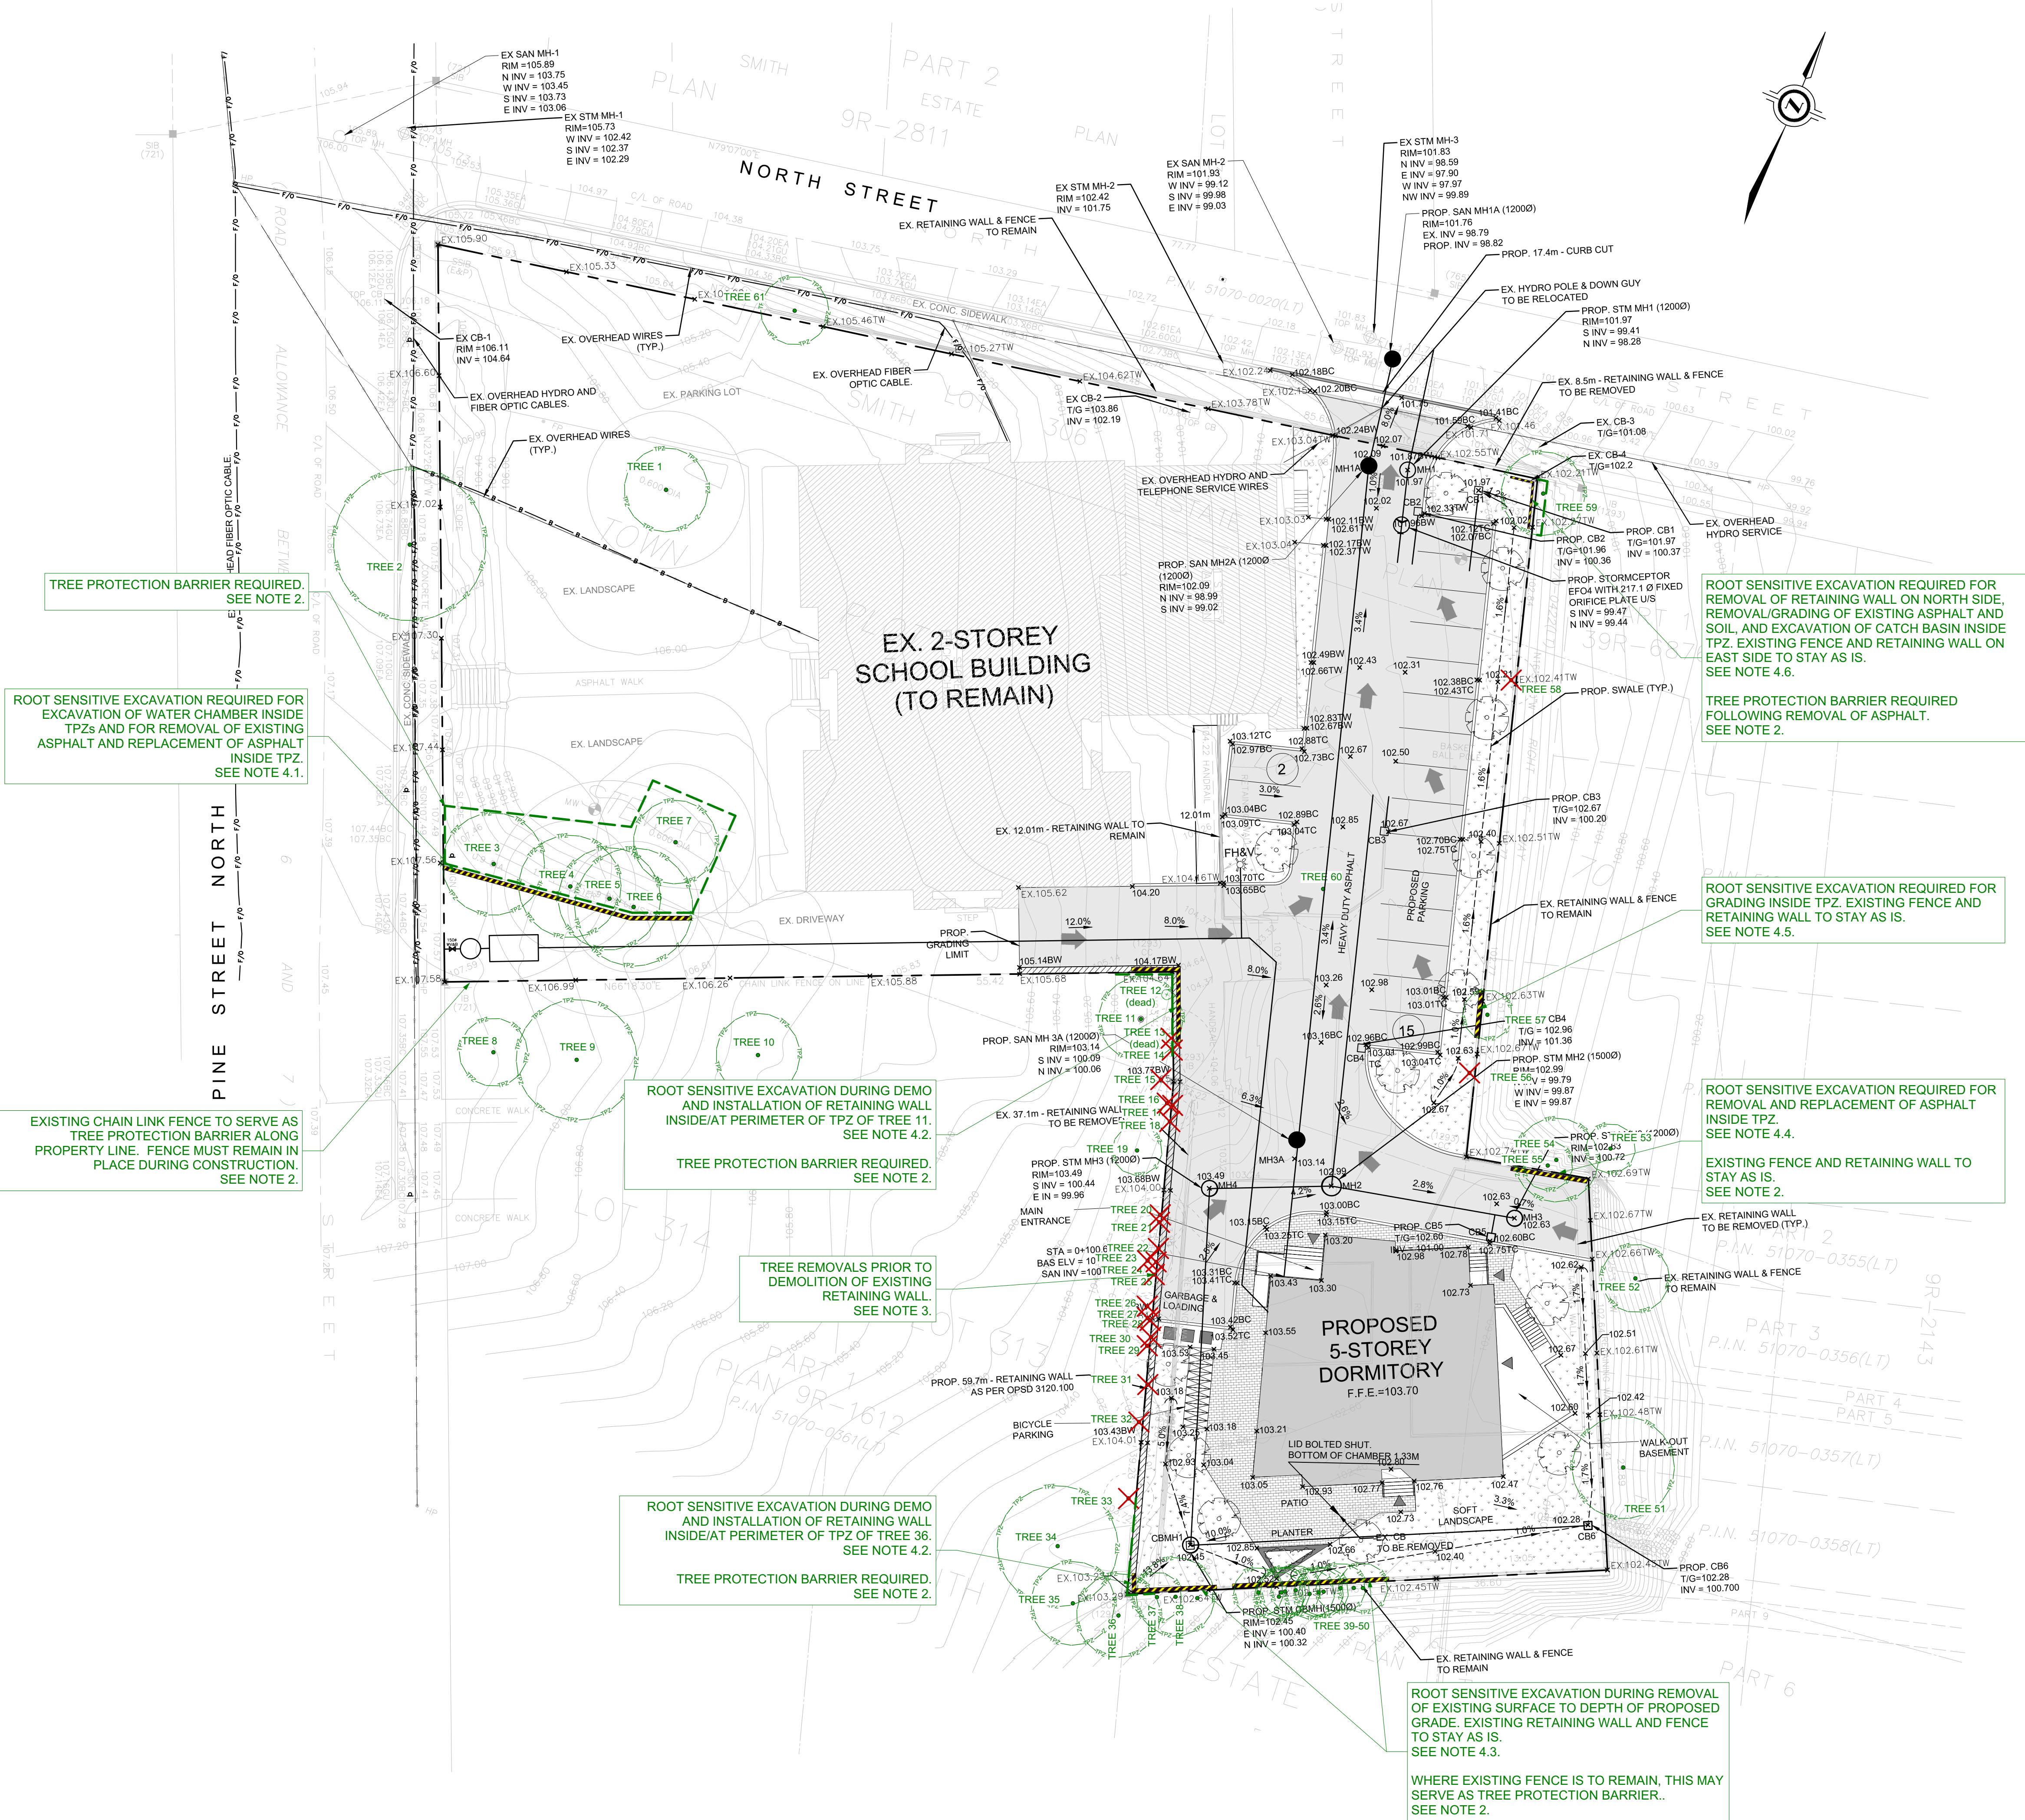
Appendix III – Tree Protection Plan

4.1 WATER CHAMBER EXCAVATION, REMOVAL AND REPLACEMENT OF ASPHALT DRIVEWAY: TREES 3, 4, 5, 6

4.2.3 THE ARBORIST IS TO ASSESS IF THE ROOT DISTURBANCE IS LIKELY TO AFFECT THE HEALTH OR STRUCTURAL STABILITY OF THESE TREES. IF THE DETERMINATION IS THAT THE TREES CAN BE RETAINED, ANY EXPOSED ROOTS ARE TO BE CLEANLY PRUNED. IT IS RECOMMENDED THAT ANY EXPOSED ROOTS ARE IMMEDIATELY COVERED WITH 4-6" OF SOIL OR WET BURLAP, AND COVERED/SECURED IN PLACE TO PREVENT DRYING.
