John, Ontario and Queen Street Heritage Conservation District Plan

Municipality of Port Hope, Ontario

Final Revision – January 2008

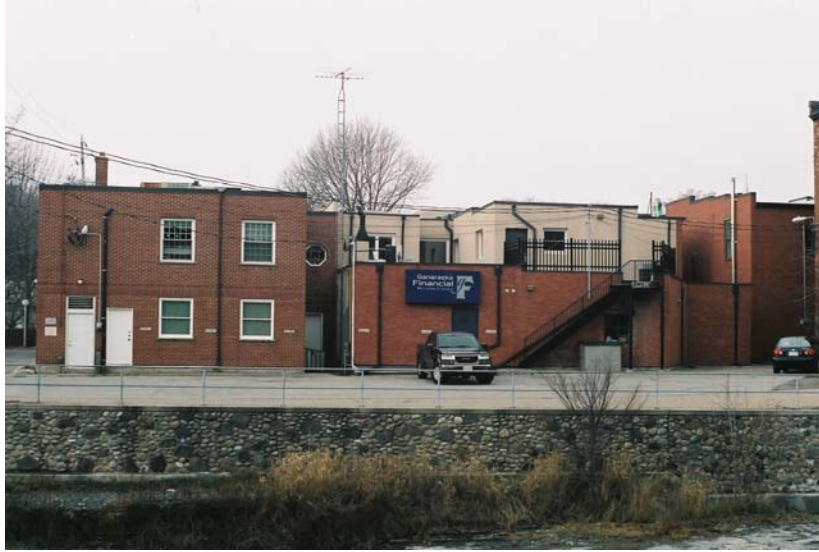
The rear elevations of building on the east side of Queen, facing the River (photo above) are plainly visible from the newly opened Rotary Walkway. At present this area consists primarily of paved asphalt, but there are various courtyards and passages which could be used for outdoor seating overlooking the river; or which might be enhanced to make them more inviting for people to move from the street to the walkway. There are also some outbuildings, and there is general variety in these rear elevations. These aspects should be used to enhance the riverside, as suggested in various entries in the Inventory.

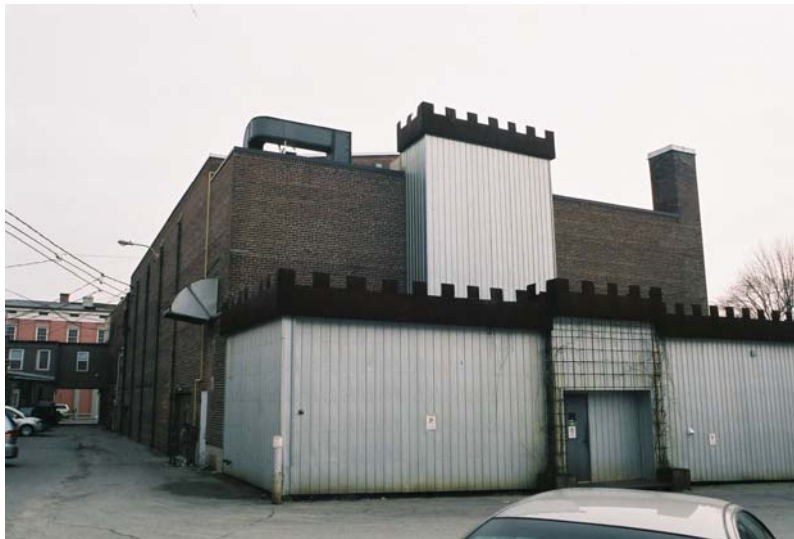
The rear elevations of buildings on the west side of Queen, facing Lent Lane, are few, but the presence of the Capitol Theatre (photo above) cannot be ignored. Starting from the covered drive off Queen, the north side of the building has an industrial presence, with varied old brick masonry and 6/6 windows in some locations and blocked apertures in others. At the west end of the building, the corrugated steel and crenellated iron parapet give the impression of an industrial, fairy-tale castle: one which is theatrically appropriate in enlivening an otherwise blank elevation.

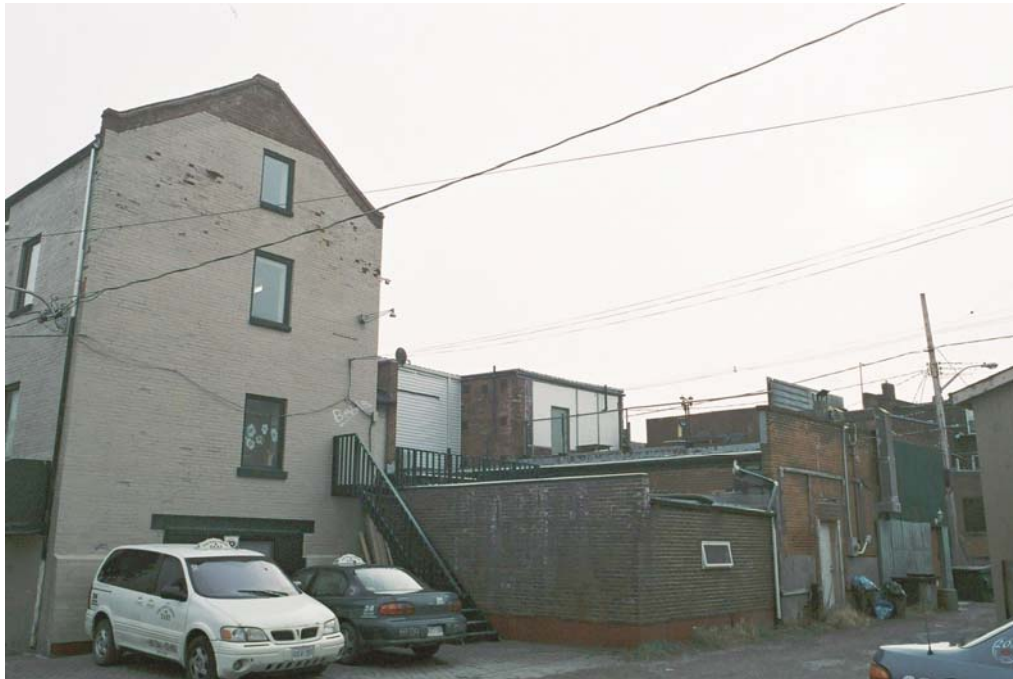
The sides and backs of buildings on the west side of Ontario Street (seen from just off Maitland Street) are a collection of types, sizes, materials and conditions. Most prominent and intact - aside from the rear of the Ganaraska Hotel - is the three-storey, painted brick wing on the south side of this lane. The other buildings are something of a mixture, though not without appeal. The lanes and back streets (see Section 3.7 below) contain interesting remnants of industrial occupancies and varied, *ad hoc* building additions and the like. These should be retained wherever possible.

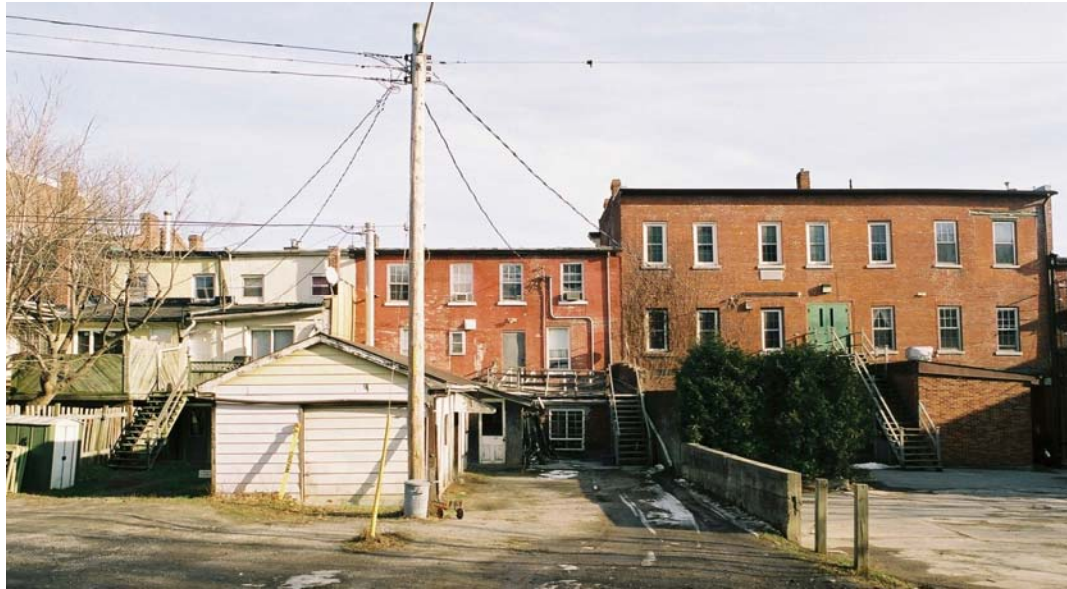
Rear elevations on the east side of John Street are described under the category of Lanes elsewhere in this section. Rear elevations on the west side of John (seen above from Brewery Lane) are most appealing, partly for the bricks, windows, doors, sheds etc. which many of these retain; and perhaps more so for the settlement which has occurred in many of these buildings, a feature appealing to the visitor from a modern city of rigid verticals and horizontals in industrial concrete, steel and glass, or of acres of stucco over Styrofoam insulation.

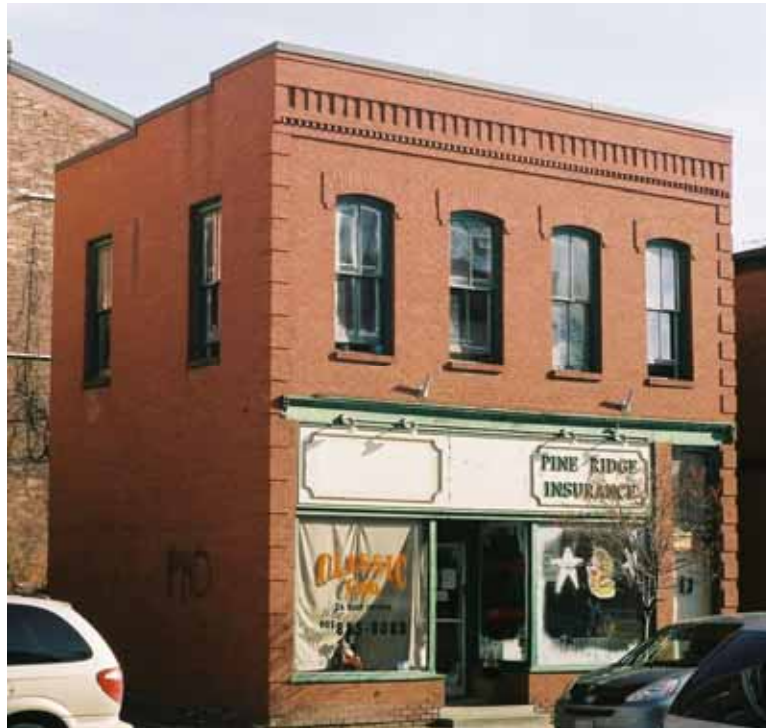
7, 9 and 11 Queen Street

- Two-storey (re-faced) red-brick building with period fascia and end-brackets, and original, segmental-headed 2/2 front windows (c.1875). **Designated** under the OHA Part IV.

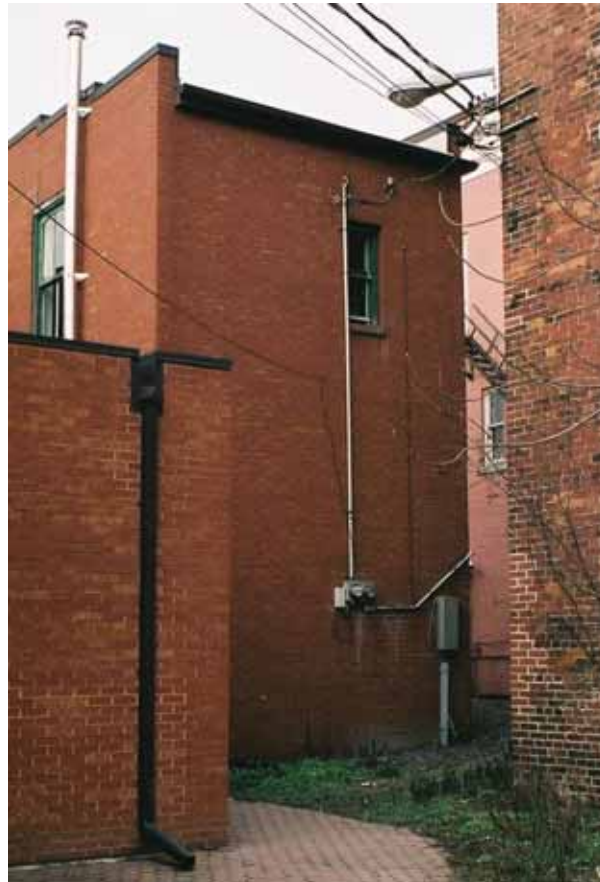
7, 9 and 11 Queen Street (continued)

- South Side and Rear Elevations – South side is plainly visible from east, and boasts an unusual combination of old 2/2 window with segmental-headed glazing, set within a new rectangular aperture with steel lintel above. Rear elevation is also plainly visible from Ganaskara River and Trail, and contains one old 1/1 window at upper level, again within new masonry, with rowlock header sill and steel lintel above.

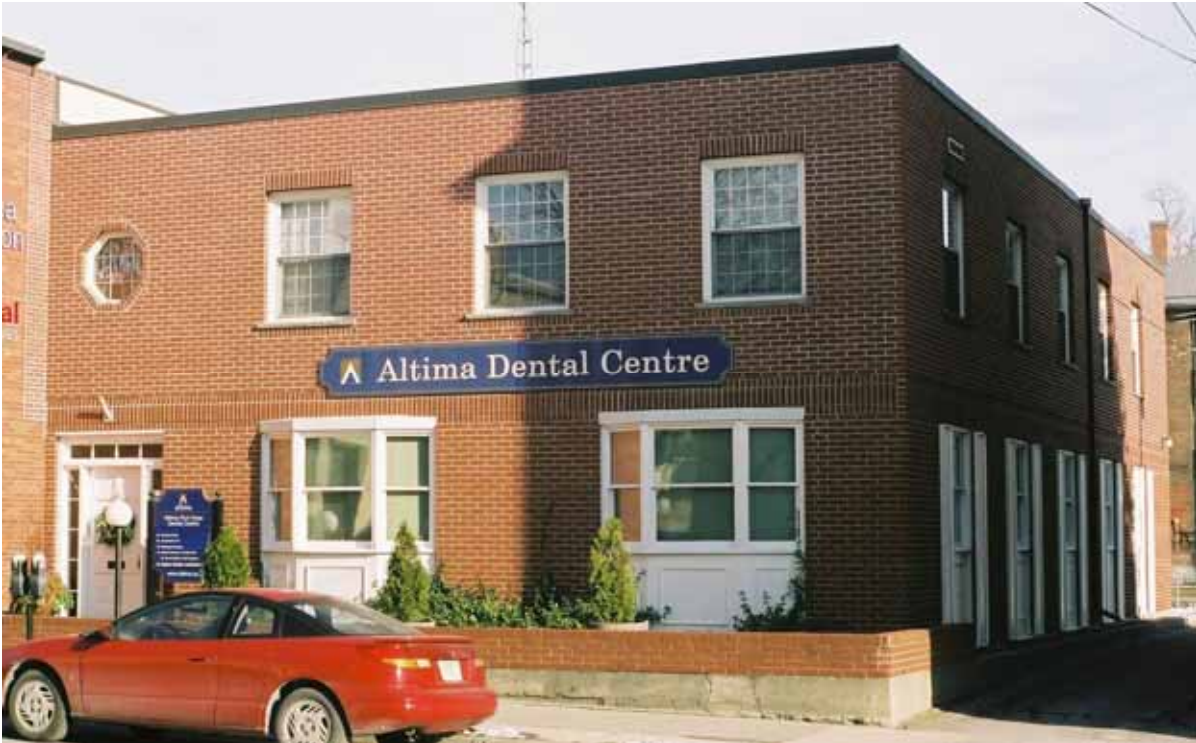
**19 Queen Street**

- Simple, two-storey, Neo-Georgian red-brick building with varied fenestration (c.1960).
- Description – Recent red-brick building is set behind low brick wall on concrete foundation, with small garden behind. Ground floor entrance at LH side has wooden, six-panel door between six-pane sidelights, with full-width, four-pane transom window above. To right are two wide, slightly projecting bay windows with 2/2 units in each face, each with larger central unit. Panels below are of plywood with planted mouldings. Continuous band of stacked rowlock headers, soldier course and additional row of headers, marks top of ground floor. At second floor, nine-pane, octagonal window over front door is reminiscent of early twentieth-century neo-Georgian houses. Three windows to right are almost-mediaeval in type: 15/15 units (with narrow false dividers) with thin, rock-faced limestone sills (over rowlock headers) and steel-angle headers supporting soldier-brick voussoirs. Plain brickwork continues up to deep, pre-finished aluminum flashing at wall-head.

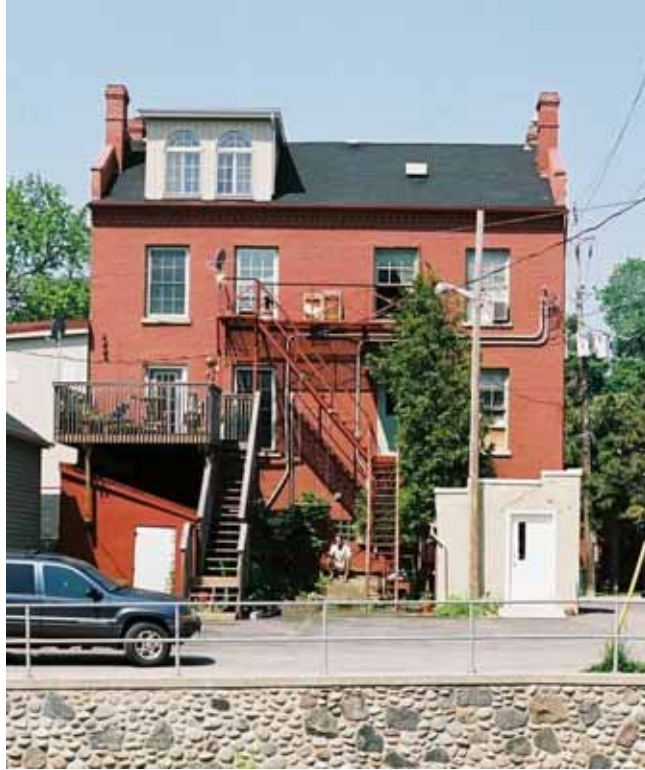
23 and 25 Queen Street (continued)

- Side and Rear Elevation – North elevation is of red-painted brick, and contains altered central window at ground floor, original 6/6 window at second floor, and two apparently more recent, smaller 1/1 windows at top floor. Projecting upper and lower bands at pitched and central parapet are attractive feature. Rear elevation resembles front, i.e. three storeys four bays wide, with cornice, roof, parapets and chimneys as described. Apertures have flat-arch lintels with simple, soldier voussoirs. Plastic conduit is something of a feature across this elevation. At ground floor, both addresses have modest, painted-brick, shed-roofed addition (with stepped parapet at no. 23) extending out from side and back walls. Elsewhere, steel, slab-type door at LH side occupies an original opening. Rear is dominated by wooden and metal stairs rising, respectively, to second-floor wooden deck at no. 25 and second- and third-floor metal landings at no. 23. At second floor, two original windows remain, and two have been replaced with modern, partly glazed doors. At third floor, windows at no. 25 are 6/6 replacements (with false muntins), while 6/6 originals remain at no. 23. No. 25 also has large, shed-roofed dormer clad in board-and-batten siding, and containing two, round-headed apertures each with pair of 6-pane, vinyl casements under arched transom windows (all with false muntins). Old wooden hydro pole, with utilitarian fittings, suits back-lane aesthetic.

- Comments – Tall brick building is a unique presence on Queen Street, and more in keeping with Walton, providing an indication of what has been lost along this road. Stucco at ground floor is assumed to hide alterations and possibly variety of brick types, whereas remainder of building is little altered, aside from various replacement windows. Only following careful investigation of the existing fabric, and ideally archival photographs also, might one be able to determine the original configuration here. Steel plates at front, second and third floor levels suggest former problems with front and rear walls spreading, now assumed to be inactive. Cement pointing and render at parapets and chimneys should be carefully removed and masonry repointed. At rear elevation, hodge-podge of old one-storey additions, wood and steel stairs, and even new dormer, give an appealing back-lane presence. Modern doors at second floor, especially “French” door with peripheral white vinyl frame, are out of keeping, as are long PVC electrical conduits.

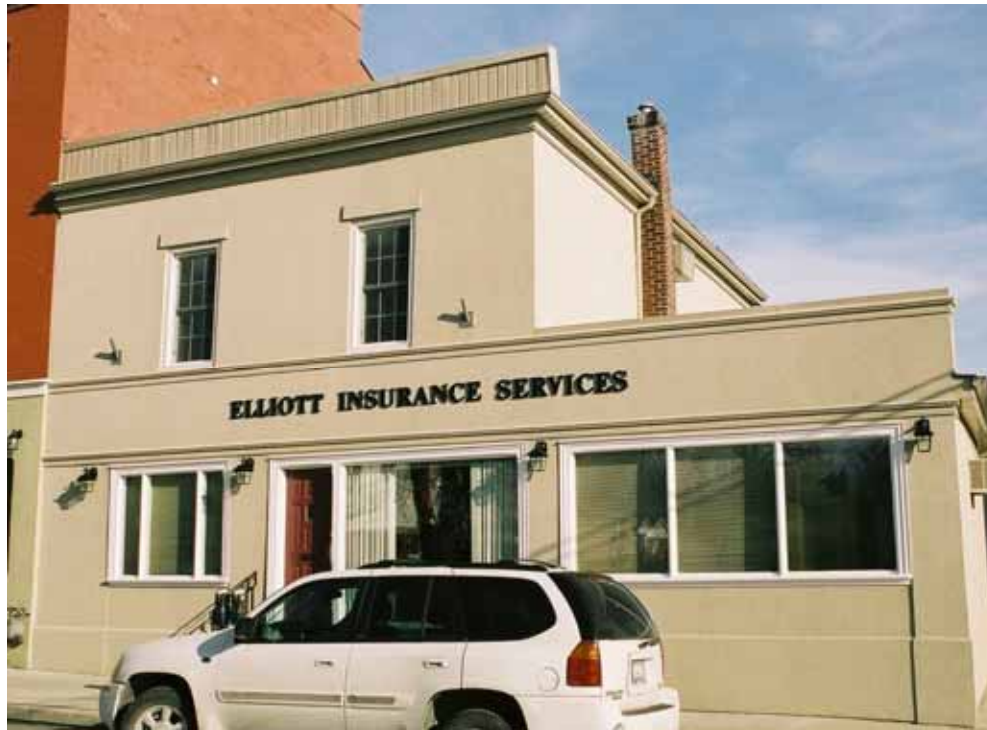
27 Queen Street

- Two-storey, stuccoed, apparently recent building, with one-storey south block (c.2000).
- Front Elevation – Stuccoed (E.I.F.S.) building seems to be new, except for unusual asymmetry, and older brick chimney at south wall. Entrance is located near centre of two-storey block, reached by small flight of concrete steps with ornamental metal railings either side. Front door is modern, wooden, nine-panel door with small window. Modest wooden casings extend at right to frame also very large, single-pane window. To left of door is triple-sash window with wider central unit, framed as door, and with thin wooden sill. One-storey south block has fenestration comprising three large, single-pane sashes with trim as described. Building is lit by four heritage-style lanterns at ground floor. Deep stucco fascia, framed by identical top and bottom mouldings, extends across entire building, forming signage band for attached, individual letters. At second floor are two, new 6/6 windows (with false muntins), set within aluminum-flashed frames. Wall is without decoration or trim, though both windows have slightly projecting lintels. Wall-head is capped by fascia with profiled bottom edge, shallow wooden soffit and wooden fascia with modern aluminum gutter. Front parapet rises some two-feet above gutter, clad in vertical vinyl siding and capped by deep flashing.

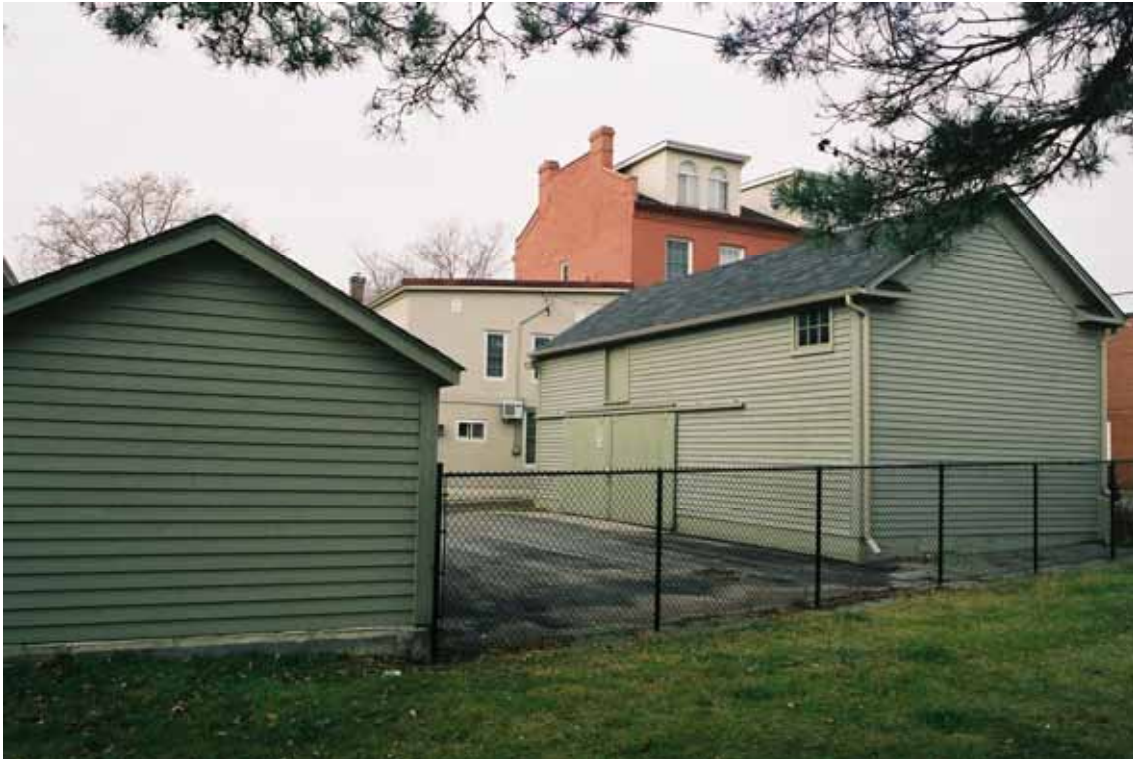
**27 Queen Street** (continued)

- **Side and Rear Elevations** – Side elevations are also stuccoed, with second-floor soffits wider than at front, and with central, single-vent, red-brick chimney having re-built head.

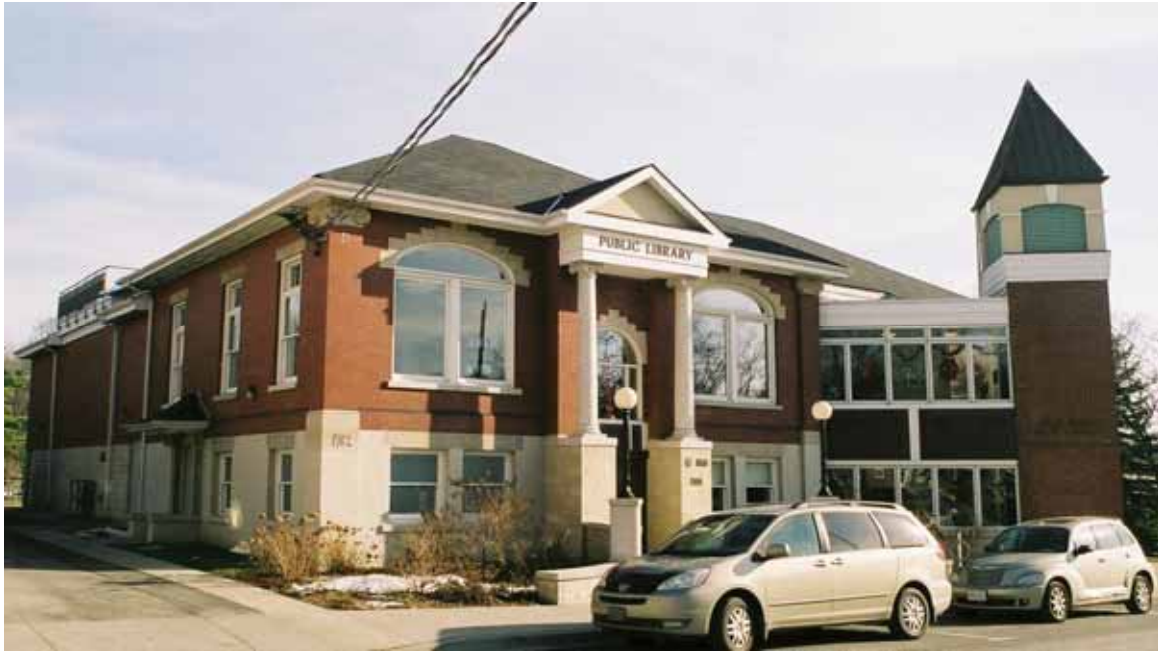
31 Queen Street

- Typical Carnegie Library (1912) with later tower and south block and Post Modern addition at east side (c.2000). Building is **Designated** under the Ontario Heritage Act, Part IV.

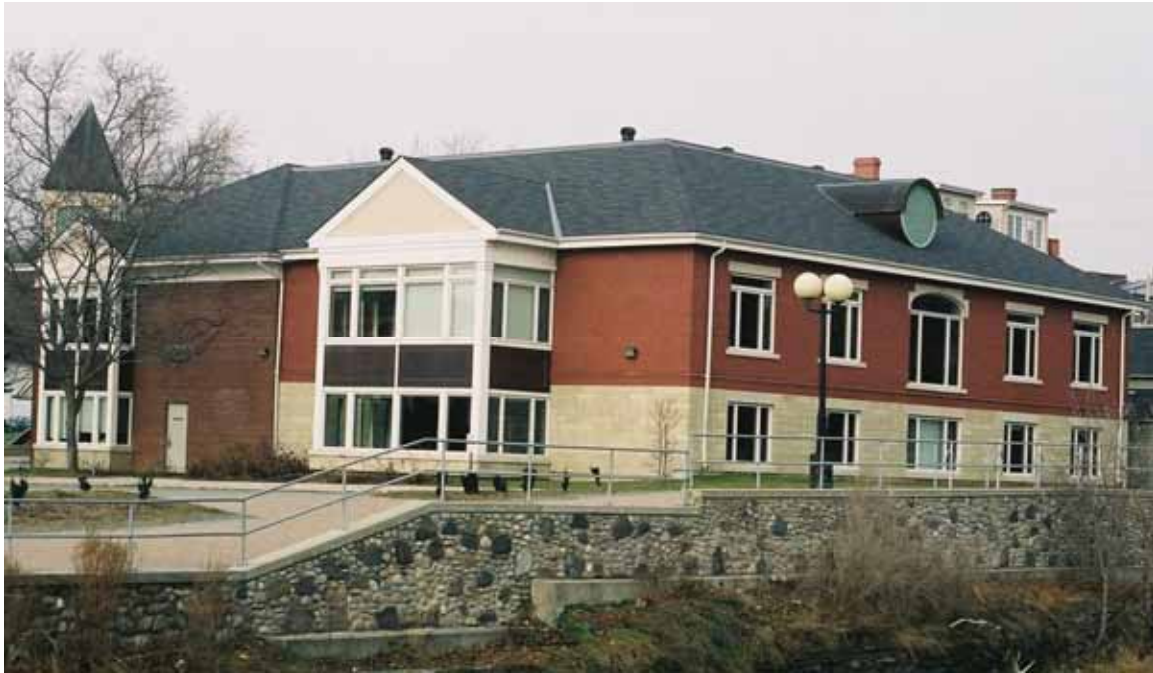
**31 Queen Street** (continued)

- **Comments** – Attractive Carnegie Library has been adapted and restored to meet modern requirements. Loss of front staircase is perhaps unfortunate, but understandable. Ornate doorway at north elevation of original library is quirky and attractive feature. Recent addition, reworking aspects of 1971 addition, is deferential to original at front, and appears as new building, with attractive features, when seen from south and east. At east elevation, large windows afford good views of adjacent Ganaraska River and Rotary Walkway.

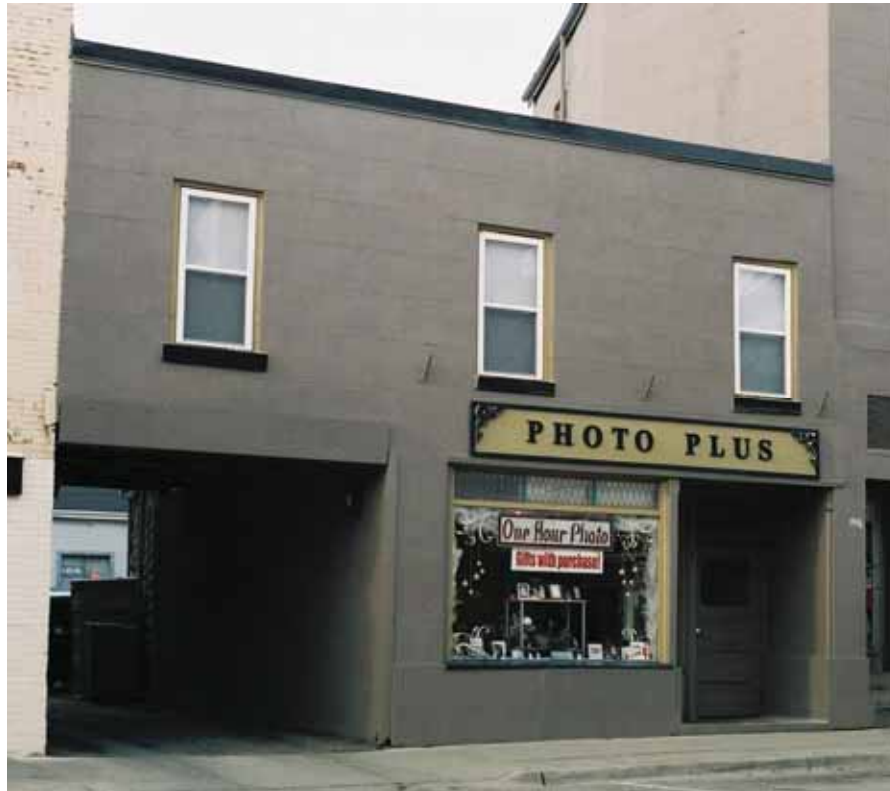
6 and 8 Queen Street (see also description in Stokes Walton Street District Plan)

- Lane Elevation – Side wall beyond passage is early pre-cast concrete blocks, imitating stone.
- Comments – Small building has a various interesting elements, especially at shopfront level. Rendered wall surface is out of place and though similar to building to north, removal is encouraged. Absence of beam or fascia over shop window is odd and there may be old materials hidden here, as also at stall-riser. Recent loss of original $\frac{2}{2}$ windows is unfortunate and $\frac{2}{2}$ form should be replicated, in wooden units.

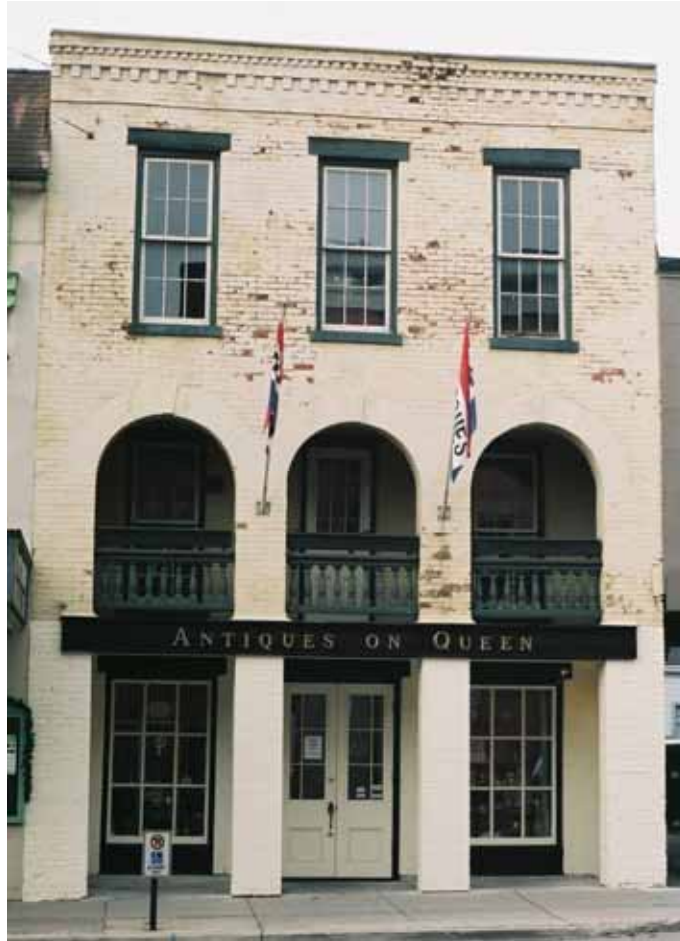
10 and 12 Queen Street

- Comments – At front elevation, building is unique within Port Hope, with its recessed front wall and two-storey round arches. Unusual doors to shop should be replaced with more suitable period doors. At second floor, central voussoirs are failing and require attention. And at third floor, extensive spalling paint and bricks indicate water (whether rain or vapour problem), which should be investigated and remedied. At side elevation, diversity of building provides attractive back-lane presence, though revealing of windows – if these exist – would be an improvement, and these could be blacked-up with painted glass if necessary. At rear elevation, blank brick wall is not unattractive, and though metal-clad and rusty crenellations are odd they are in keeping with a theatrical building. This elevation, facing the parking lot and lane beyond, is sufficiently prominent that there might be something more for the public view – perhaps suitable advertising for events being staged at the theatre.

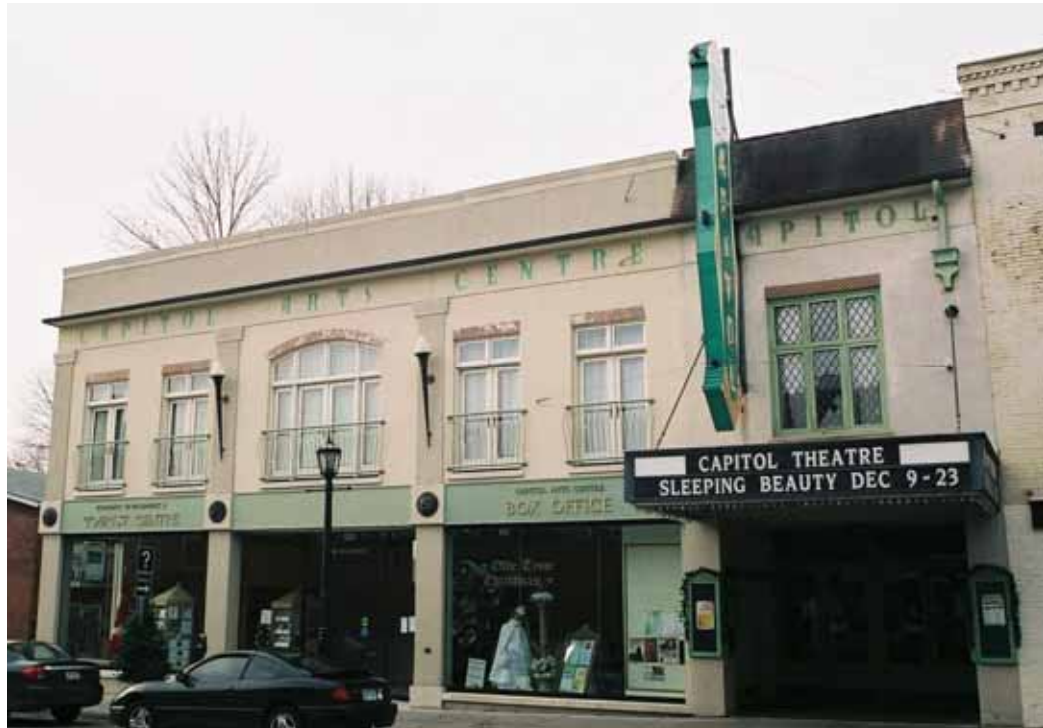
14 Queen Street

- Rear Elevation – see 10 and 12 Queen Street.
- Comments – Original bay of 1930 theatre is unusual within Heritage District, and provides an attractive combination of different components. Recent addition provides contrast, especially at fully-glazed ground floor; but otherwise combines elements of northern bay and typical parapetted buildings of Port Hope, although in this case stuccoed throughout.

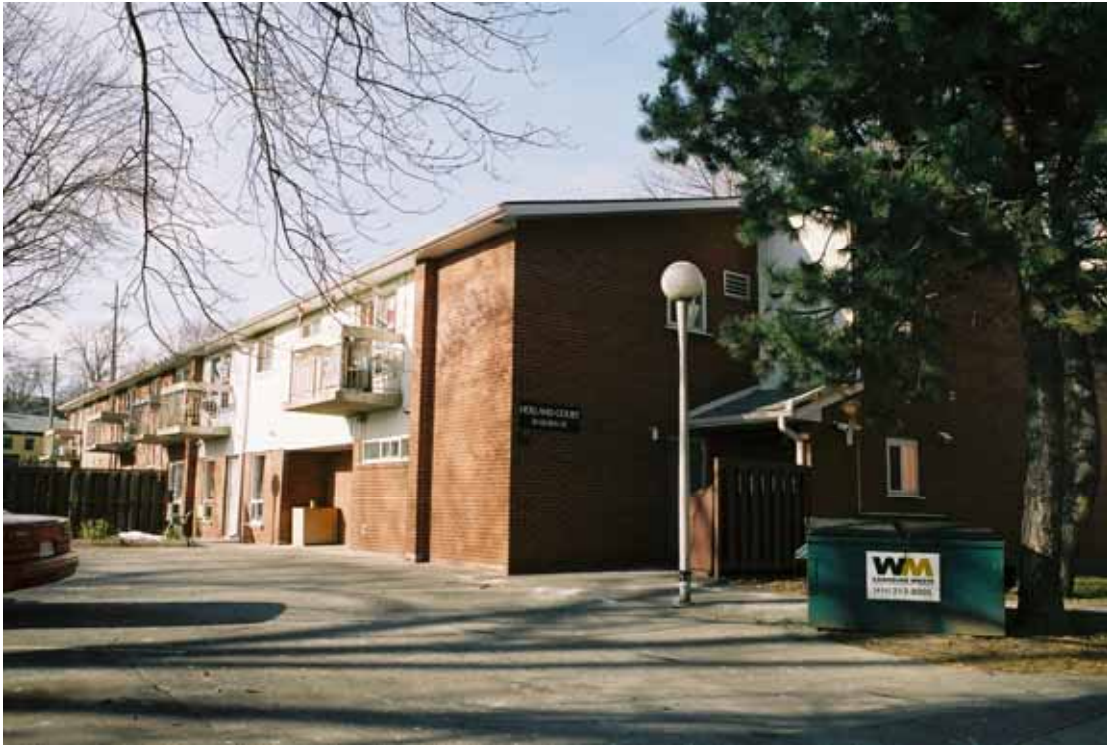
**24 Queen Street**

- Comments – Modern residential building is generally out of character with Heritage District: in architectural form, in blank gable wall yielding lack of street presence, in doors and fenestration and in use of aluminum trim throughout. While units facing park are removed from Queen Street, east elevation could benefit from some reworking to make it more suitable to the context. Existing wide, grassy verge with thick pine trees gives a suburban presence, including unsuitable tree species, although these trees do have the benefit of concealing the building somewhat. See the Guidelines for recommendations on these various conditions.

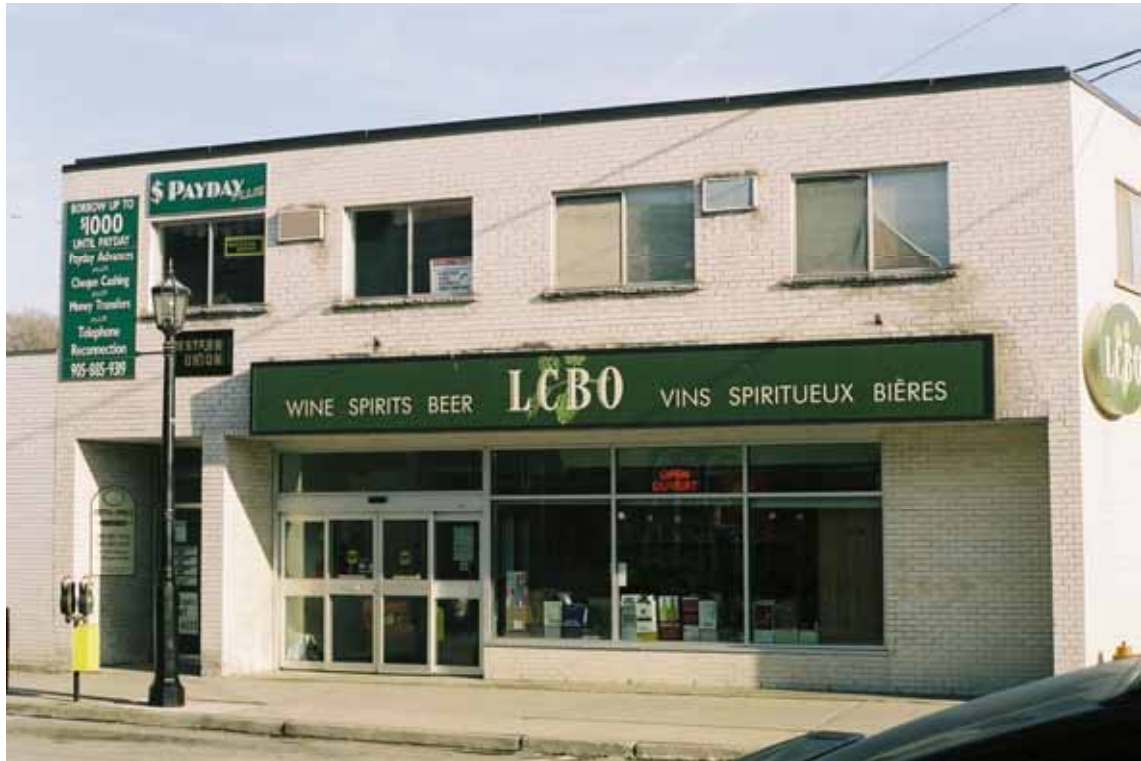
15 and 17 Ontario Street

- Comments – This building provides a good example of the contrast between traditional and more contemporary construction, being generally horizontal in design and dull in appearance. Back-lit sign, though modest in size, is inappropriate to the historic context. Brogden’s Lane extends along south elevation to (future) Rotary Walk adjacent Ganaraska River, and this provides an opportunity for a commercial presence on the lane, an opportunity yet to be realized. On the south side of this lane, there are a number of interesting rear elevations to buildings on Walton Street. These too present various courtyard and terrace opportunities near the river, though thus far only the drive-by pharmacy off Ontario gives the public a reason to come into this area. The empty lot behind the building is another area for potential development, and has the advantage of being adjacent to the riverside walkway. Property to rear is plainly visible from opposite side of the river and new construction could significantly affect the appearance of central Port Hope. Future proposals should be made in consultation with the Guidelines, as well as investigation as to what previously existed on these sites.

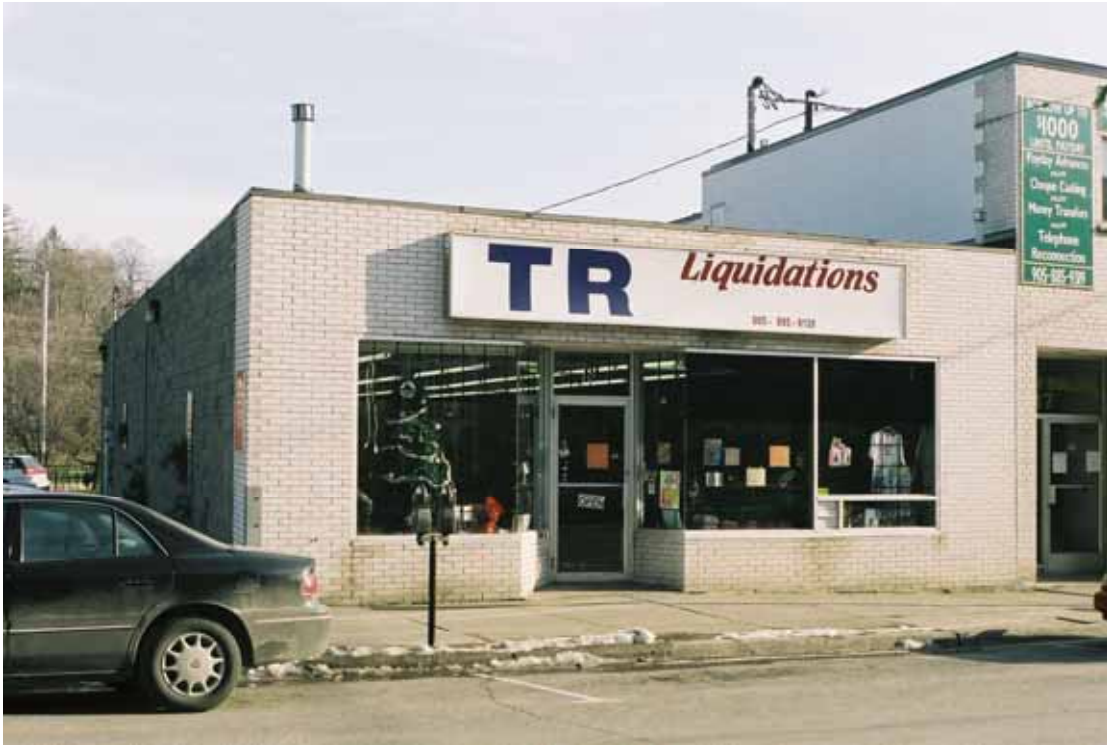
19 Ontario Street

- Comments – Building appears to be the Sleeping Beauty of Ontario Street. Although shopfront may retain little heritage fabric aside from, perhaps, high-level glazing, there seems a strong possibility that original fabric remains behind extensive metal-cladding above. Selective removal of finishes is encouraged to see what exists behind, and in what condition this may be. Historic photos may also exist. Upper floor window canopies should be removed and windows should be replaced with period facsimiles. If sufficient 1950s material remains at shopfront level a composite approach to this restoration might be considered. *(NAH much of this restoration work has been completed since the photograph was taken)*

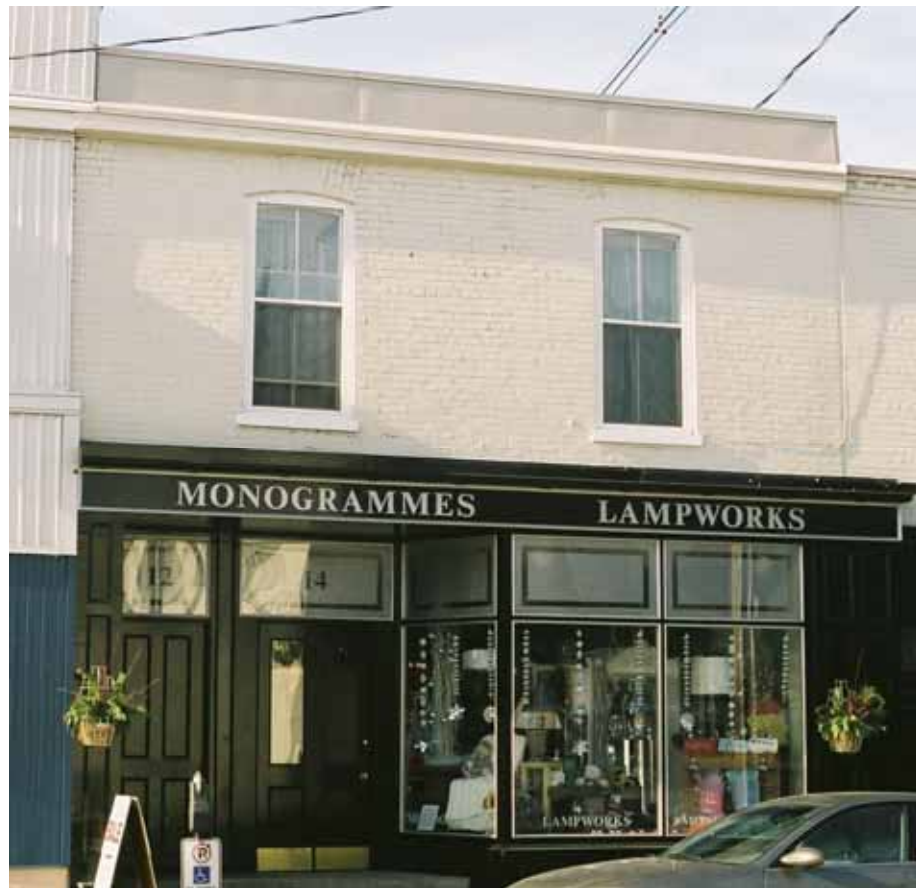
12 and 14 Ontario Street

- At second floor, wall is built of painted red brick (assumed to be without polychromy), with headers typically every sixth course. Windows are two, 1/1 aluminum replacement units, retaining wooden sills (RH unit is visibly repaired), and are set within segmental arches.

- Comments – Modest main-street building is much altered at shopfront, but older elements appear to remain behind and above Post Modern signage and trim. These should be investigated. Recent installation of planted mouldings on plywood appears at first suitable to the historic context, but these could be improved and a more suitable period-type shopfront might one day be installed. Brickwork has presumably been painted because of spalling at upper levels. This should be investigated and water ingress, or humidity migrating though wall, should be prevented. Ideally paint should then be carefully removed from bricks. Loss of original windows at second floor, presumably with curved upper sashes, is unfortunate.

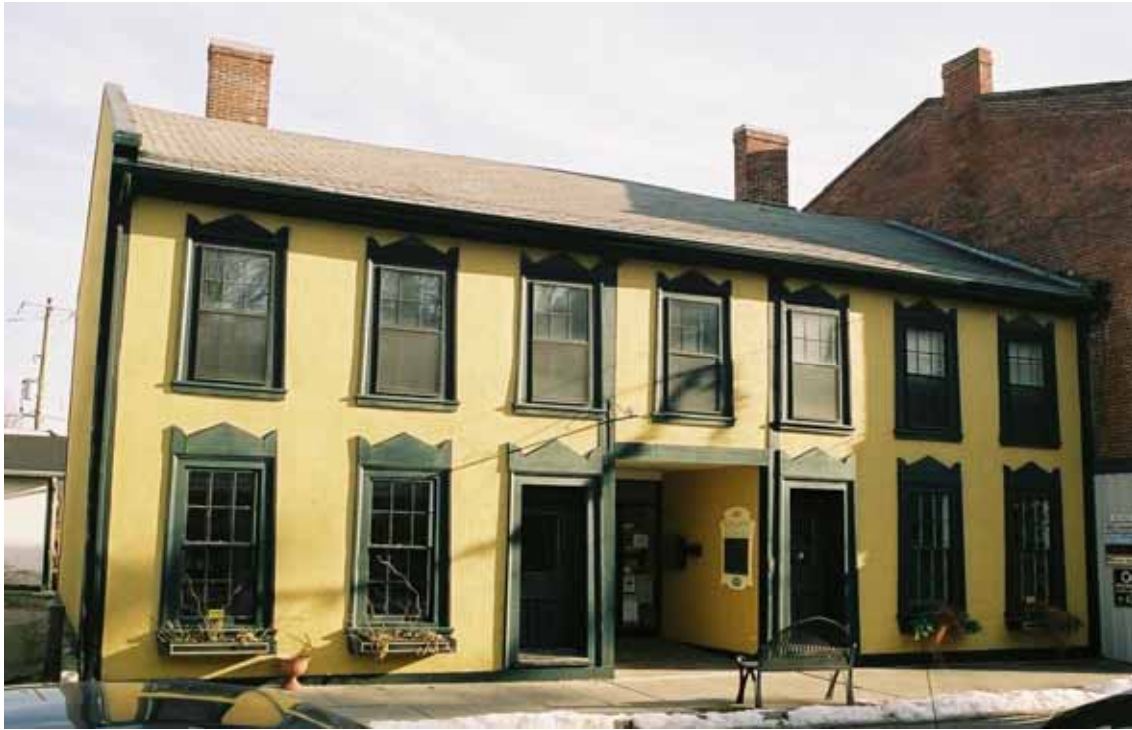
35 John Street

- Comments – This is a rare building with many original elements intact. Most significant are the incised render, the front windows and their tapered-and-crowned trim, the panelled doors and door recesses, the longitudinal chimneys and the five extant 6/6 rear windows.

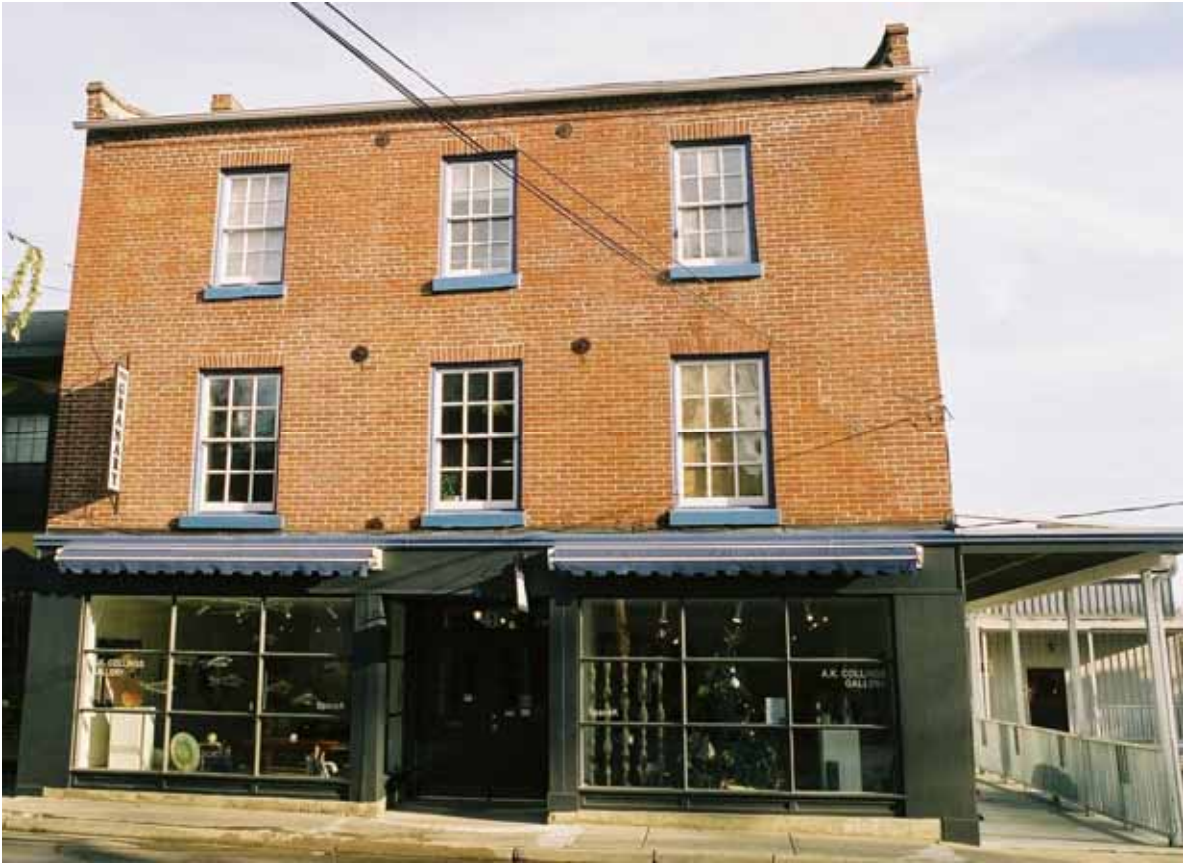
**41 John Street**

- Comments – An attractive building, though with a number of recent elements. Shopfront, doors and transom window are obviously modern and could be more to heritage norms (especially doors), but are generally attractive. Shopfront pilasters and fascia lack suitable ornament and detail. Thickness of muntins in new 6/6 windows is somewhat noticeable, and metal frames of individual thermopanes tend to catch the light. See the Guidelines for comments on replacement windows. Window arches are generally sagging and may require support by concealed angle-iron. At rear addition, tower (assumed to have former industrial purpose, as would be fitting adjacent former railway line) and old Coca Cola sign at north wall are valuable heritage elements and should be conserved. For any proposed development of the large parking lot to the south, see the Guidelines. Note that this three-storey Georgian building is the last of its kind as one heads south on John Street and so marks the ultimate point of transition between Original Commercial Sector and Transitional Residential Sector.

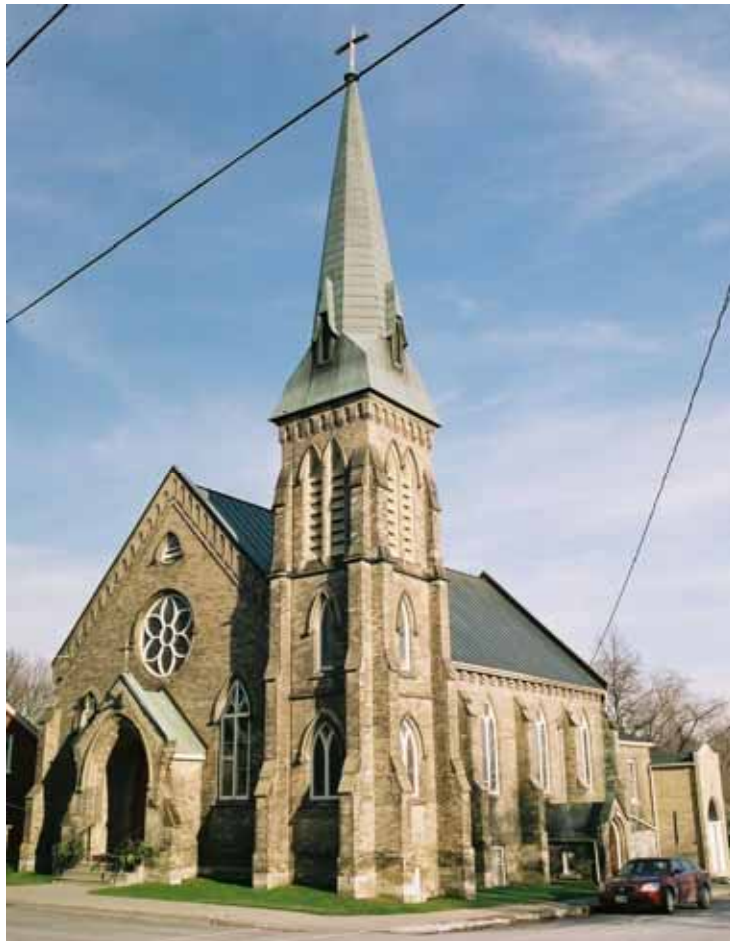
59 John Street

- Gothic Revival, buff-brick, Baptist Church with prominent corner tower and spire, and sandstone trim (1867). Church is **Designated** under the Ontario Heritage Act, Part IV.

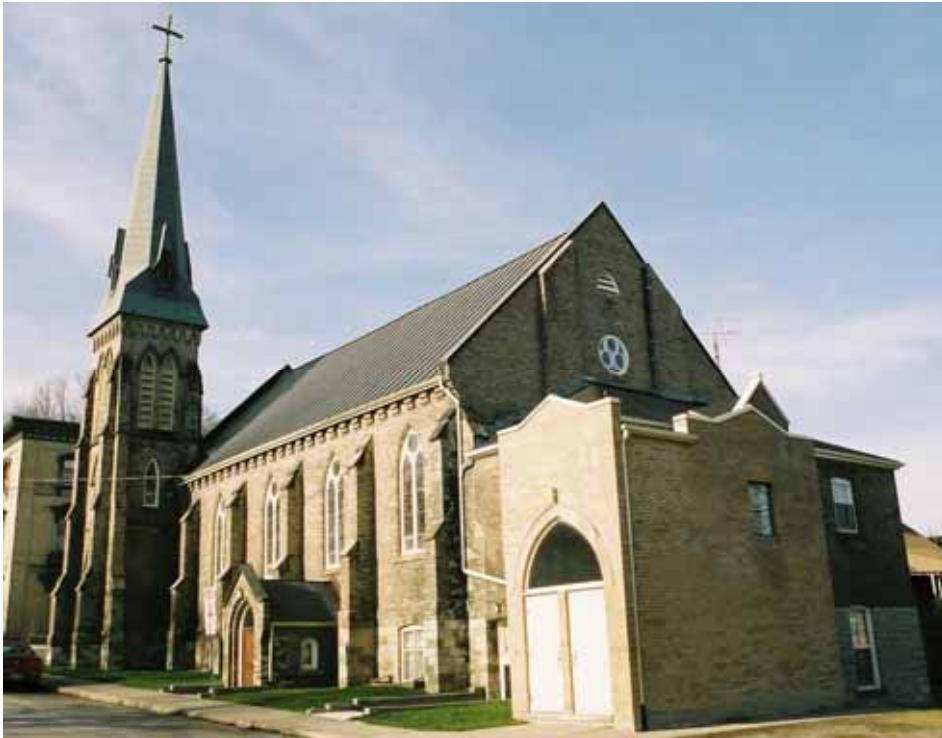
**59 John Street** (continued)

- **Comments** – A most impressive, Gothic-Revival church, especially for fine carved heads below hood mouldings. Building is in good repair and should remain so, although loss of imposing chimneys at east gable is unfortunate, and reinstatement is much encouraged.

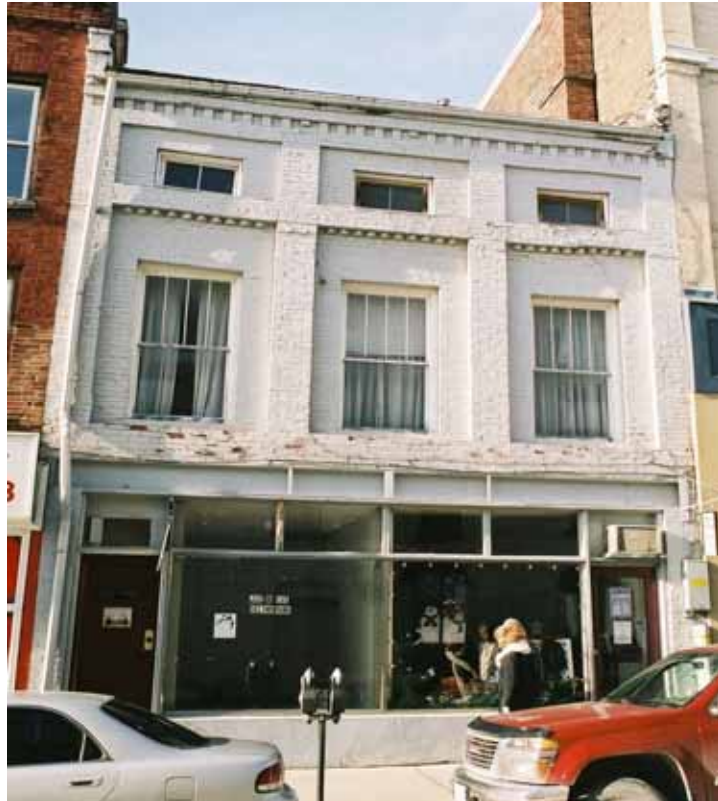
16 - 18 John Street

- Comments – An attractive building in rather neglected condition, and suffering from much settlement (assumed to be inactive). At ground floor, shopfronts are simple and lack of fascia and cornice at exposed beam is inappropriate to the context. Second-floor concrete sills – assumed to replace wood – do not project beyond masonry this may be aggravating peeling paint and spalling brick below. Four-pane top sashes seem in fragile condition and should be maintained. RH chimney head needs re-pointing. Removal of paint from masonry is to be encouraged, assuming brickwork below is neither excessively decayed nor varied in type.

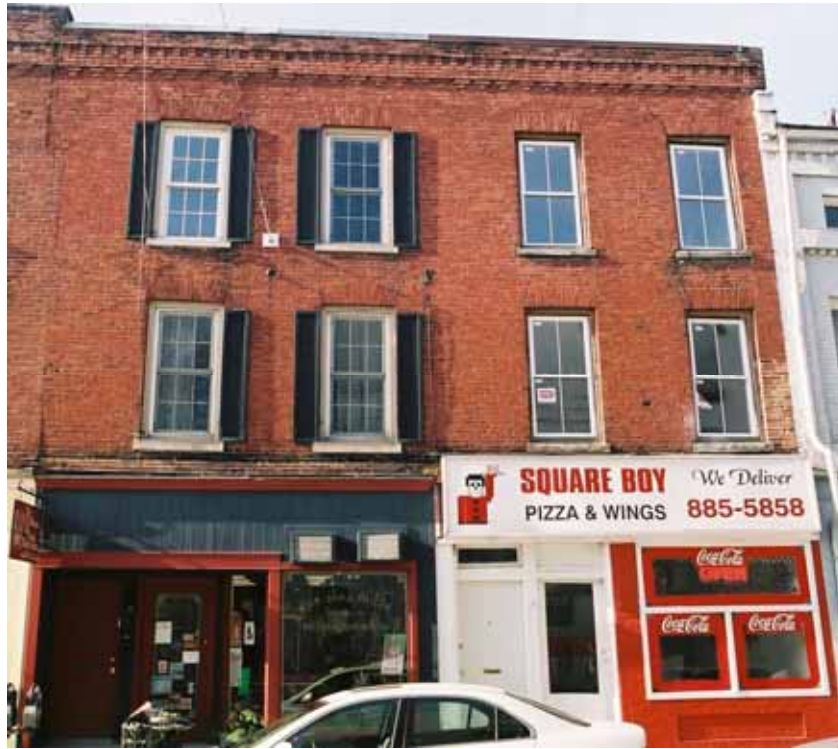
20, 22, 24 and 26 John Street

- Comments – This elegant façade is generally in good repair, but suffers from much settlement (assumed to be inactive), especially at RH side. Shopfronts are recent but as mentioned, may conceal older material, given depth of boarded fascia at left (note also flashing witness above). This should be investigated. Shop windows and all doors are unsuitable, and should be one day be replaced in accordance with the Guidelines. At upper level, all windows are new. 2/2 units at right may replicate original windows, though 6/6 seem more probable. 6/6 windows at left, however, too small, and made of an unsuitable material. Old metal flashing at RH parapet needs replacement, and sections to left should be tidied. Re-pointing is needed in various places at failed voussoirs.
