John, Ontario and Queen Street Heritage Conservation District Plan

Municipality of Port Hope, Ontario

Final Revision – January 2008

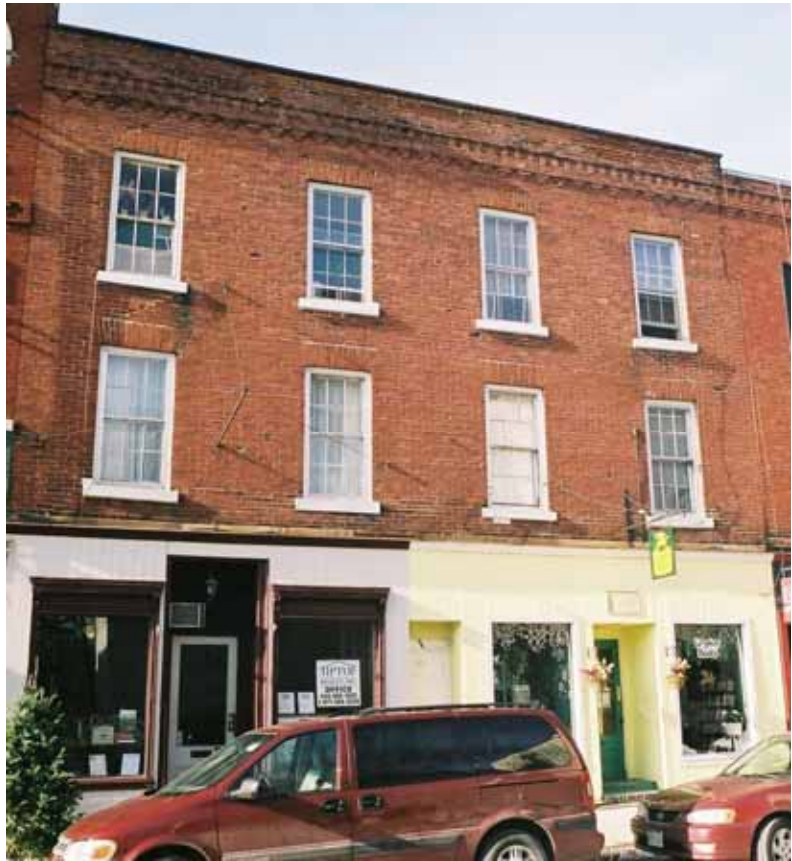
28, 30 & 32 John Street

- Upper Floors – At second and third floors, building comprises four plain bays built of hand-made red bricks laid in common bond. Window apertures have metal-flashed wood sills and flat-arch voussoirs, and there is much settlement in bays one and four. All windows are original 6/6 units (all with frames for metal storms) and seem in reasonable condition.

- Rear Elevation – Lane elevation has numerous old 6/6 windows in rather patchy brickwork
- Comments – Elegant façade is generally in good repair, though suffering from settlement (assumed inactive) at outer bays. Ground-floor shopfronts may hide older material, given depth of boarded fascias and remaining old posts and glazing at no. 32. Here, windows are somewhat unsuitable, doors less so; and old windows at entry to no. 30 should remain and cornices etc. over adjacent windows are unusual and worth retaining. At upper levels, 6/6 windows should be retained and repaired. Severe cracks at areas of settlement should be repaired and repointed, and upper parapet requires much repointing.

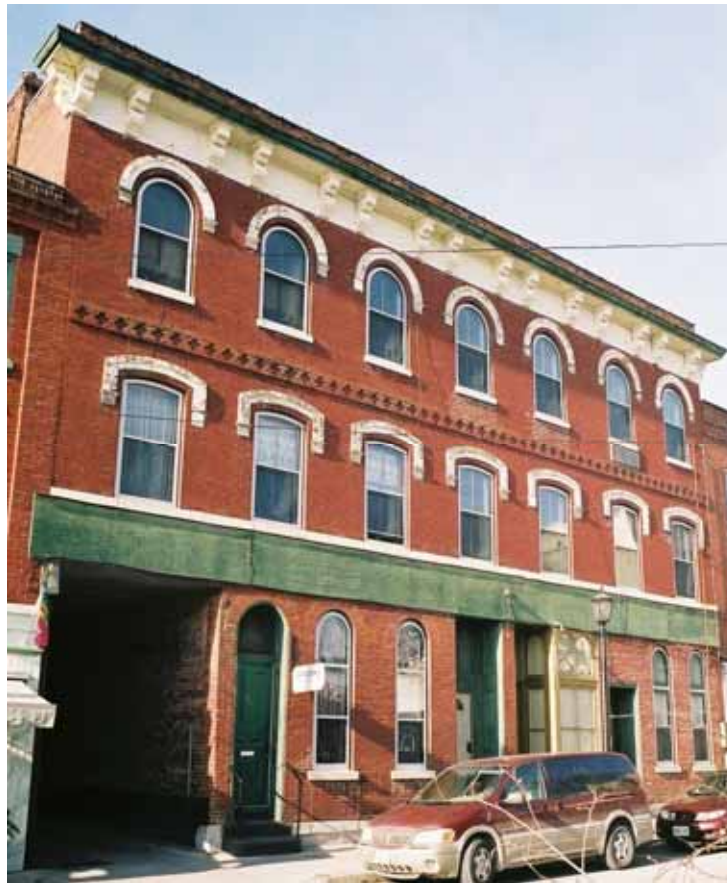
34, 36, 38 & 40 John St.

- Comments – Façade is in good repair, though hood-mouldings and wooden corbels need some repair and painting, and some have fallen off. At ground floor, old panelled recesses and soffits, and old transom windows are rare and in good repair. Metal storm-windows, though not beautiful, protect old windows and should remain until a sensitive interior double-glazing system is installed. Parapet needs repointing, and a suitable lower cornice should be reinstated. Rear windows are wonderful.

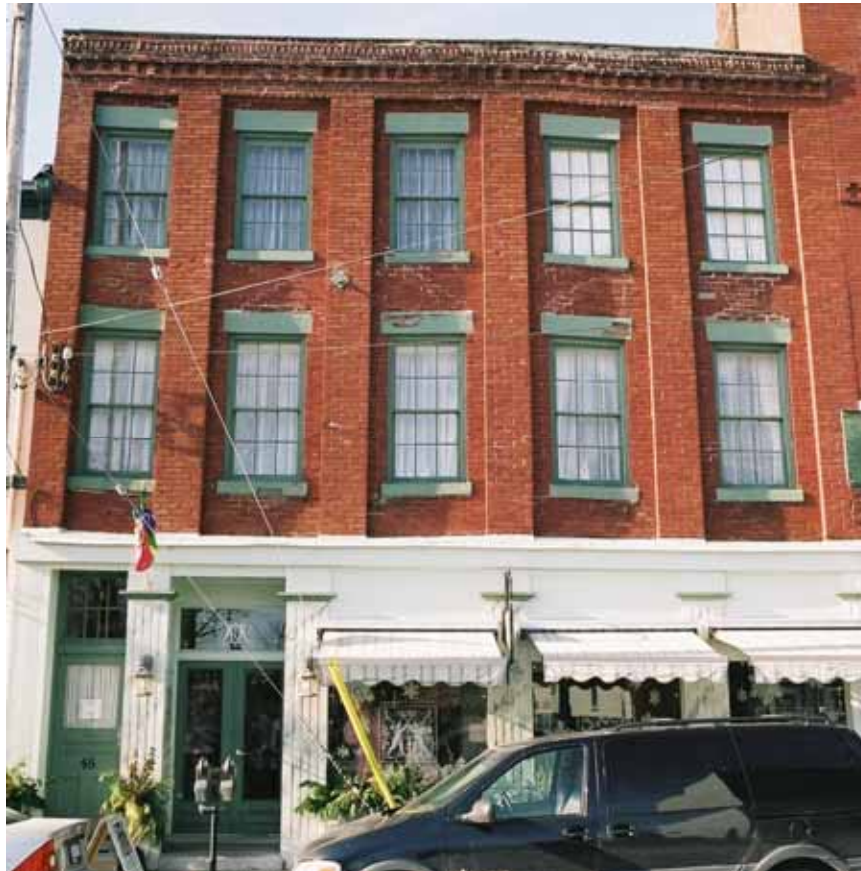
46 & 48 John Street

- Three-storey, 5-bay, red-brick building with original 6/6 windows, wooden lintels and sills (c.1860).
- Ground Floor – Rhythm at street level differs somewhat from that of upper storeys, due to doors at LH side. Bays are divided by recent, grooved pilasters (assumed to have brick piers behind), with modest cap mouldings towards tops. Three large, recent, shopfront windows at RH side have planted mouldings on plywood panels at stall risers. Large painted panels above may indicate older shopfront glazing behind. Doors to shop (no. 46) are recent, glazed wooden doors under recent decorated transom window, with old, two-pane, shop-window in recess to right. Door to upper floors (no. 48) is old, half-glazed, three-panel wooden door with bolection mouldings, under old six-pane transom window. At top of ground floor, band of vertical v-jointed boards replaces a cornice.

- Rear Elevation – Lane elevation retains original 6/6 windows, in wall with considerable settlement.
- Comments – Brick building is generally in good repair, but has suffered from significant settlement, now assumed to be inactive. (Note also bulging masonry behind RH pilaster.) Ground-floor shopfronts are not in keeping with period types, including use of vertical v-jointed boards, but post-modern rather than modern. When alteration is contemplated, these should be replaced using suitable forms and materials, perhaps replicating an older shopfront if period photos are available. At upper levels, original windows and wood lintels and sill are charming features, and painting is required. Similarly, all old 6/6 windows should be retained, maintained and repaired as necessary.

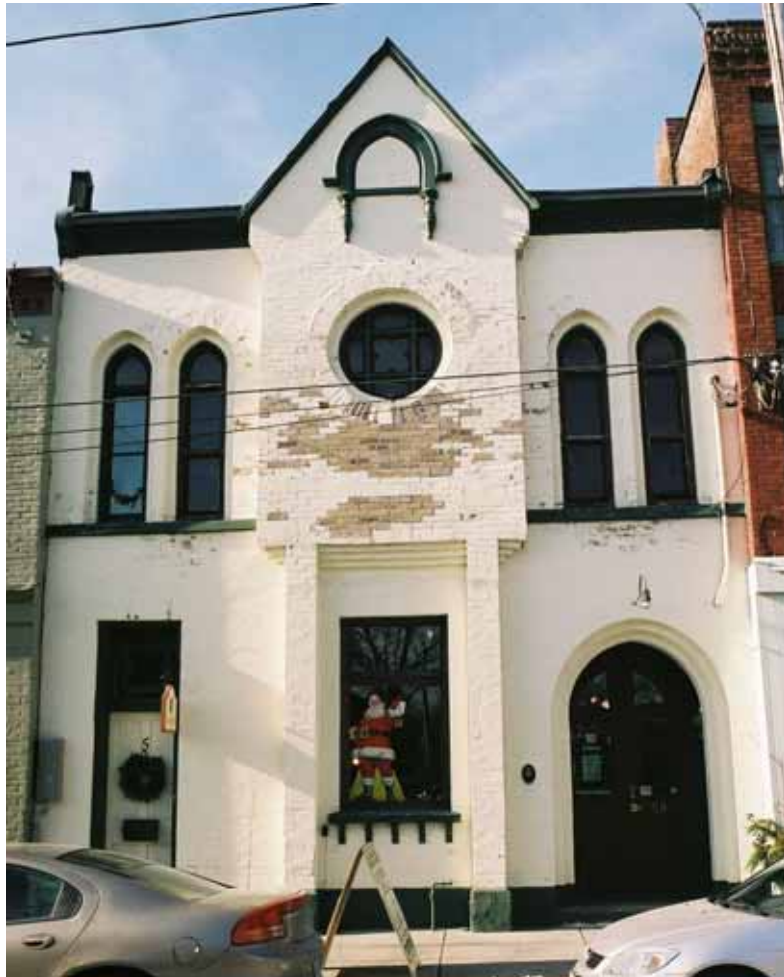
50 & 52 John Street

- Three-bay, two-storey, painted-brick Victorian Gothic building with upper oculus and wall-head gable (c.1874). Buildings **Designated** under the OHA, Part IV (Easement held by Ontario Heritage Trust).

- Description – Attractive, asymmetrical Victorian brick building has variety of eclectic elements. Brickwork is painted throughout (except in area of apparently recent repair) which, given style, may hide polychromy. Base of building is articulated by projecting courses with bevelled bricks at top course. Entry is set in large, slightly pointed arch at right, having multiple jambs and voussoirs, and band at flush hood-moulding. Doors are pair of tall, curve-headed wooden doors with two upper panes and single panel below. At central bay, rectangular aperture is set between narrow pilasters and has large single-pane sash under transom window. Projecting, canted wooden sill has five wooden brackets below, while wood transom above is plain. At LH side, aperture seems to be altered (voussoirs extend to right of jamb). Door to upper level is simple, four-panel door with bevelled-edge stiles and rails and flat panels. Transom window has old glass and unusual “gothic” wooden frame mounted within. At second floor, dominant element is projecting central bay, corbelled out to meet plane of pilasters below. Central bay contains large oculus within double voussoirs, again with flush hood-moulding. Oculus contains square central sash, with four-leaf inner motif, framed by segmental sashes. At either side, fenestration is pair of narrow, pointed-arch windows with original, two-pane casements under fixed transom windows, all over continuous, thick wooden sills. Apertures have double jambs and voussoirs, again with flush hood-mouldings. At gable, brickwork corbels out to either side, evoking mediaeval practices. Gable contains rendered, blind aperture in ornate, slightly pointed-arch, wooden frame, with unusual half-spindles below sill at either side. Eared wooden hood-moulding is evocative of flush hood-mouldings faintly apparent throughout building. At adjacent wall-head, deep wooden fascia with substantial cornice butts into decorative wooden brackets at either side of building. At gable fascia, trim consists of narrow profiled shingle-moulding.

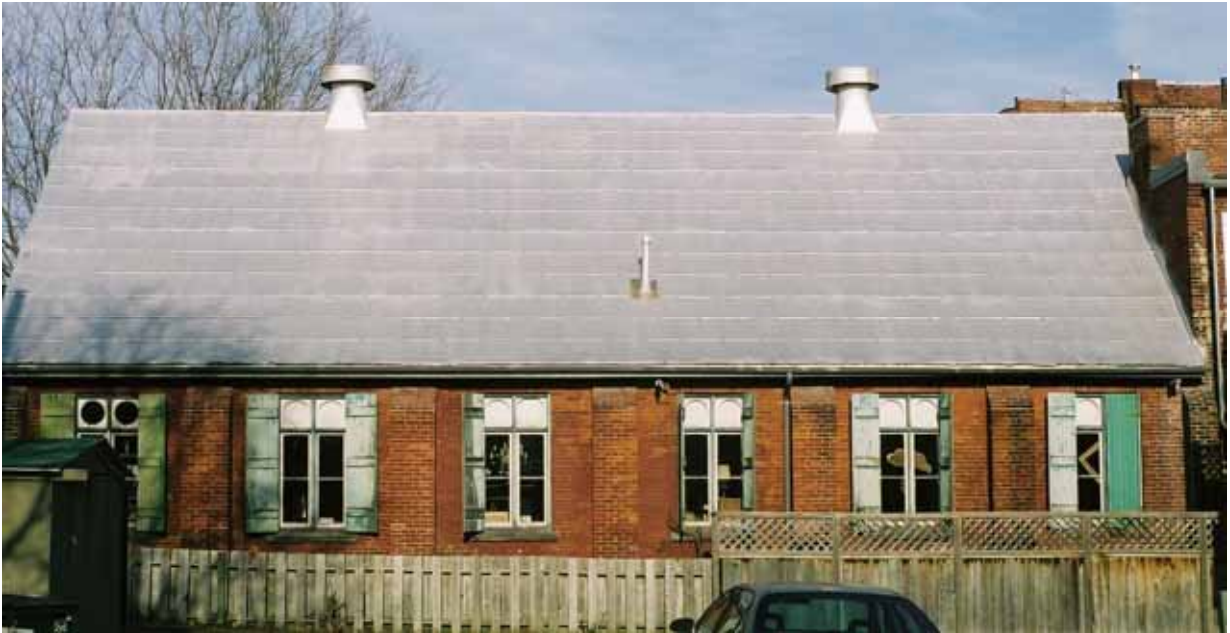
**50 & 52 John Street** (continued): **South Elevation at Brewery Lane**

- Lane Building – Six-bay, buttressed, red-brick building with steeply pitched roof clad in galvanized sheet-metal panels, and with two large metal ventilators at peak (former Orange Hall, c. 1850).

- Comments; Front Building - This is an unusual and attractive Victorian Gothic building with many original elements. Recent repairs should be painted; or paint should be removed throughout. Paint, may well polychromy at flush hood-mouldings and perhaps elsewhere. Any further brick replacement should be done using hand-made bricks of suitable size and colour. Metal flashing should be removed at upper LH bracket. Lane Building - Located at rear of site, on Brewery Lane, fabulous old building is plainly visible and presents prime opportunity for enhancement of rear of property. Concrete block structure at west end might well be removed; or enhanced in appearance. Witnesses above suggest a demolished, pitched-roof structure here, which might be reinstated. Gable and south lookouts and rafter-ends should be repaired and a new (painted) fascia (and perhaps soffits) should be added. Chimney top should be rebuilt/repared, and west oculus requires repair and re-opening. Also, two window arches are collapsing at north elevation. Metal roof, which was rather rusty in 2003, has fortunately benefited from recent repainting, and should remain in good repair for many years.

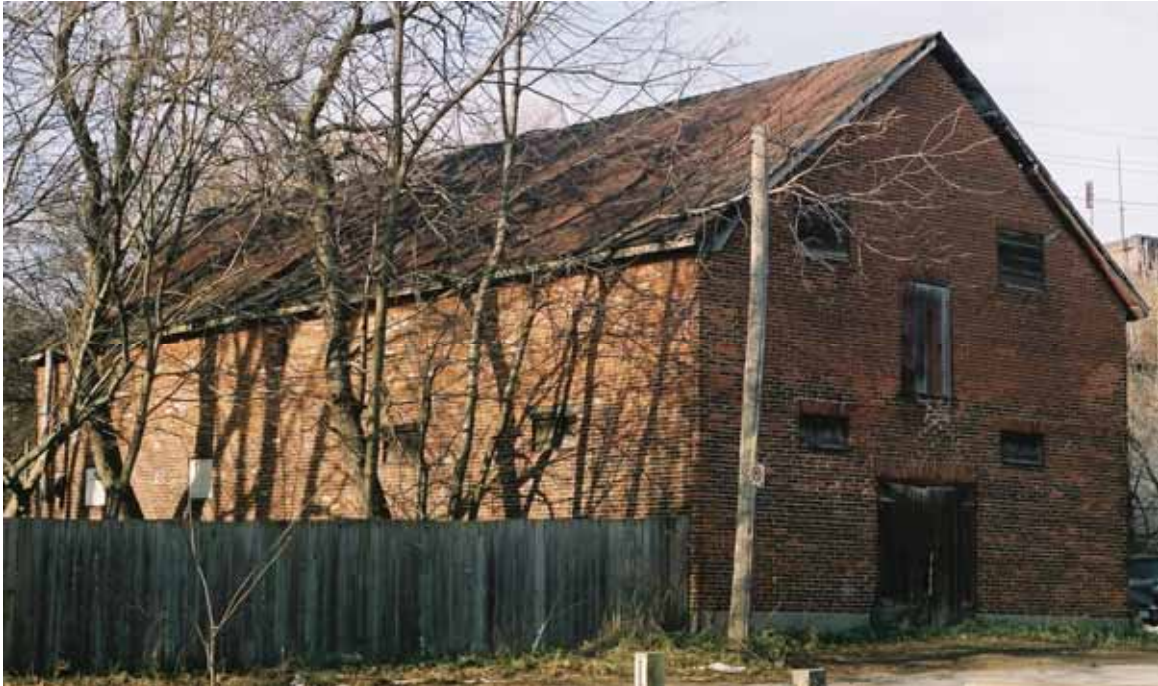
**Red-Brick, Gabled Building** (west side of lane)

- Pitched-roof, 2½ storey, vernacular (Brewery?) building with varied openings and metal roof (c. 1860).
- **East Elevation** – Large, pitched-roof structure is built of hand-made red bricks laid in common bond with intermittent, paired headers typically every sixth course. This elevation has appealing and unusual symmetry, suggesting original building was of some importance, being perhaps formerly a stables or brewery for the Saint Lawrence Hotel (on Walton Street). **Ground floor** has central aperture formed by (failing) brick flat-arch with soldier and header voussoirs rising to uniform course line above. Pair of simple, unpainted doors, made of v-jointed, vertical boards are assumed to be original. At either side of entrance, set somewhat above, are single, wide and low apertures, also formed with flat-arches but consisting of somewhat haphazard, single soldier-voussoirs only. There is no sign of former sills in boarded-up openings. At **second floor** is another centrally located, outward-opening door, made of unpainted vertical boards, and with remnants of a wooden sill, and with wooden lintel. To either side, virtually aligned with small windows below, are additional square apertures closed with horizontal boards. Flat arches at upper level apertures are as described at lower small windows. **Soffits** at gable reveal various conditions, with both fascias and soffit boards lost at north pitch, and old decking boards now visible from below.

- **Roof** is clad in large sheets of rusting, galvanized sheet-metal with somewhat *ad hoc* ridge flashing. Cut of roofing material at south edge indicates skew in front wall relative to side walls.

- **Comments** – This is a fabulous vernacular building presenting a wonderful but unrecognized back-lane opportunity. Building needs repair in some specific areas, particularly at crack extending up from central aperture to upper RH window; though cause of crack should first be identified. Roof and walls are straight, but areas of south wall are failing at and beyond lintels and require repair. Fascias should be repaired and, in particular, new ogee (not K-type!) galvanized gutters and corrugated RWLs should be installed to get water off bricks. Nearby old hydro-poles, armatures and tangle of wires add to interesting and semi-rural Brewery Lane ambience.

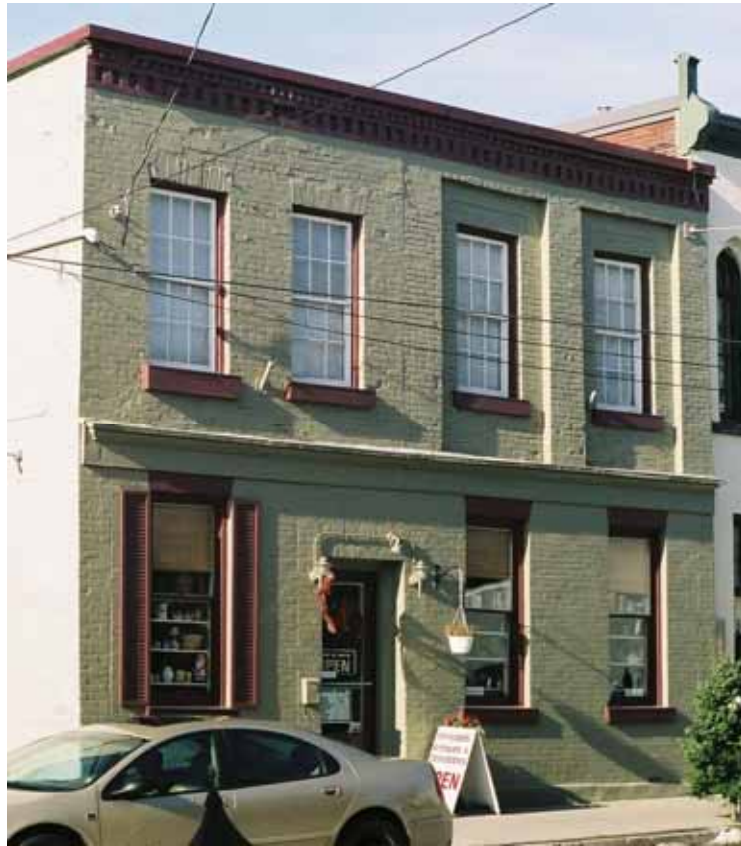
**54 John Street**

- Two-storey, flat-roof (painted) red-brick building with varied upper-floor masonry (c.1870)
- Description – Variations and toothed- and butt-joints in brickwork indicate composite nature of what appears at first to be a single building. At ground floor, building comprises four bays, with entry at second bay from left. Painted brick masonry is built off cement-rendered base at LH side, which may indicate stone foundation behind. Low door, without transom window, appears to be one of several changes to building. (Toothing-in of brickwork and discrepancies in course heights to left of door indicate alterations in this area.) Door itself is fully glazed, modern wood door reached by single concrete step, with soldier-and-header course voussoirs forming flat arch above. Ground-floor windows are three tall, 1/1 units with boxed-in wooden sills and flat arches apparently consisting of single soldier-course only. Modest fascia, spanning full-width of building just above window-heads, has beaded lower edge and chunky cornice, which returns into fascia at ends of building. At second floor, differing aspects of building are more apparent. Upper four bays comprise, at RH side, two recessed brick panels between plain brick pilasters, then central butt-joint where course heights change, and flush brickwork in two LH bays. Windows are 6/6 throughout, all with boxed-in wooden sills, RH windows being higher and having wooden lintels. Units at LH side have flat-arch, soldier voussoirs as at ground floor. At parapet, masonry consists of corbelled course under double course of alternating projecting and recessed headers, then additional plain course below slightly projecting dog-toothed course, with additional top courses largely hidden by deep metal flashing.

- Rear elevation retains original 6/6 windows at upper level, much hidden by large wooden deck.
- Comments – Simple and traditional brick building is more complicated in origin than it seems, yet most attractive in its old variety. Bricks below parapet are damaged, presumably where water has entered masonry from behind. Paint also probably hides a variety of brick types, and this should be investigated before removal is considered as masonry may comprise a wide variety of bricks and mortar types. Chimney (not visible from front) needs repair, and various replacement bricks.

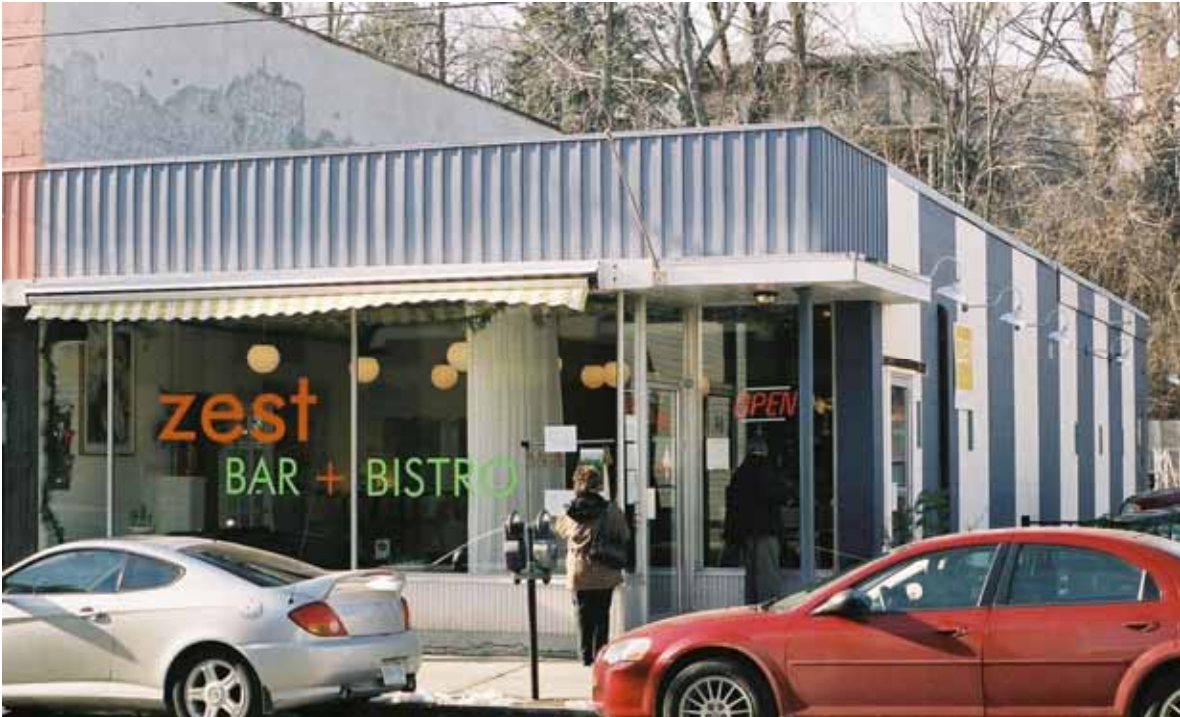
**64 John Street** (north)

- Modern, one-storey commercial building with large windows and metal cladding above (c.1960).
- Description – Recent structure is not consistent with street in form, scale and materials. Above concrete curb and aluminum-lined stall-riser, shop windows have standard aluminum-frames, with standard glazed door recessed under flat, aluminum-flashed canopy at RH corner. Window signage is bold, and though not unsuitable to this building it does set something of a precedent. Retractable striped yellow awning does contribute to the heritage streetscape. Wall above awning is clad in deep bank of painted, ribbed sheet-metal. Bold stripes painted on metal cladding at north wall, lit at night by several spun-metal lamps, are a prominent aspect seen across large parking lot to north.

- Comments – There is not a lot to be said in favour of this structure, given its location towards the south end of the Original Commercial Sector of John Street. When the time comes for this to be replaced, there are two alternatives. One would be to replicate a building which once stood here, if there was such a building and if the appearance of this can be determined, and the other is to build a new building in accordance with the Guidelines. The large parking lot to the north also presents a development opportunity, particularly given connection to Brewery Lane, leading up to Walton Street. Research might reveal the nature of previous structures on this site also, and otherwise, the Guidelines should be consulted.

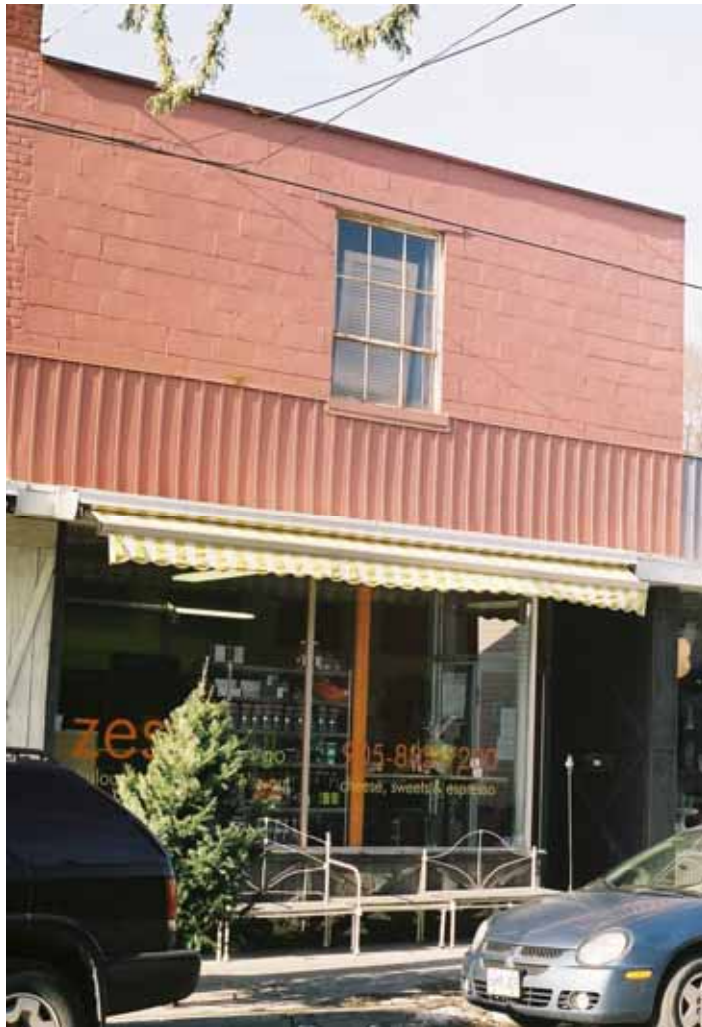
**64 John St.** (middle)

- Modern, two-storey commercial building with painted, concrete-block upper floor (c. 1960).
- **Description** – Recent structure is out of keeping with street in form, scale and materials. Adjacent pavement, base of wall is clad with rustic vertical boards with apparent cross-bracing, providing a sharp contrast to the huge aluminum-framed windows above. Windows and door have standard aluminum-frames, with typical modern glazed door recessed at RH side. Retractable, striped white-and-yellow awning above is an attractive feature. To right of door, in recess, is additional area of rough vertical boards with upper and lower cross-bracing. Area of traditional fascia and cornice is finished with deep band of painted, ribbed sheet-metal. Window signage is similar to adjacent shop to north (which has same occupancy), but although modern in style, is slightly smaller here than next door. At second floor, painted concrete block is obviously recent, though tooting-in at LH side and metal-frame, 6/3 window suggest this may be an older structure, with original cladding later replaced in concrete block. Window sill is concrete, lintel is metal angle, and parapet has thin metal flashing.

- **Comments** – Aside from (modern) awning, this is not a building in keeping with historic, commercial buildings of John Street. As noted, upper floor (and therefore building) may be older than this seems and this aspect deserves some investigation. Alignment of window head with those at number 64 John Street (south) may be significant. If upper floor is recent, then two additional floors might replace this, with fenestration typical of rhythm on the street, all as per the Guidelines. This would probably imply an entirely new building. In the meantime, the paint on the concrete block mitigates its natural appearance, and the metal-framed window is an anomaly which may have interesting story behind it.

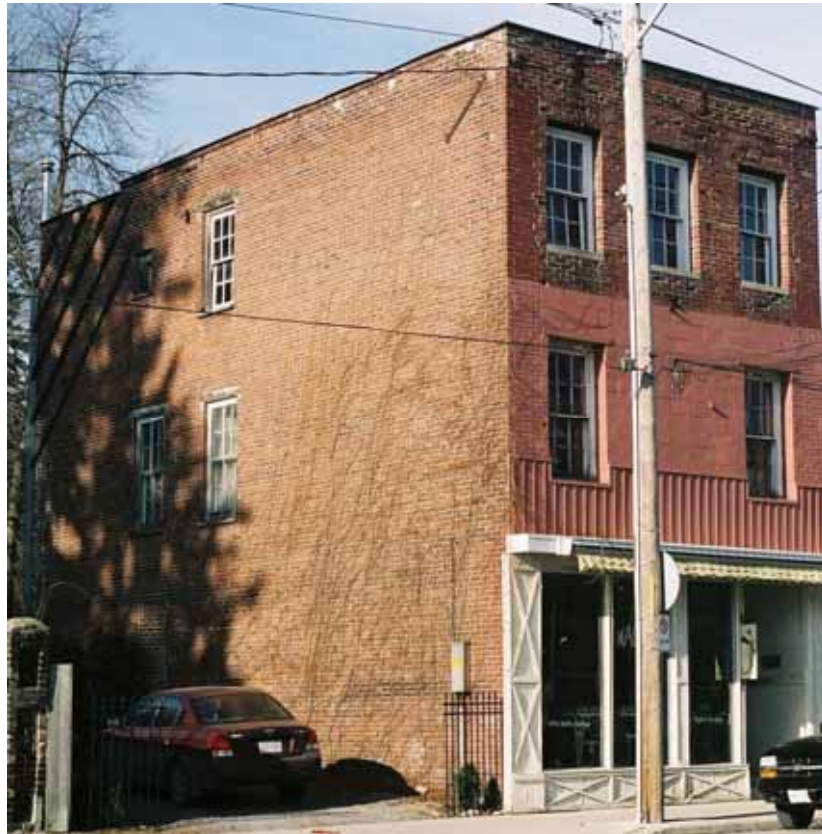
**64 John Street** (south)

- Three-storey commercial building with extensive rebuilt masonry at upper levels (c. 1870 and later).
- Ground Floor – At shopfront level, wooden materials are recent, used in a rustic contemporary manner. Stall-risers are finished with rough vertical boards having modern-section, face-applied frames and central cross-bracing. Large piers at either side are finished similarly, while narrow intermediate supports have simpler wooden cladding. Actual glazing framing is aluminum, and front door (to RH side) is similar. As at buildings to right, area of traditional fascia and cornice is finished with painted, ribbed sheet-metal and, again, striped yellow awning contributes to heritage streetscape. At second floor, pair of old, 6/6 wooden windows have concealed sills and exposed, metal-angle lintels. Masonry to either side of windows is painted red-brick laid in common bond, with outer window-jambos apparently rebuilt. Masonry between and above windows is painted concrete-block, as at building to right. At third floor, masonry is somewhat as described but in unpainted brick, with small adjacent areas rebuilt using reclaimed brick starting inwards of line 4” beyond outer jambos. Lintels are concealed angle-iron without voussoirs or headers, and plain parapet is obviously recent. Fragments of original decorative parapet elements remain at both upper corners, particularly at RH side. Wall-head is capped with rowlock headers immediately below projecting thin metal flashing.

- Comments – This is an anomalous building. Much of upper two floors has rebuilt masonry, and original form is not easily determined. It appears that old brick was for some reason replaced in central and upper areas of façade. Rebuilt sections, and concrete block, are not so intrusive and might remain, since there may be an associated narrative. This aspect should be investigated. Reinstatement of decorated brick parapet is encouraged, and introduction of suitable signage fascia, in place of vertical metal cladding, would be welcome. Shopfront is expendable whereas south wall and all old elements which it contains, should be maintained. Braces may require maintenance too, in due course.

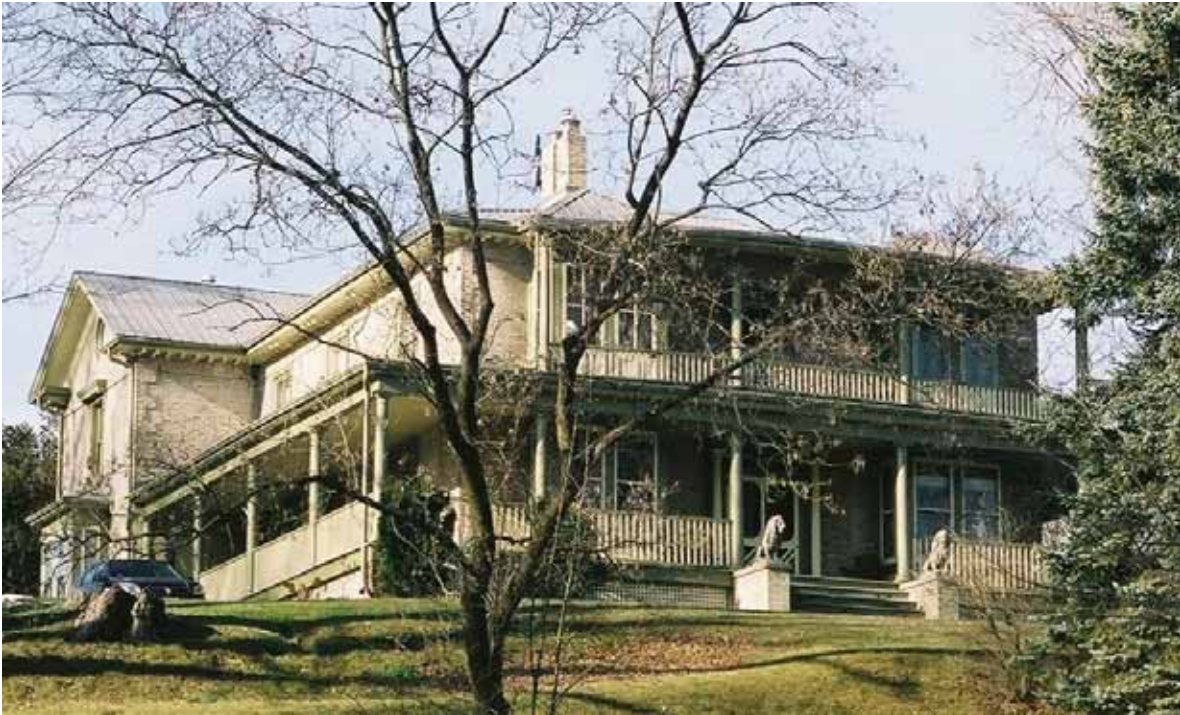
68 John Street/47 Pine Street South

- Italianate, buff-brick house (c. 1860) with large verandah, altered entrances, and addition at east side, 2nd floor. The house is **Designated** under the Ontario Heritage Act, Part IV. This large house, set high on a hill, has access via brick gates on John Street and winding drive, and also via more recent, cast concrete gates and drive off Pine Street South.

- East Elevation, Ground Floor - L-shaped house has symmetrical façade facing east, at top of old drive from John Street. Hipped-roof verandah at north, east and south sides has traditional, full-height columns, with turned bases and capitals and square pads at top and bottom. High wooden railing between columns has plain top and bottom rails and simple square-section pickets, suggesting that all elements are recent replacements. Verandah ceiling is finished with narrow, v-jointed boards. East entry, assumed to have been original principal entrance, is reached by broad, central flight of wooden stairs flanked by lions on plinths at either side. Inner doors are behind traditional wooden screen doors, and are set within projecting, rectangular vestibule with traditional, full-height columns at corners. Ground floor windows at either side are within similar square bays (which appear to be recent) and consist of paired 1/1 units at face and smaller, single 1/1 units at sides (all with 1/1 storms). Bays are trimmed with plain corner pilasters and wooden panels below windows. Masonry is buff brick throughout, with projecting quoins extending full-height at corners.

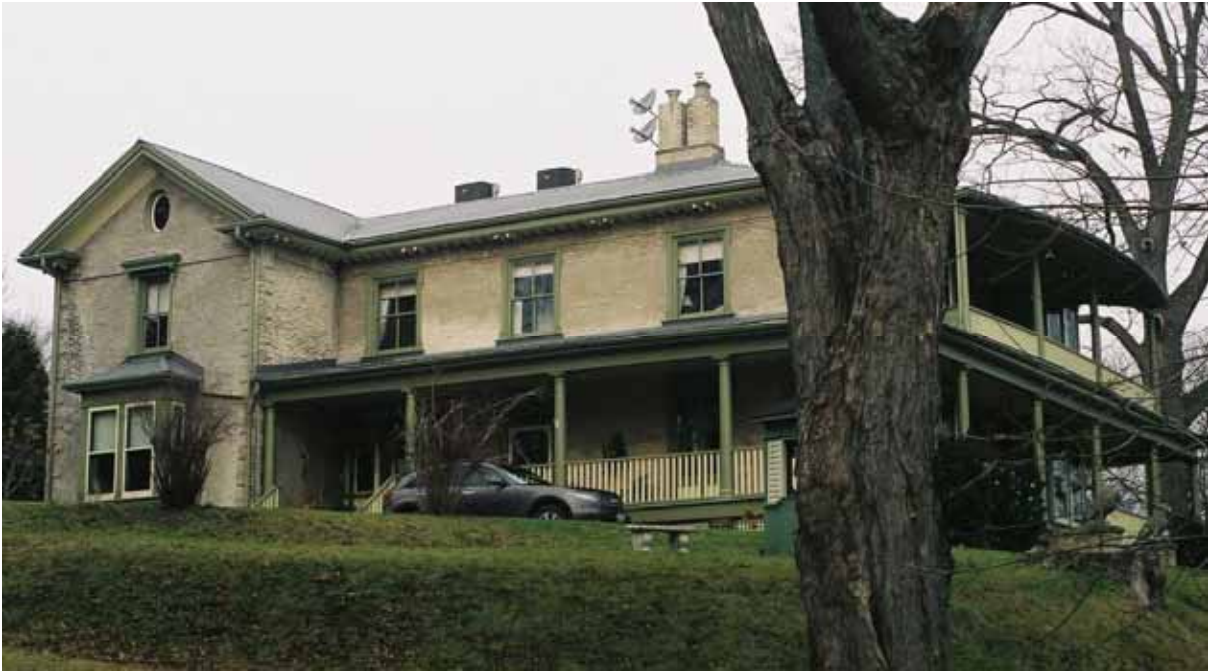
**68 John Street/47 Pine Street South** (continued)

- South Elevation comprises eastern wing (see above) and projecting, gabled wing at LH side. Hipped-roof verandah is as described (but without upper level) and ends at broad wooden stairway to unusual entry (assumed a later alteration, and now apparently main entry) next to projecting gabled wing. Doorway consists of two fixed, door-like panels flanking central, half-glazed door. Door and fixed, half-glazed side panels with applied swags at bottom panels are separated by tapered, fluted columns with traditional bases and capitals. Masonry recess to doorway is lined with triple wooden panels at sides, corresponding to panel and pane heights in door. Transom windows are unusual: segmental-arched window at center, while outer window-heads curve down towards column at central bay and are rectangular at outer corners. Further to right, single door (with Colonial-type screen door) has rectangular transom window, while doorway further to east has pair of full-height French doors. Wooden architraves at latter two openings, and at three, 2/2 second-floor windows, are eared at top and bottom. Masonry throughout is buff-brick with projecting quoins. Gabled Wing, also with projecting quoins, has squared rubble foundation plainly visible. Ground floor has recent, square-plan, bay window with pair of 1/1 front windows having three simple fluted pilasters, set over continuous moulded sill and two plain, recessed panels. Sides have narrow, 1/1 units over similar sills and panels, with entire structure built off visible joists. Hipped-roof is finished in ribbed sheet-metal. At second floor, central 2/2 window again has eared wooden architraves, and small entablature on modest wooden brackets. As elsewhere, brickwork corbels out slightly at upper second floor. Gable has central, vertical oval window framed by header bricks. Gable trim differs sharply from trim elsewhere, and consists of bold dentilled band between upper and lower mouldings, adjacent plain soffits and fascias. Eaves have full returns at gables, and rainwater goods and roofing are as described. A plain (rebuilt), double chimney exists at west pitch.

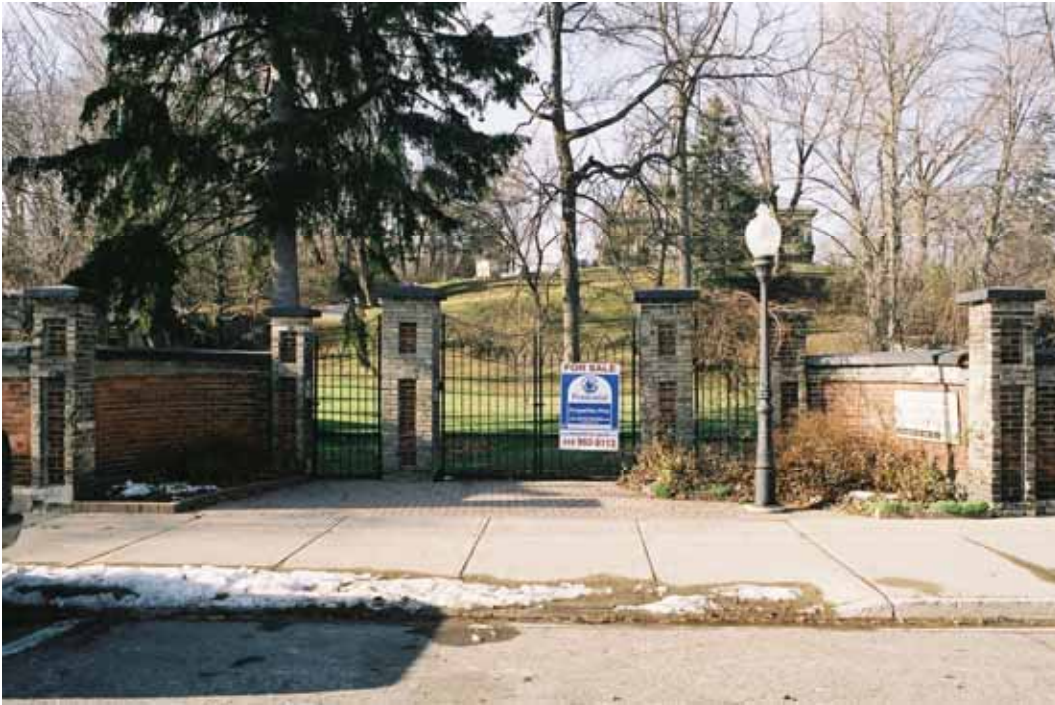
68 John Street/47 Pine Street South (continued)

- Walls and Gates – John Street Walls are built in hand-made, red and buff brick not in keeping with house itself. Wall is built of red brick, with triple course of buff-brick at top and bottom, as well as apparently bevelled, upper buff-brick course at base, most of which is now cement rendered. Hipped coping is, surprisingly, made of wood, now covered with painted sheet-metal, all of which appears original. Wall is divided into bays by projecting piers, with bases and tops as described, and with corners also in buff-brick, framing recessed red-brick panels. Towards north end, concave curve recesses wall back into property, with taller piers having also upper, recessed red-brick panels, marking pedestrian and coach entries, the latter having somewhat wider piers. Fine, gothic iron gates are attractive, but assumed not to be original. Line of old drive beyond is visible, winding its way up to house, and is important component of garden landscape. South Pine Street Gates, and balustraded walls beyond, are more recent and are made of concrete cast into neo-Gothic forms, with bevelled corners, recessed panels and concentric discs, and with complex pyramidal copings with mini-dormers at each face.

- Comments – The house is something of an anomaly, being quite different in style and materials from the walls along John Street, and also unusual within itself. Possibly original building is pitched-roof wing at west side, dating from circa 1850, later altered and extended by Victorian addition to east, and altered again more recently in various areas. Without detailed investigation, evolution of building is hard to discern. House is generally in very good repair, though lack of lintels is causing settlement at west elevation. The John Street Walls are a most unusual and valuable element within the street, and are in need of considerable repair. Failed, or failing, sheet-metal flashings, as well as general weathering and movement, are causing decay in masonry, particularly at upper levels; and low-level render should be removed and bricks be replaced. Extensive reinforcing rods and bars indicate other problems which need to be addressed. Masonry at concave entrance gates and piers is generally in better repair. At the Pine Street South Gates, the piers surface render has many small cracks and will require repair soon. Driveway up from John Street is another valuable component of the historic context of this house, and indeed of John Street. See also the Guidelines for any proposed repair or alterations to aspects of this extensive, diverse and most interesting property.

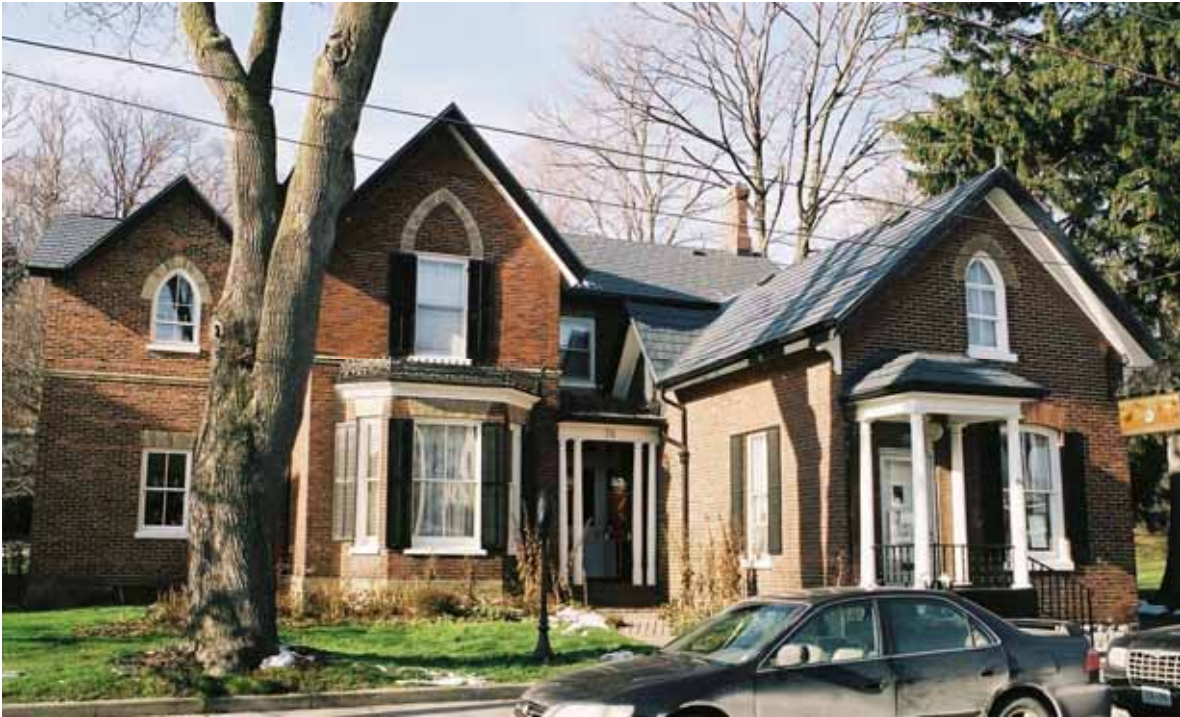
**76 John Street**

- Dichromatic, two-storey, gabled Victorian house with additions to east and south (c.1870 ff.)
- Original House – Large Victorian house has entry tucked into recess to right of bay window. Porch has sandstone step and landing, and pair of replacement columns support metal-clad pitched roof, with iron cresting at base of slope. Attenuated columns, with entasis, have elongated cylindrical bases with incised upper ring, extending to more typical base, while at top echinus and abacus are closer to traditional norms. Entrance consists of central, half-glazed, coloured-glass door with 3 tall, segmental-headed lights over single panel with wide bolection mouldings. Sidelights are similarly glazed. Glass exists in blue, ochre and umber, with patterns on inside of panes. Mullions and transoms are finished with robust roll-moulding, halved adjacent masonry, and three transom windows have clear glass, with Saltire at central unit. Single 2/2 window (with metal storms) above roof has wooden sill and buff-brick voussoirs at flat-arch. Projecting, gabled block to left is built of red brick, over stone foundation and buff-brick plinth with bevelled top course. Ground-floor bay window has central 2/2 window and 1/1 windows at side, all with wooden sills and flat-arch, buff-brick voussoirs. Louvred wooden shutters are operational and appear authentic but are too narrow for apertures and unlikely on Victorian house. Wall-head has thick wooden cornice, with cast-iron cresting masking metal-clad hipped roof behind. Second floor above has double-course, corbelled buff-brick stringcourse and consists of red-brick masonry with central 1/1 window having sill and shutters as described. Blind pointed arch above is built of tapered, buff-brick voussoirs framing red-brick tympanum built over narrow wooden lintel.

- Fascias and Roofs – Soffit boards are beaded throughout, and wooden fascias have beaded lower edge and deep shingle-mouldings. Roofs are clad in textured, interlocking metal shingles. Gutters are conventional, aluminum profiles with iron hoppers below eaves. A two-vent chimney, in good repair, exists at north end of main roof peak, with base having bevelled top course, chamfered bricks at corners, and with corbelled and dog-toothed bands in lower courses of chimney-head.

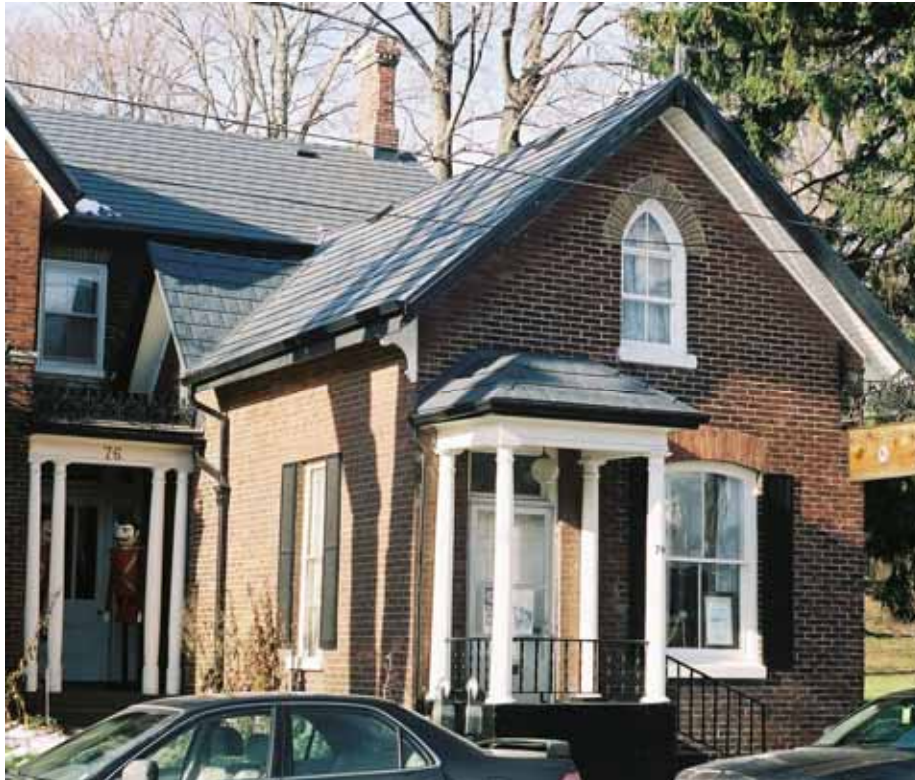
**76 John Street** (continued)

- **East Addition** - Gabled addition at right is later (c. 1880?) than house behind, as testified by butt-joint in brickwork to right of front door. Red-brick masonry is in common bond at front, and with headers every sixth course at sides. **Porch** has steps and landing rebuilt in concrete, with four traditional, full-height, turned wooden columns rising to peripheral beam with typical upper and lower mouldings, and hipped roof above. Front window, to right, is 2/2 (with fixed modern shutters) having wooden sill and segmental-arch head with buff-brick voussoirs. **Upper level** has 2/2 unit and two-pane transom window in pointed-arch aperture as at central gable, with unusual, thick roll-moulding at transom. Wall-head is finished with modest moulding, and front eaves have decorative wooden bracket either side under projecting, v-jointed fascia boards. Small king-post at peak is assumed to be remnant of gable finial. At **south elevation**, ground floor has 4/4 window (with metal storms), and small, 2/2 window at second-floor dormer beyond.

- **Comments** – This is an attractive, authentic and, because of the different periods of construction, an interesting house, all in excellent repair. Alterations to front porch are slightly incongruous but tastefully executed, and recent addition to south is convincing, with huge window visible only from south side. Addition in fact serves as good example for new work within the Heritage Conservation District. Roofing material is unsuitable, and original material should be investigated and perhaps one day be reinstated. (Remnant of original material may remain where peak of addition meets front pitch main house; or nail patterns or old photos may indicate this.) House may originally have had no rainwater goods, but installation of more robust, period gutters downspout profiles, would be an improvement. Only metal storm window at front elevation is above front entrance and this should ideally be replaced with a wooden storm instead.

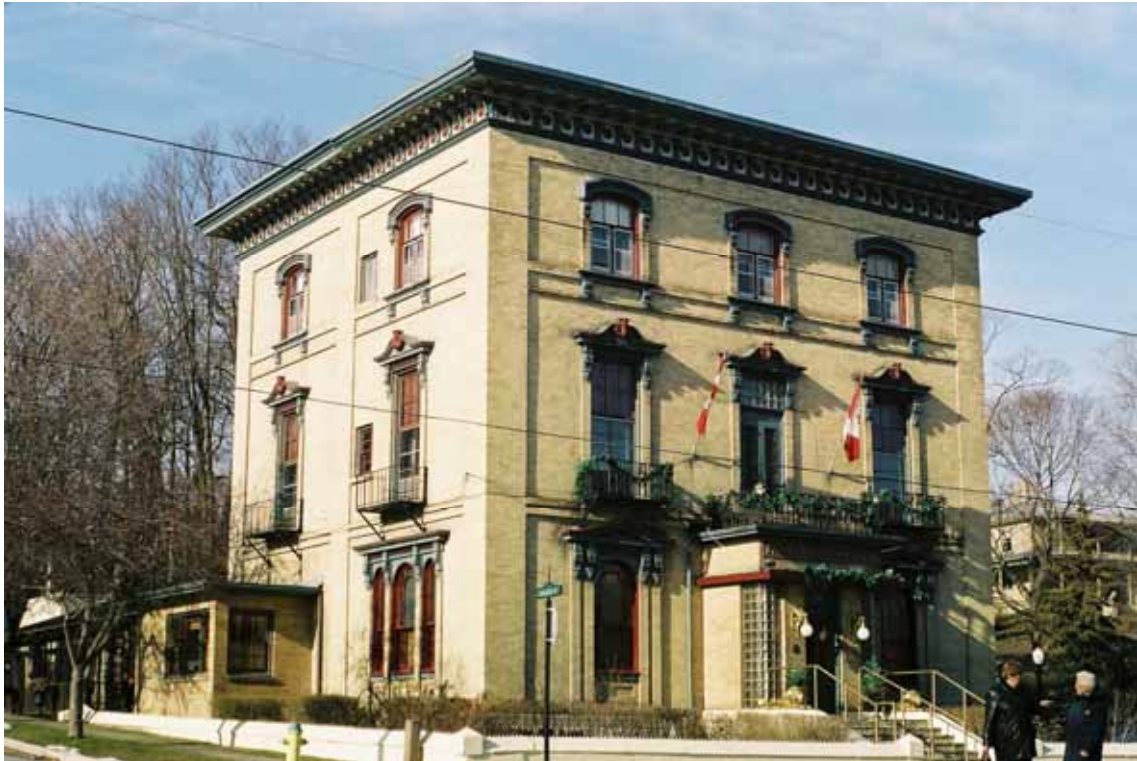
86 John Street

- Imposing, three-storey, Victorian buff-brick palazzo, with fabulous, metal window entablatures (1857). Former Bank of Upper Canada, apparently by F.W. Cumberland, is **Designated** under O.H.A. Part IV.

- Front Elevation, Vestibule – Symmetrical front façade has palace-like aspect, with buff-brick vestibule reached by broad stair and landing now clad in rustic limestone pavers and with plain brass railings at center and sides built into stone copings. Vestibule is c. 1950s addition comprising two brick piers, curved glass-block corner panels and simple, painted metal cornice above. In contrast to fifties theme, front door is recent but traditional in style, with two round-headed windows over two vertical panels. Transom window is blocked with plywood bearing address of property. Buff brick above, laid in common bond, is also assumed to date from 1950s, with simple boarded soffit and plain wooden fasci, the latter supporting traditional ogee gutter leading to corrugated downspout. Small balcony above, however, has period cast-iron railing with ornate corner posts with finials (original assumed to be at LH side) and balustrade of iron panels with round-headed arches housing various decorative elements.

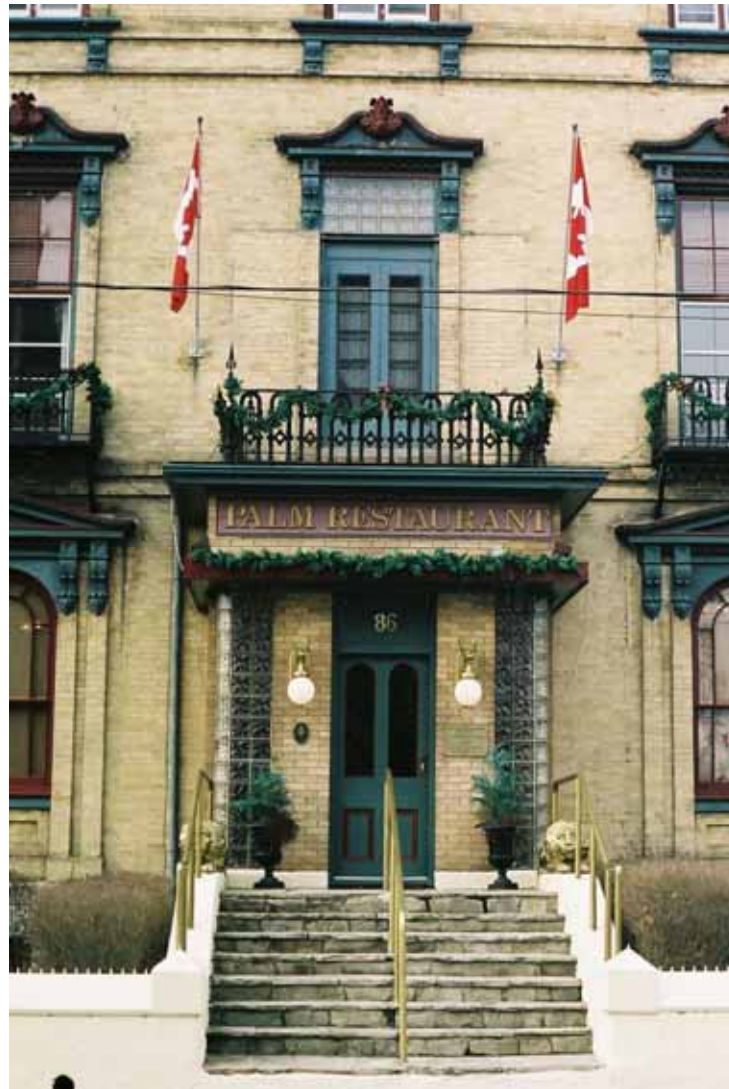
86 John Street (cont.)

- Front Elevation, Second Floor – Second-floor fenestration is variation of that described at ground floor. Three symmetrically placed apertures have single pilaster at either side, rising to single iron brackets and pediments as described, though here with scroll-type or Chippendale pediment having central wheat-sheaf-type ornament with small fleur-de-lis above. Windows are combination of (at right) original 6/9 (with metal storms), (at left) six-pane sash over two-pane casement windows (with metal storms), and (at centre) pair of five-pane French doors (with wooden screen doors) and more glass block above. Outer windows have small metal balconies with iron balustrades as over vestibule.
