John, Ontario and Queen Street Heritage Conservation District Plan

Municipality of Port Hope, Ontario

Final Revision – January 2008

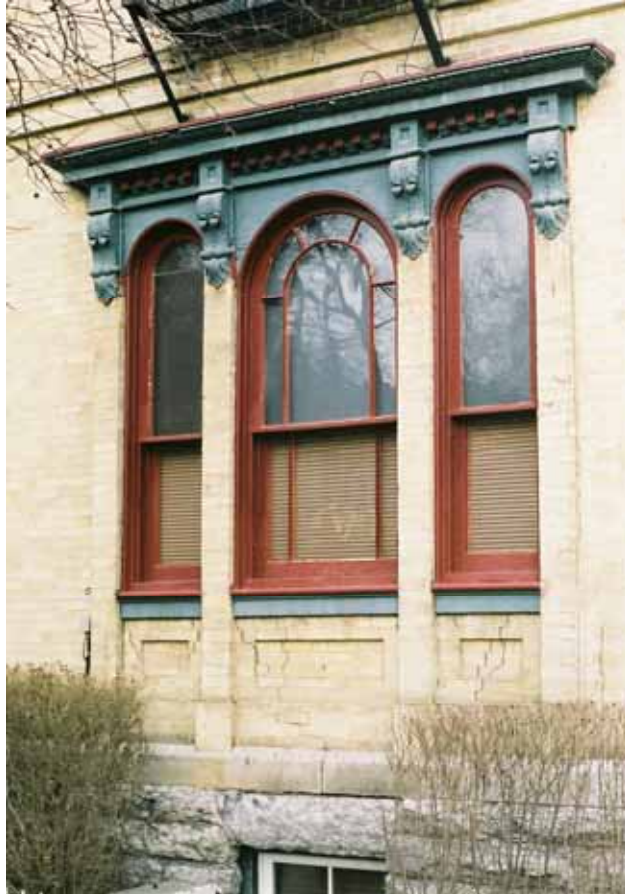
**86 John Street** (cont.)

- **South Elevation** – South elevation generally has elements as described at front, but is separated by central pilaster into two bays. **Ground floor** - Ornate window at RH side is divided by narrow pilasters and has recessed brick panels in spandrels below. Window comprises three, round-headed lights with wider central unit having sashes as at front, with inner muntins forming smaller peripheral panes. All units are double-hung, with taller top sashes having textured, translucent coloured glass. **Entablature** above comprises elements as at front; pilasters rise to cast-iron entablature supported on brackets cast with stylized, scrolled foliage. Entablature has also band of multiple dentils spanning between brackets, over painted cladding which conceals voussoirs of arches below. Continuous corona is crowned by *cymatium* embellished with classical, leaf-type motif, with (rusty) metal flashing above. **Upper Floors** have entablatures, doors and windows as at front elevation, with differences as follows: second floor has plain metal balconies and two small windows inserted to right of central pilaster - 2/2 at second floor and casement at third - both with concrete sills and angle-iron lintels. Mouldings at top cornice fascia change dramatically near center of building, with flashing above also varying.

- **North Addition** – Post Modern, glazed, framed verandah fronts deep one-storey buff-brick 1950s wing.
- **Comments** – An ornate and impressive building in good repair, with various alterations and additions which do not generally detract from appearance of the original. Removal of 1950s elements at front porch would be unfortunate, though perhaps justifiable. Other additions are more expendable, but less obvious. Later windows at upper south elevation are unobtrusive. New pitched-roof addition over former patio is sympathetic to the overall building. At wall on SE corner, painted coping and render below do not reflect original finishes, and might be removed if desired. Similarly, cast-iron railings might one day be reinstated. Any development of parking lot should be discouraged if this intrudes on building.
