The TOWN of PORT HOPE
WALTON STREET
HERITAGE CONSERVATION
DISTRICT PLAN

WALTON STREET
HERITAGE CONSERVATION DISTRICT
PLAN

Prepared for the
LOCAL ARCHITECTURAL
CONSERVATION ADVISORY COMMITTEE

of the
TOWN OF PORT HOPE,
Ontario

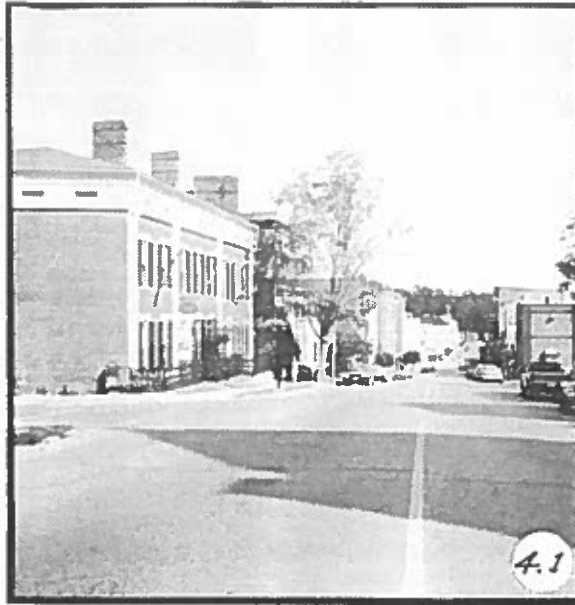
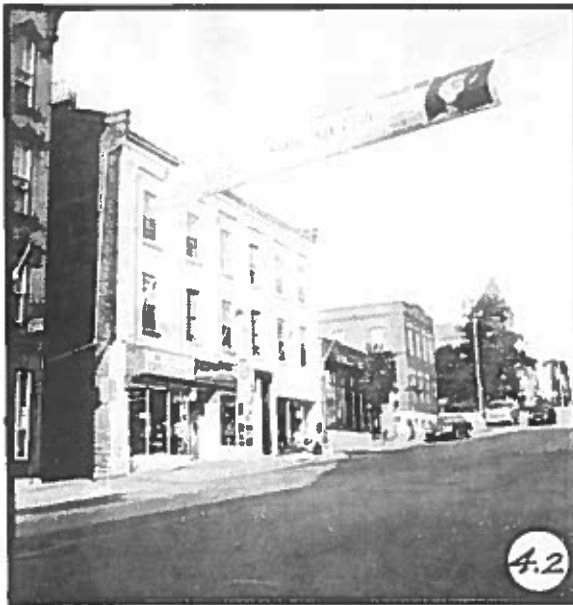
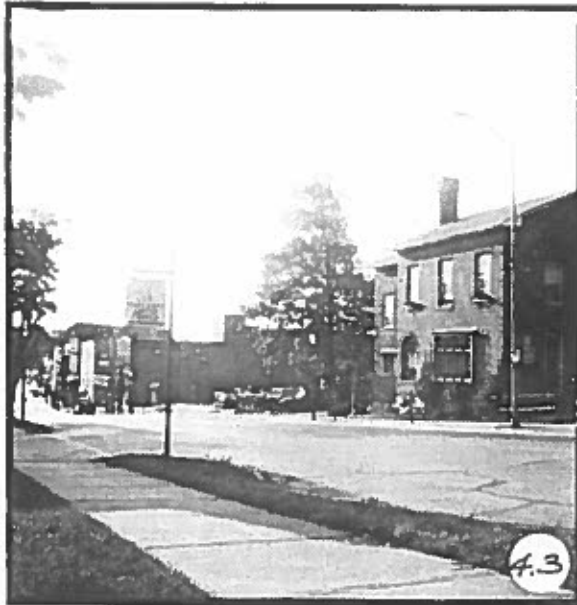
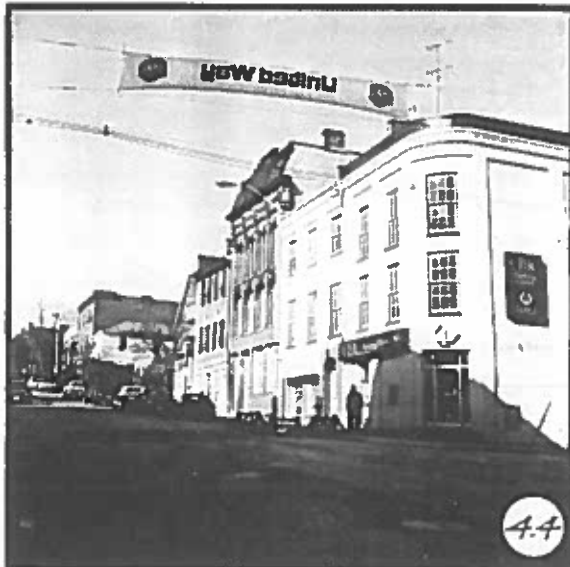
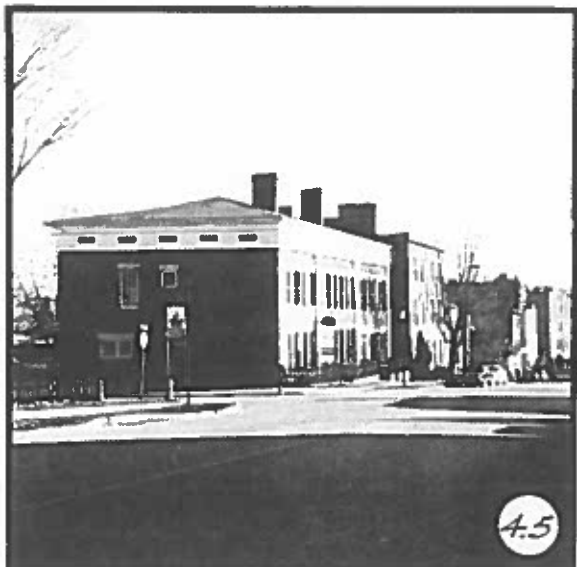
Segment 4: Cavan to Brown

- 4.1 : Walton Street looking eastwards down hill from Brown Street, another memorable introduction to the Original Commercial Sector.
- 4.2 : South side of Walton showing Blocks 37 to 49, looking west.
- 4.3 : South side showing Blocks 49 to 37, looking east.
- 4.4 : North side of Walton showing Blocks 24 to 36, looking west.
- 4.5 : North side showing Blocks 36 to 24, looking east.

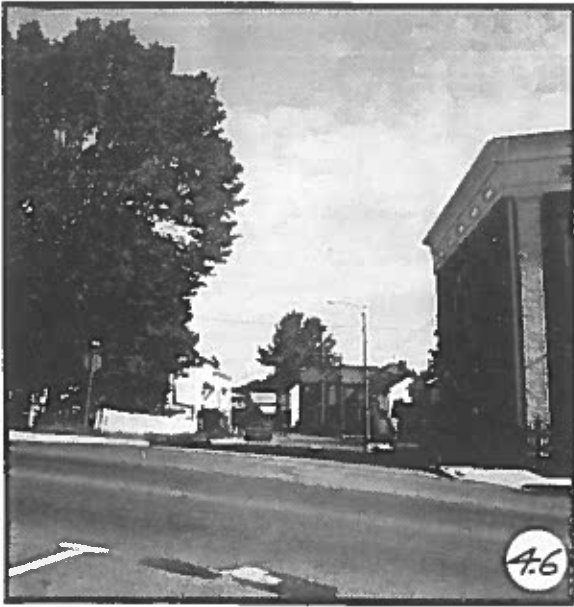
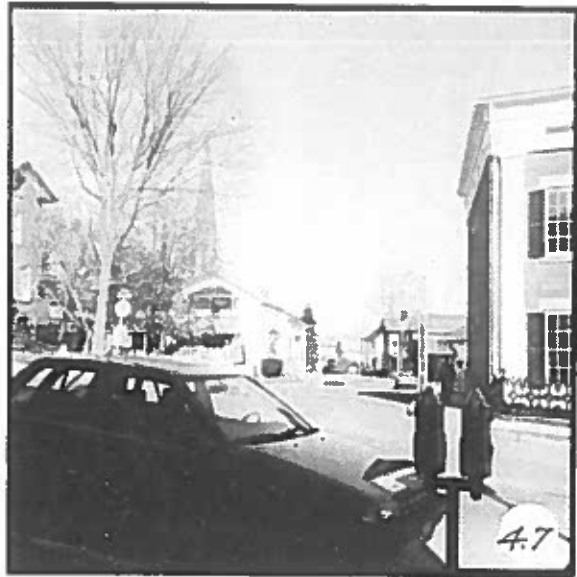
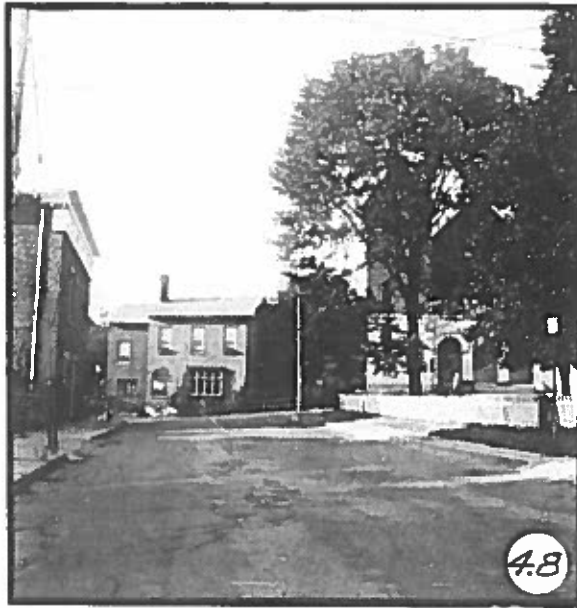
Segment 4 cont.

- 4.6 : Brown Street, dividing Segments 4 and 5, looking north from Walton, and showing curve to north-west.
- 4.7 : A winter view revealing spire of United Church at north-west corner of Brown and South Streets.
- 4.8 : Looking south along Brown Street towards Walton and focal point of Block 49.

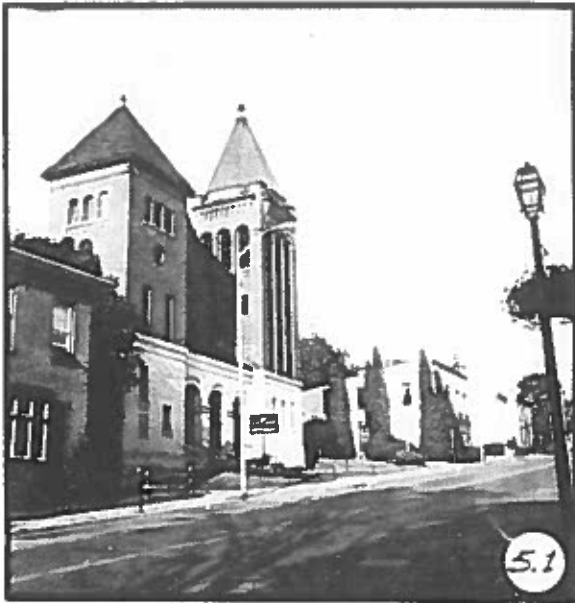
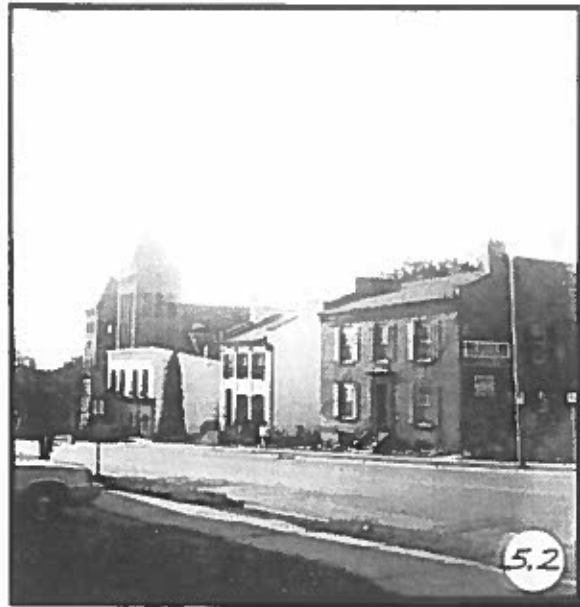
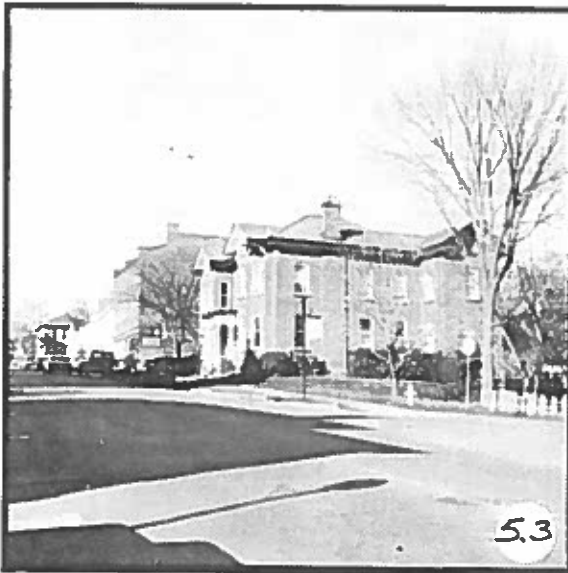
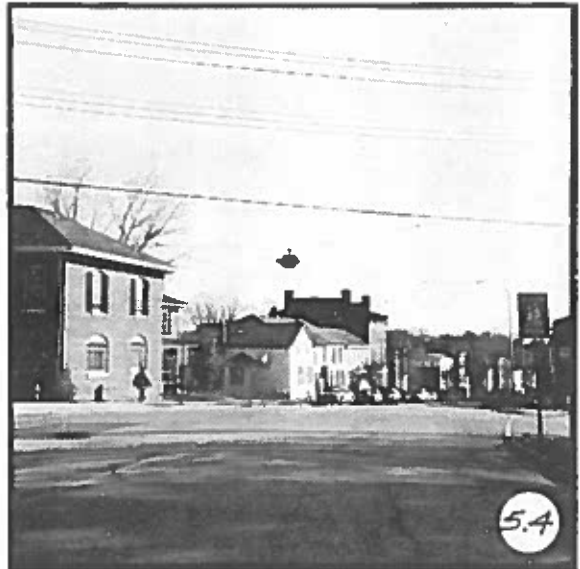
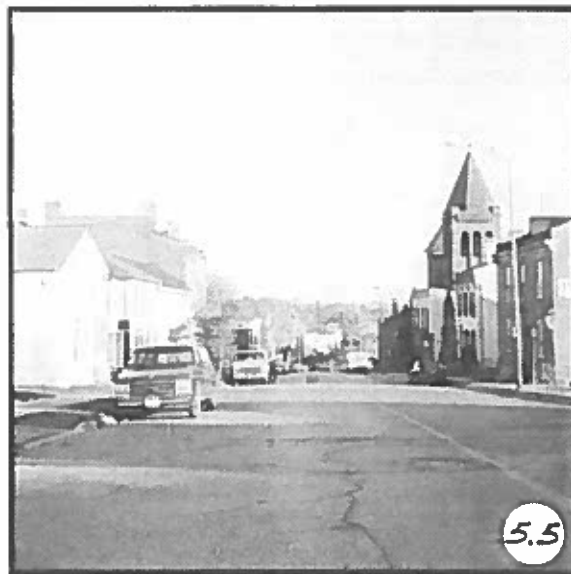
Segment 5: Brown to Pine

- 5.1 : South side of Walton showing Blocks 51 (St. Paul's Presbyterian Church) to 57, looking west.
- 5.2 : South side showing Blocks 57 to 51, looking east.
- 5.3 : North side of Walton showing Blocks 38 to 52, looking west.
- 5.4 : North side showing Blocks 52 to 38, looking east.
- 5.5 : General view looking eastwards into downtown Walton Street, a memorable arrival to the Heritage Conservation District.

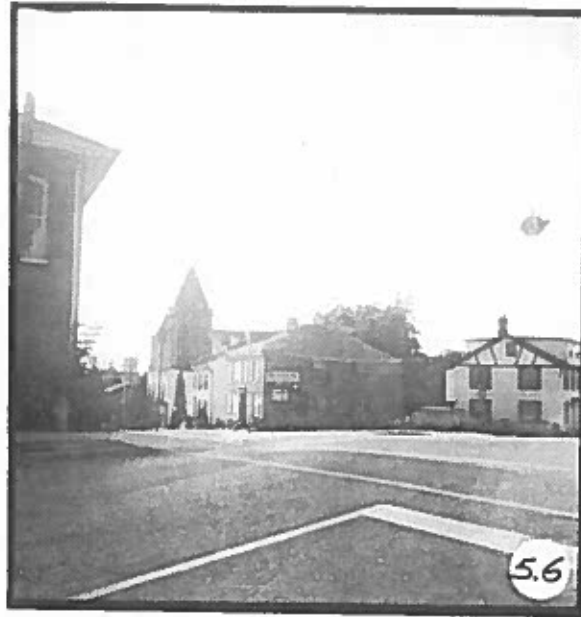
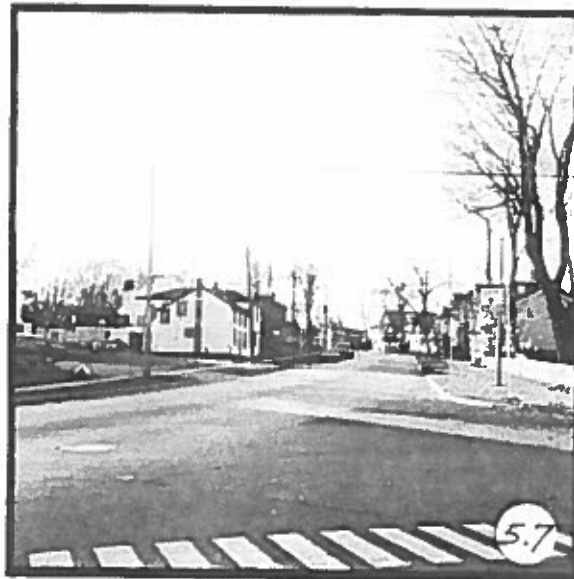
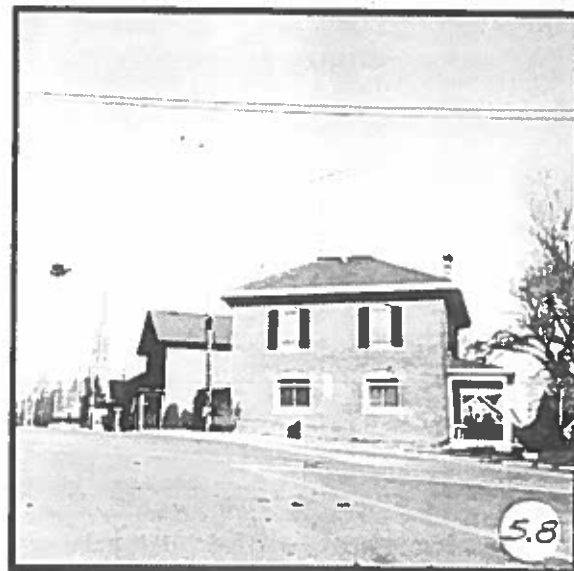
Segment 5 cont.

- 5.6 : South-east corner of Walton and Pine showing open site inviting introductory marker or monument to District, also reflected at north-west corner of Mill and Walton. (See 1.1 and 1.2).
- 5.7 : Looking westwards along Walton and out of the proposed District, the slope continuing upwards and the street curving and changing its name to Ridout in the Englishtown area.
- 5.8 : Looking north along east side of Pine towards St. John's Anglican Church with Block 52, aligned with Walton, demonstrating obtuse angle at north-east corner of intersection.

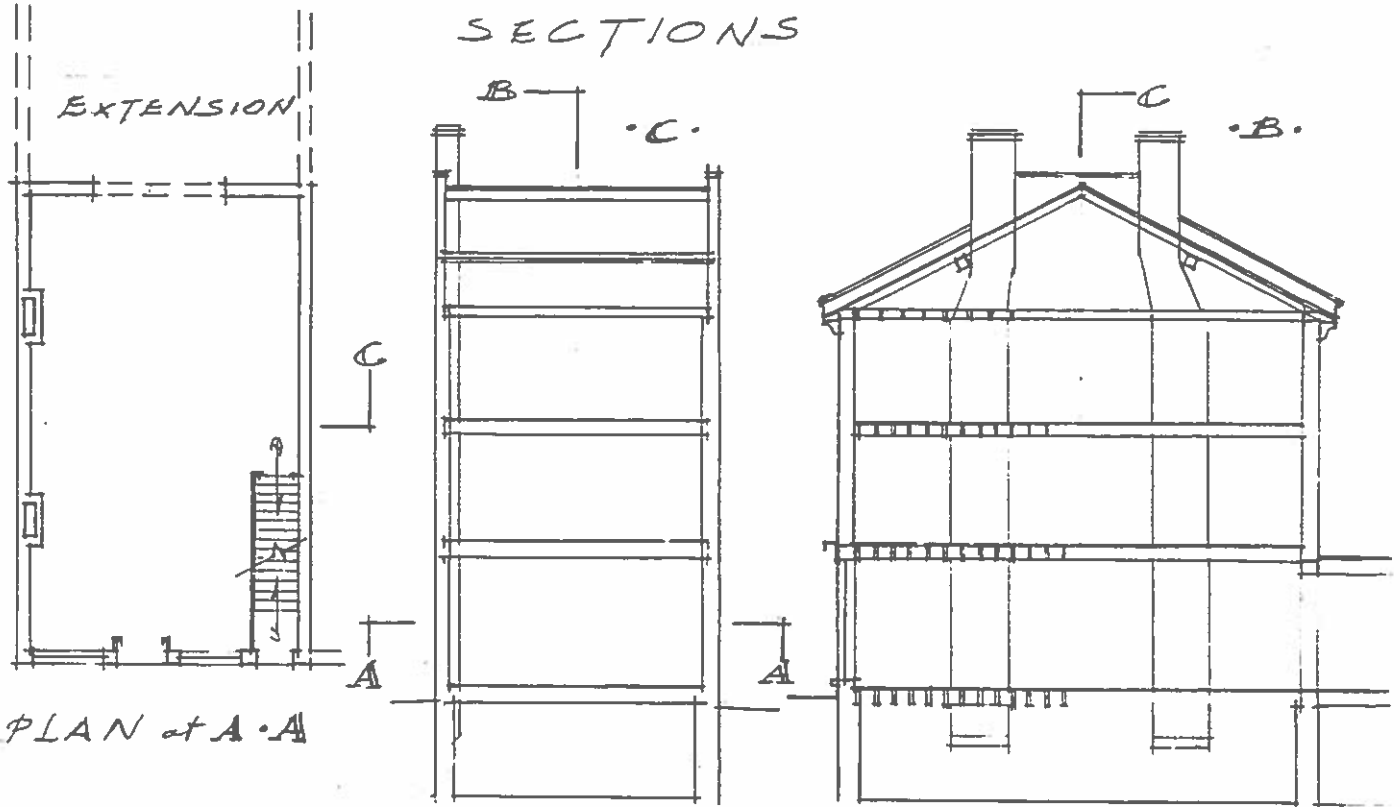
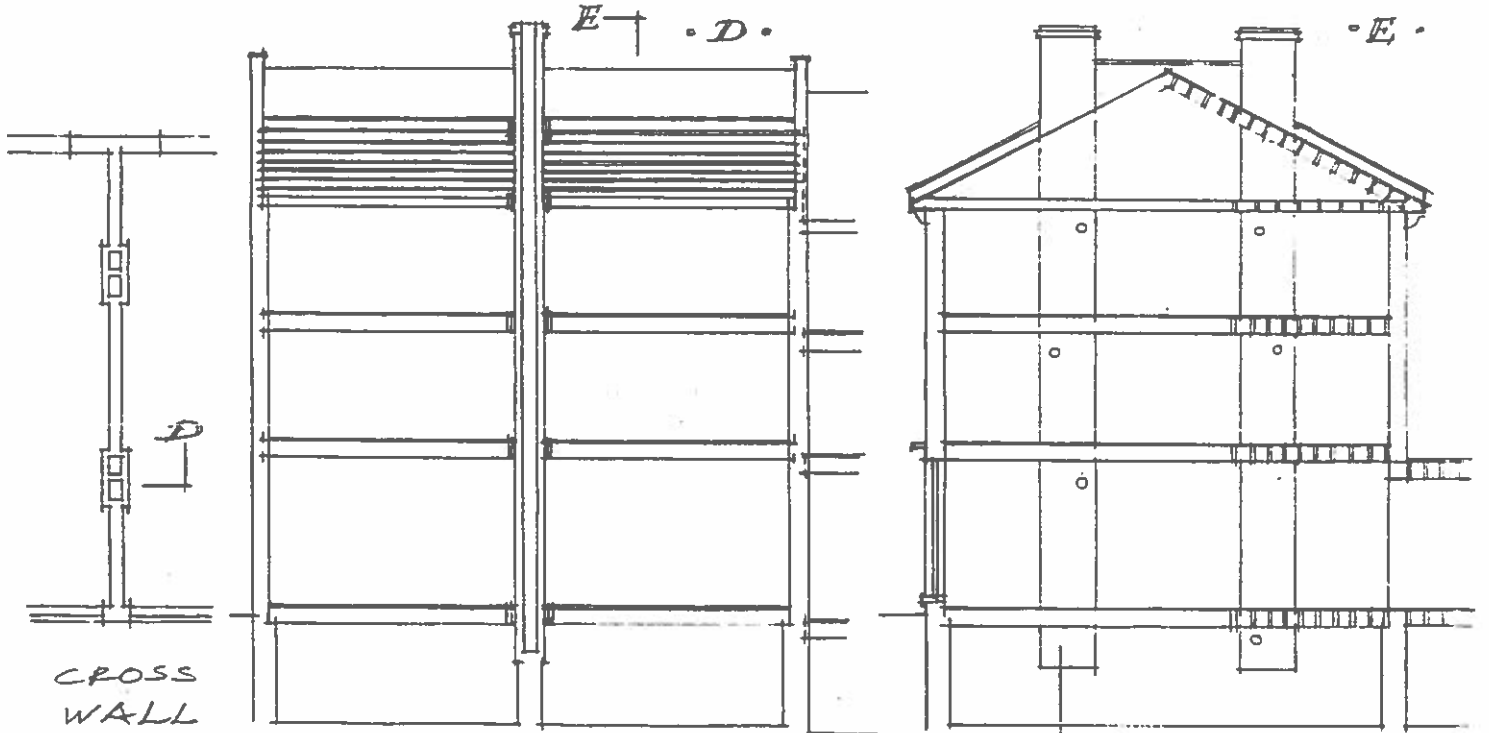
SECTIONS

PLAN at A-A

Phase 1 - RAFTER ROOF

CROSS WALL

Phase 2 - JOIST ROOF
GABLE FORM

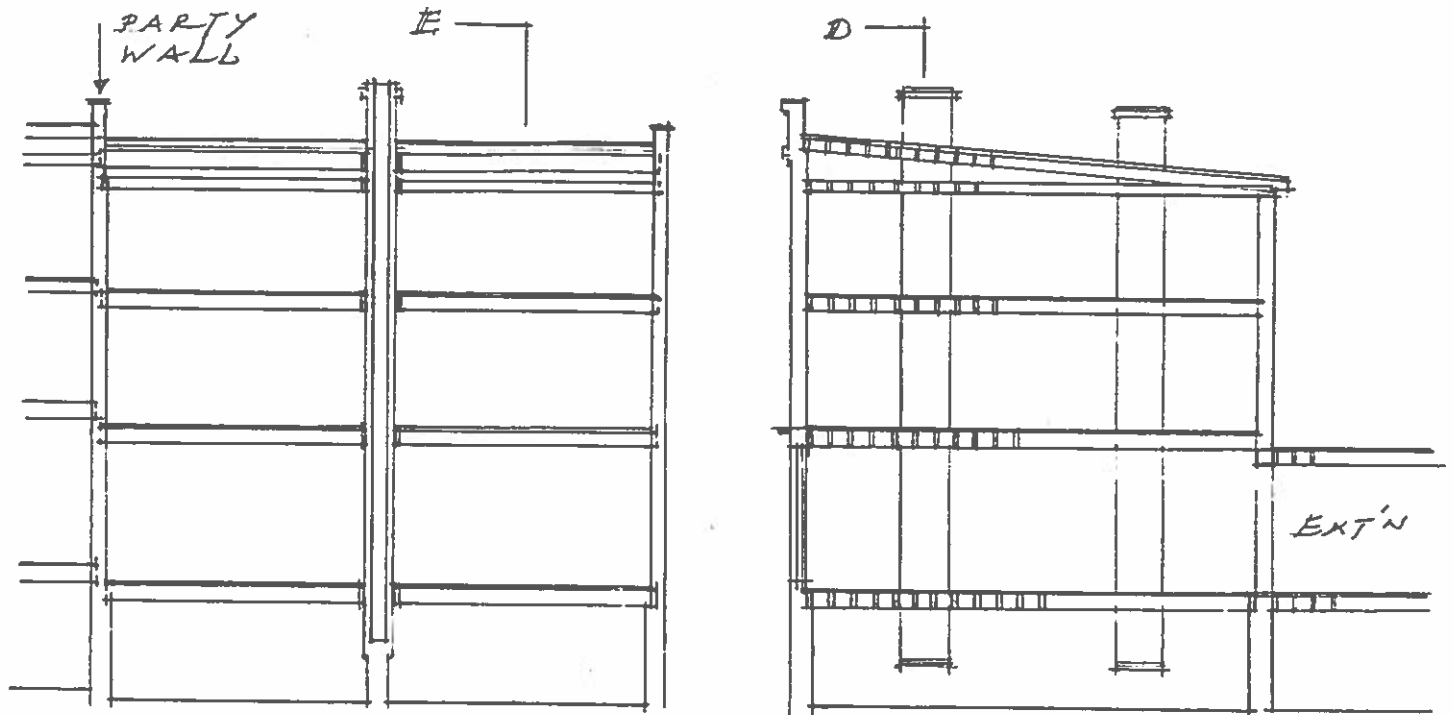
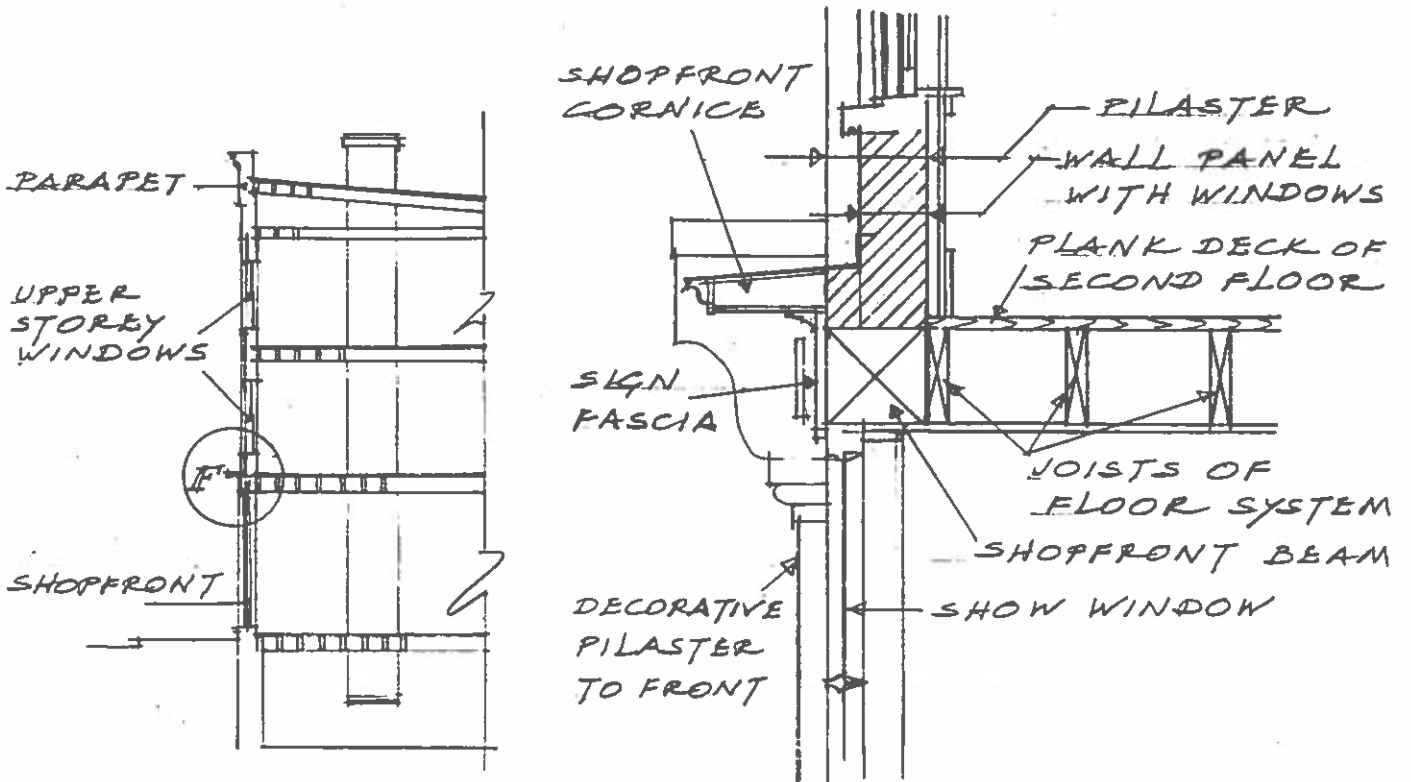
SECTIONS .D.

Phase 3 . JOIST ROOF

LOW-SLOPE SHED or FLAT FORM

DETAIL .F.

The next development, probably promoted by the development of built-up roofings of tar, felt and gravel noted as being used as early as 1858, but also adaptable to interlocking sheet metal coverings, was the roof joist system in a single slope or shed form usually of low pitch, a form conserving space and material. By this time the roof virtually disappeared from view and is no longer important in an architectural sense except in the decorative brick parapets it spawned.

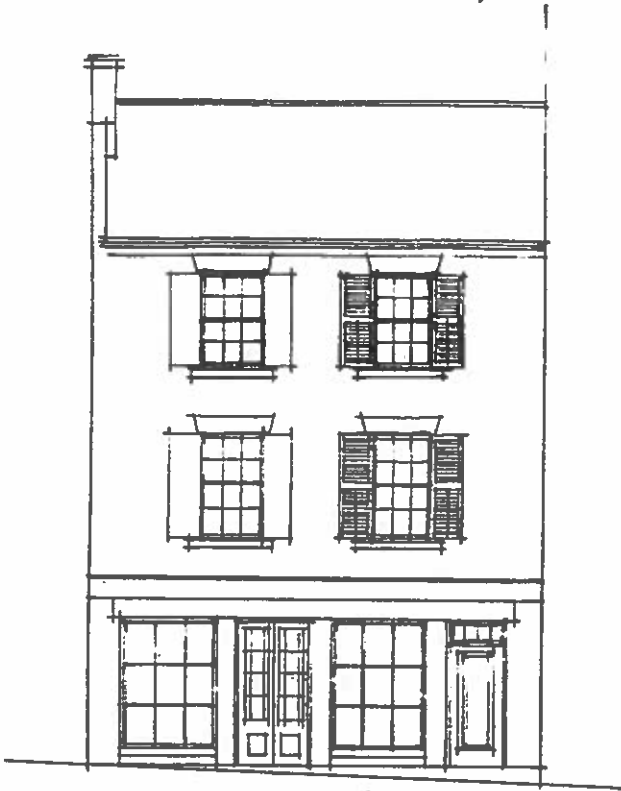
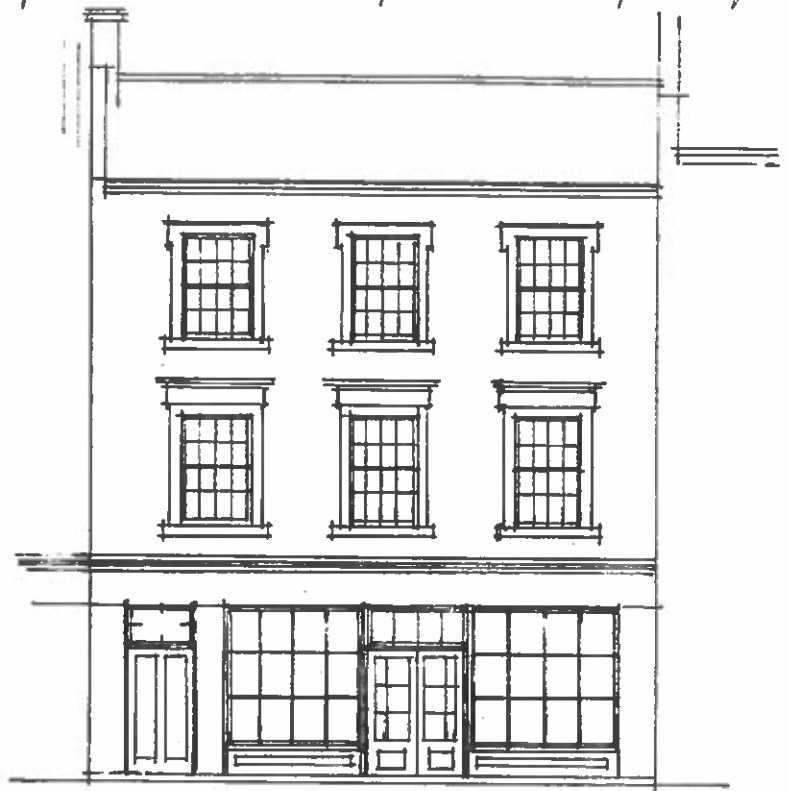
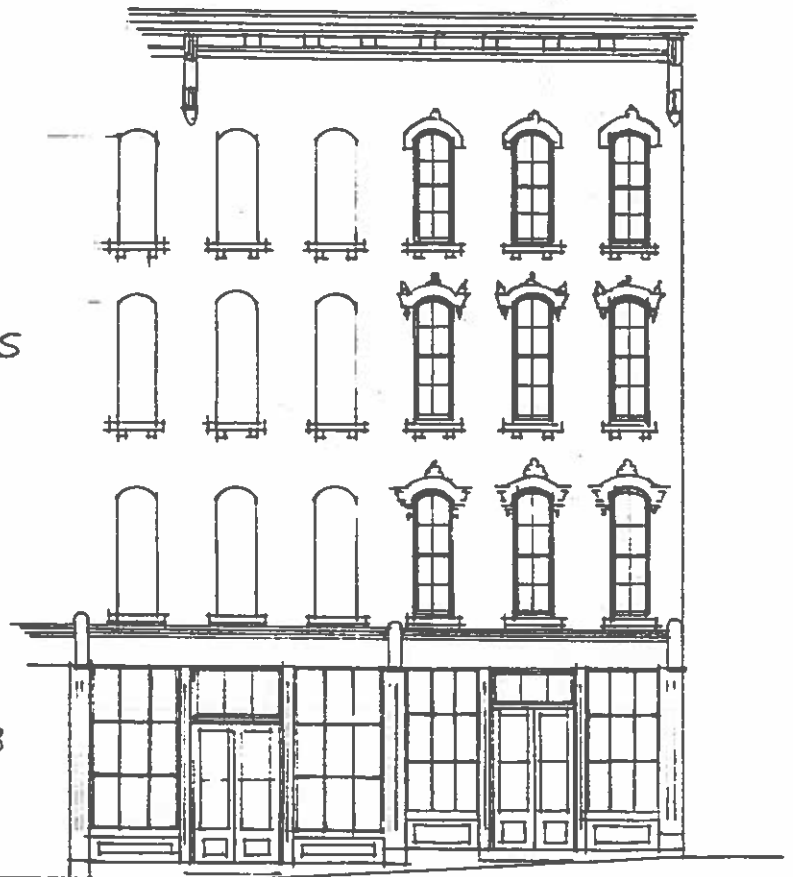
DESIGN DEVELOPMENT
 of WALTON STREET FRONTS . 1 . FIGURE 7A

c. 1841

c. 1845

FLAT or PLAIN
 WALLS with
 PUNCHED OPENINGS

ITALIANATE VERSION
 with cast iron labels
 or window hoods 1853

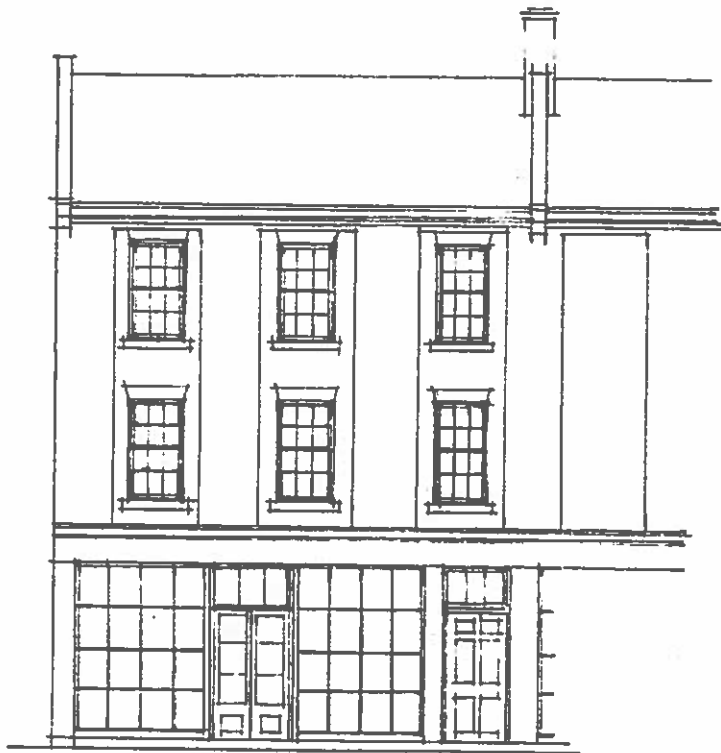
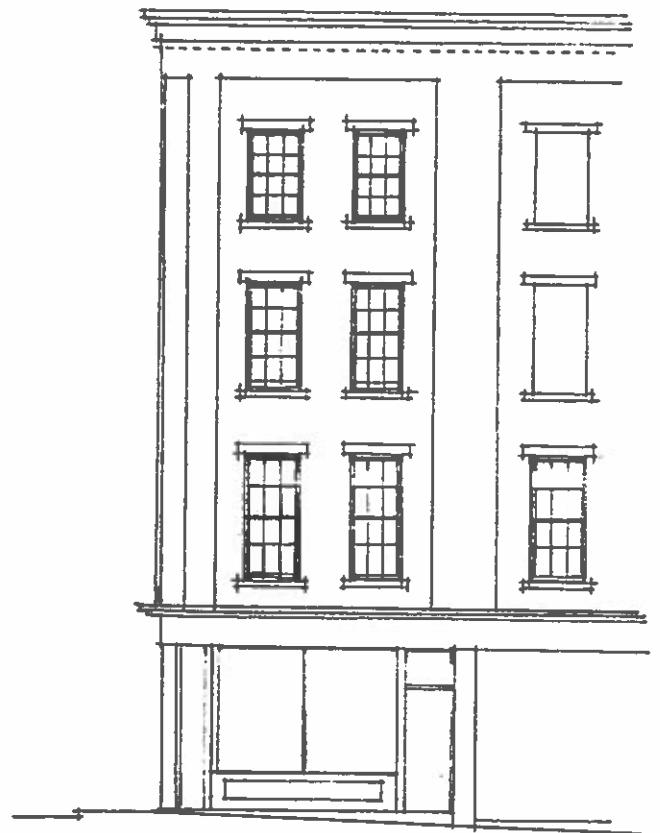
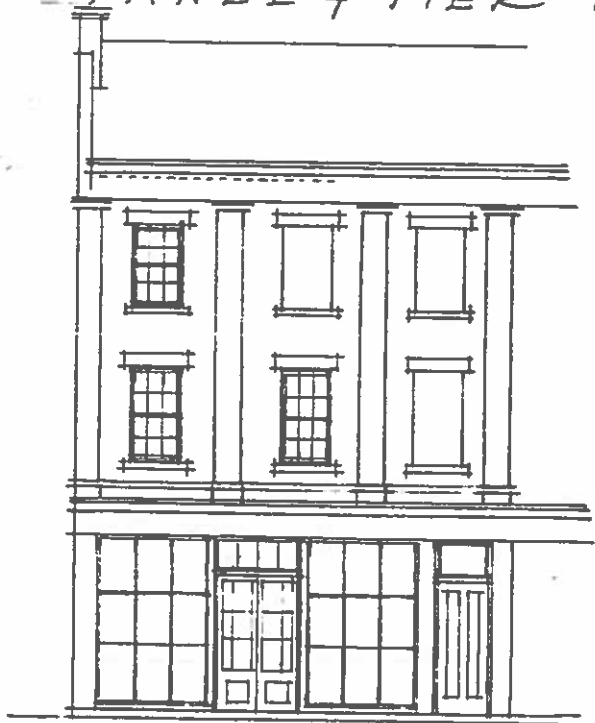
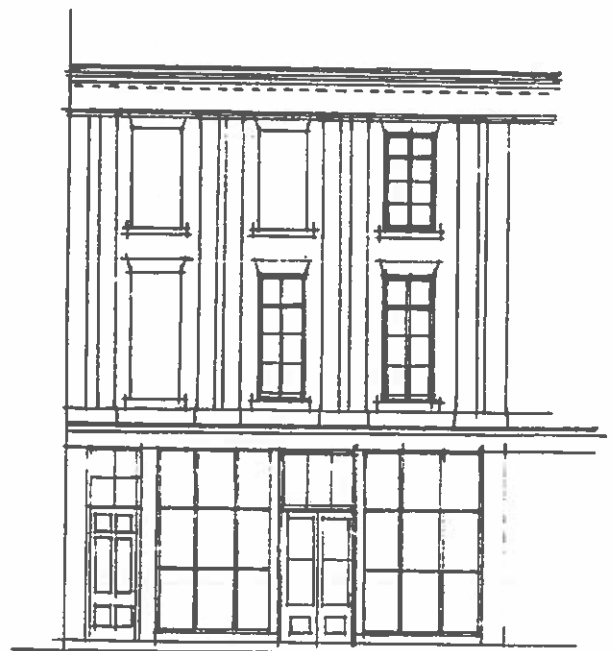
DESIGN DEVELOPMENT
of WALTON STREET FRONTS - 2. FIGURE 7B

Flat arches shown

PANEL & PIER mid-1840s to mid-1850s

Cast iron sills & lintels

PILASTER 1850s

DOUBLE PILASTER
Late 1850s

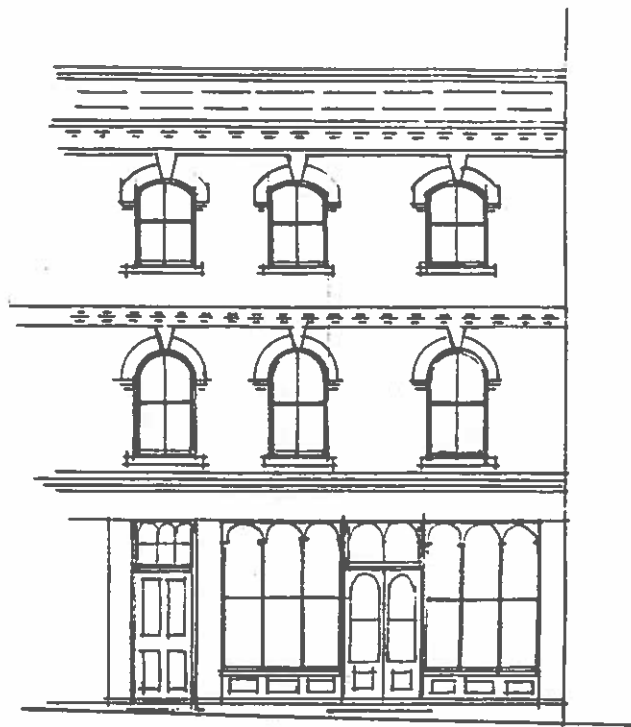
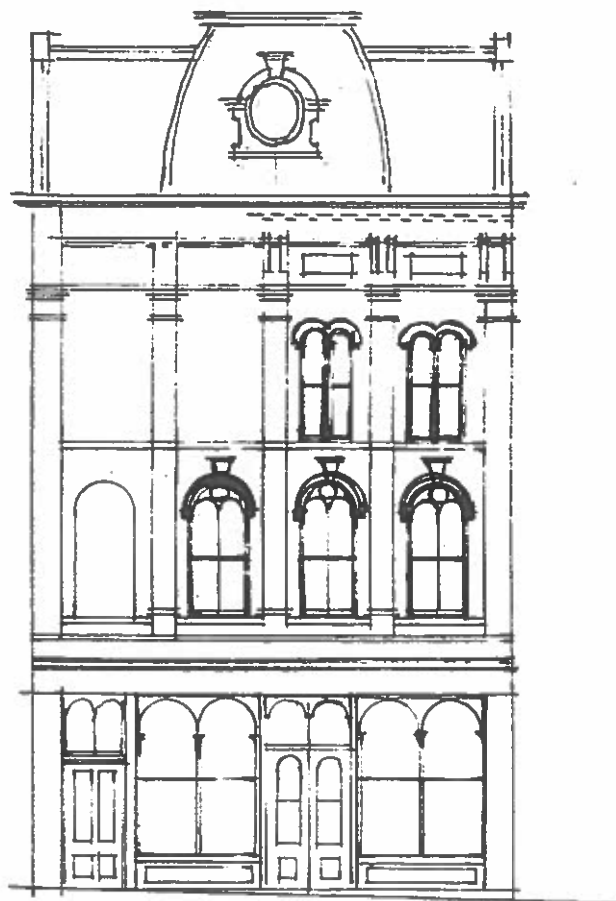
of WALTON STREET FRONTS • 3 • FIGURE 7C

Late 1850s

Cast iron labels

CULMINATION

Mid - 1870s

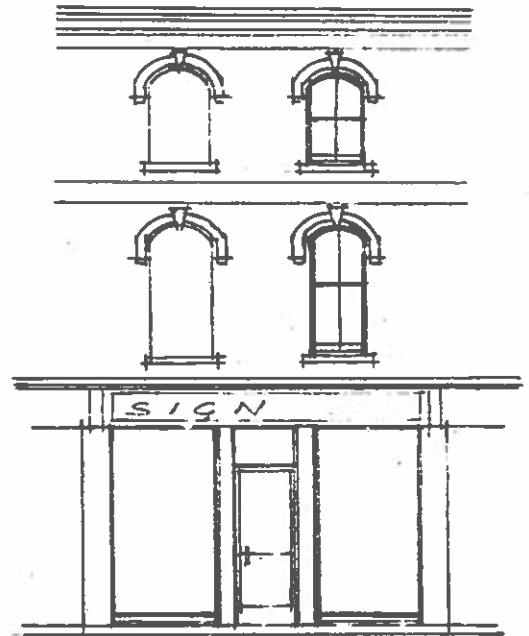
Mid & Late
 20th Century
 NOT
 RECOMMENDED

Modern
 metal detail

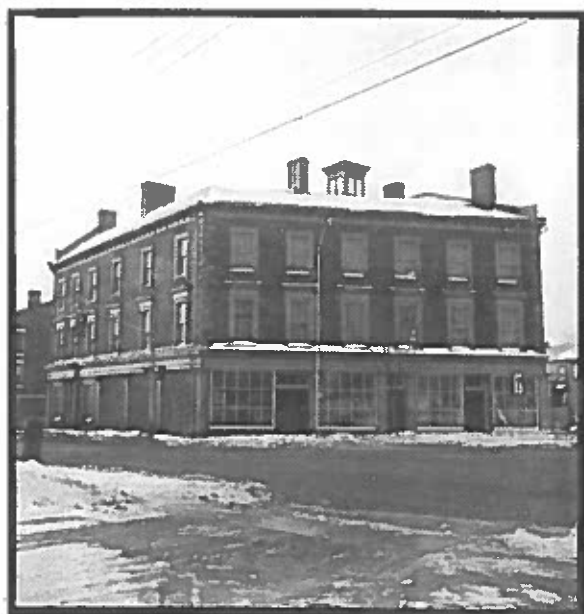
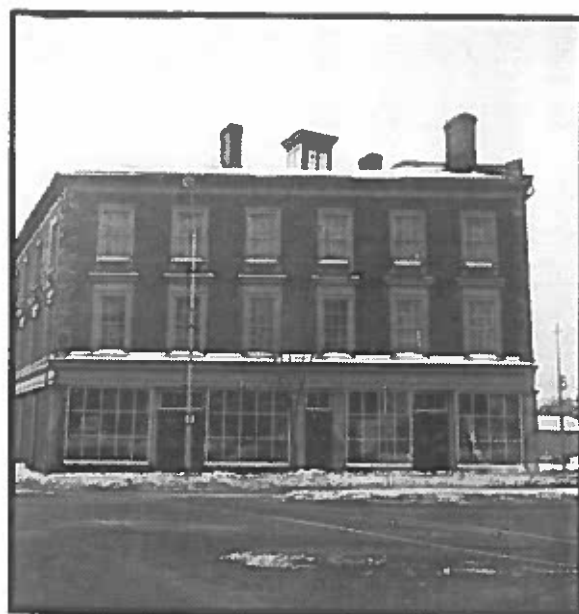
WSHCDS
Port Hope, Ontario
Block 1 cont.

Block 1: 1845 brick ell-shaped commercial block with residential space above,
Nos.1-3 believed to have been hotel originally, three storeys in
single unit with fronts to Walton and Mill Streets.

This is one of the most significant blocks, architecturally speaking, on Walton Street and one of the earliest. Its handsome façades facing Walton and Mill Streets include stone columns, pilasters and lintels at the ground floor level, rusticated stone quoins, eared wood window surrounds with cornices to architraves at the second floor and a simpler treatment with wood surrounds to openings on the third storey. The roof is gabled and turning the corner forms a hip. Original sash occur in the upper floors. The ground floor, except for the south section on Mill Street, has been considerably changed, however, with mutilation of the one remaining commercial front when original glazing bars, reported to be walnut, were removed. Further alterations however established commercial fronts to the Walton Street side, but did not seem to be inspired by the original detail of the block, but this has been redressed recently. This building deserves such special consideration because of its quality and prominent position. The balcony was reported to be a later addition and probably early 20th century. The building had been converted to apartments in the upper floors in the early twentieth century, for some time occupied by older people with long tenancy but recently has been gutted ready for more appropriate renovation. The balcony was also removed.

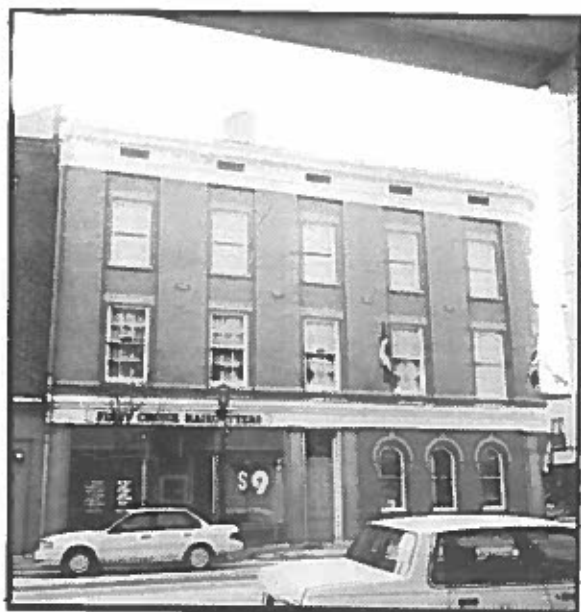
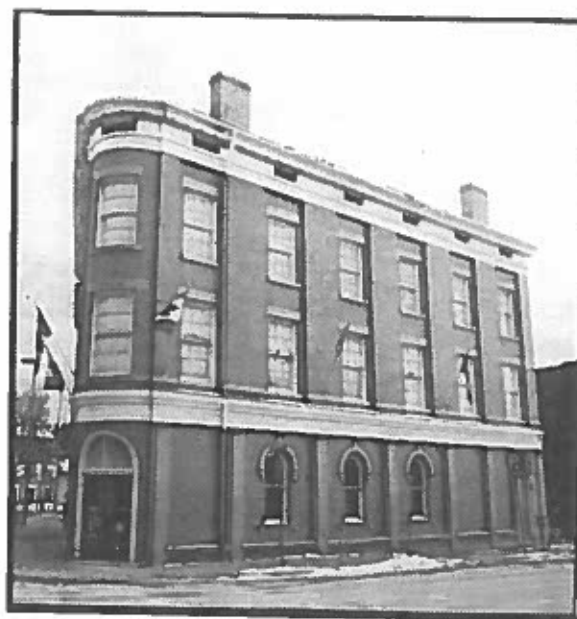
WSHCDS
Port Hope, Ontario.
Block No. 9 cont.

The wood cornices require ongoing maintenance at eaves and painting and glazing may need attention periodically. A new sign is required for the bank.

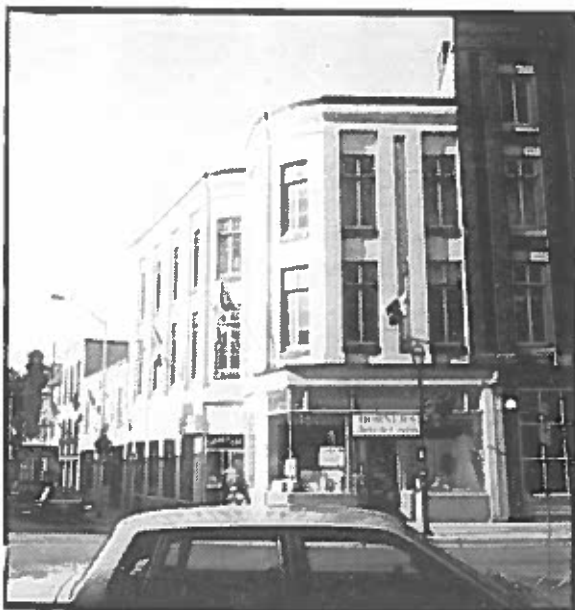
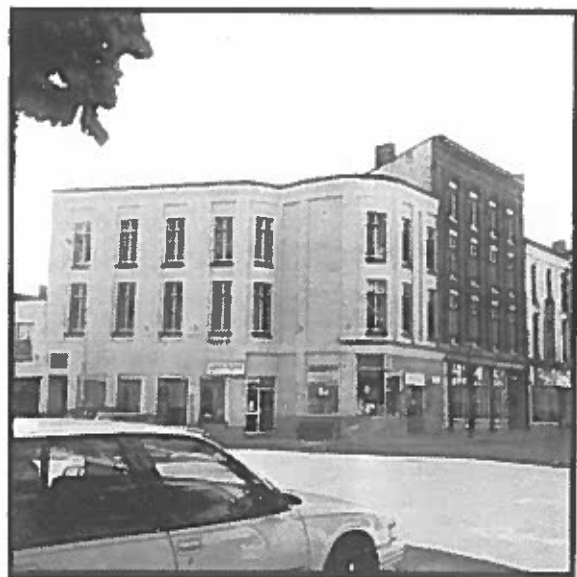
WSHCDS
Port Hope, Ontario.
Block 11 cont.

The fronts are in good condition, the rear in fair state.

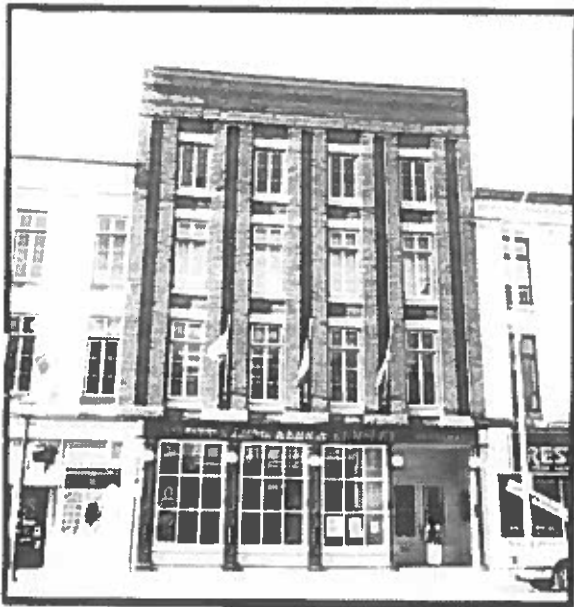
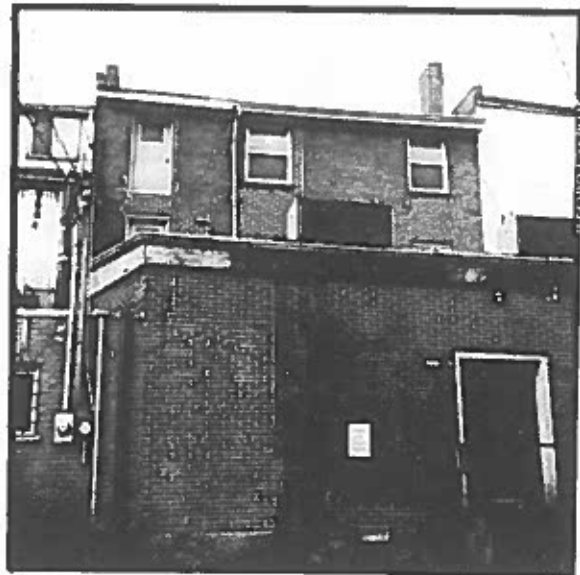
This building is, properly, part of the corner structure at Queen, and illustrates the original design of its neighbour. It has the same frontal treatment, but in the original brick finish, following the earlier tradition of the street, but with the variation of twinned pilasters and narrow recesses to windows, the whole crowned by the familiar ornamental brick cornice. The windows on the second and third floors resemble casements with transoms above, but operate as vertical sliding sash, perhaps an adaptation for better weathertightness. On the fourth floor, really an attic under the low-pitched shed roof, the transoms are omitted. The previous shopfront had undergone a number of alterations, from the original to late Victorian plate glass and then to a modern asymmetrical shopfront with deep fascia and brick panel with display case at the western end. The present scheme is the result of the new owner's wish to make a front complementary to the street and with a certain dignity in the local tradition. Hence the division of the windows to create this effect while providing a better scale in relation to the building, and the use of cast iron column fronts salvaged from the Sculthorpe Block (the site of the new Canada Permanent Office) by the late Peter Schultz in the 1960s. The design, including details, decorative light fixtures, sign placement and colour scheme, was evolved by David J. Lane, Architect, then working in Port Hope as assistant to the writer.

The building is now occupied at the second floor level and plans are prepared for full conversion of the space.

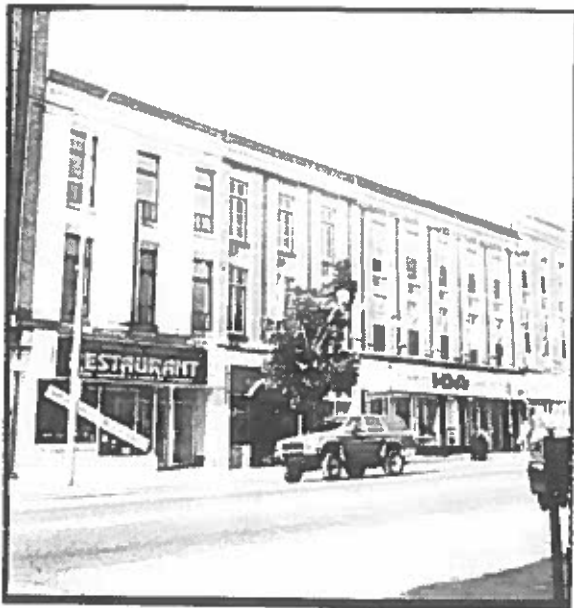
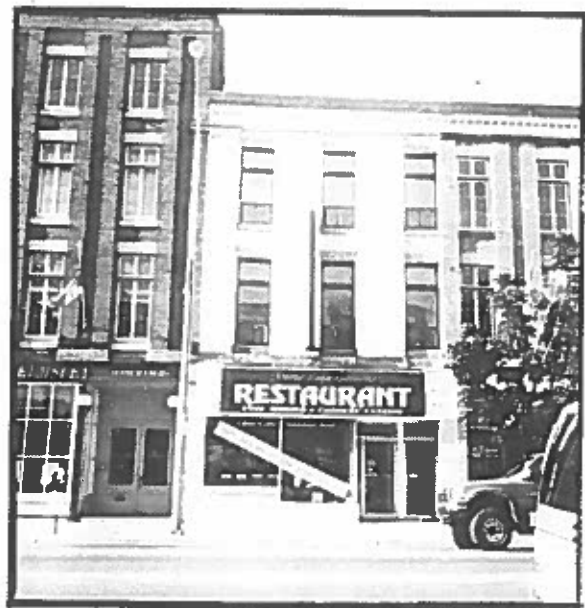
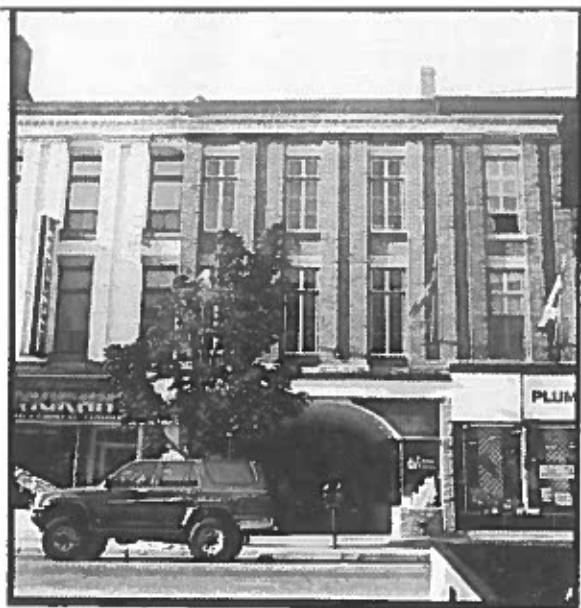
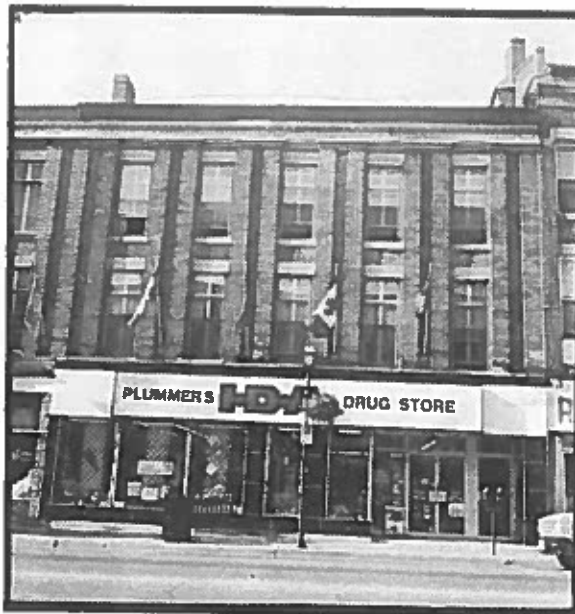
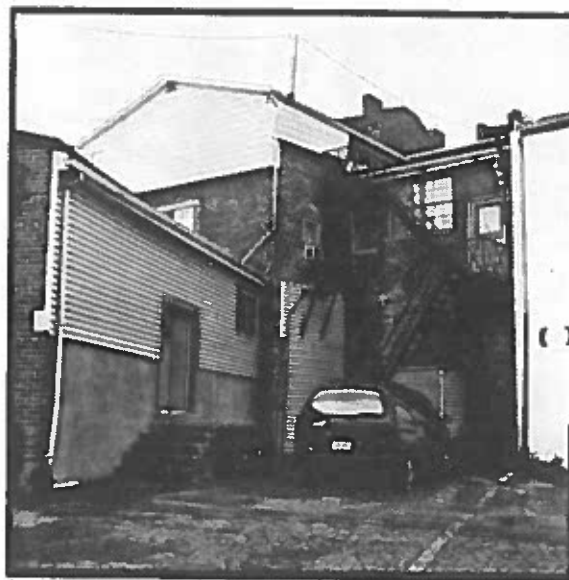
WSHCDS
Port Hope, Ontario.
Block 15 cont.

Shopfront sags are very evident at either end of this block and the misalignment of windows in upper storeys is disturbing visually. However collapse is not an imminent danger, for floor structures bear on cross or fire walls, but ultimately rebuilding of these sections of the front might be wise after attention to shopfront beams and supports.

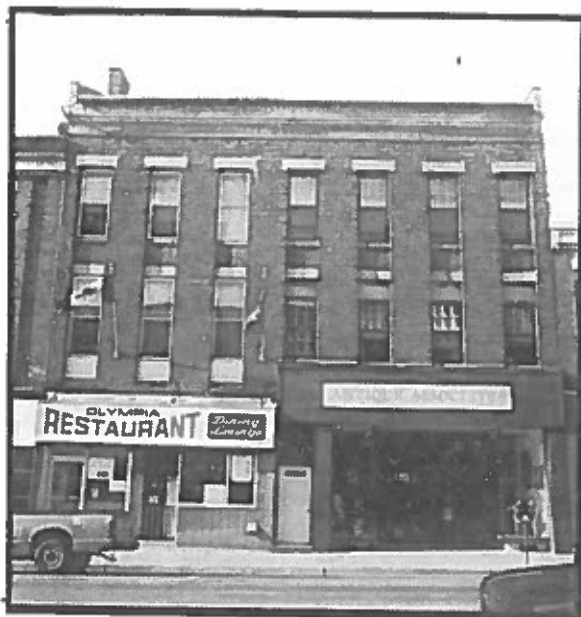
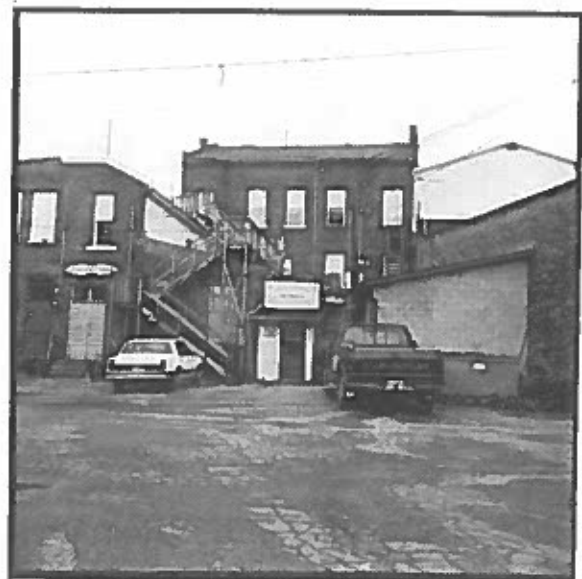
WSHCDS
Port Hope, Ontario.
Block 17 cont.

This block has been handled more carefully in shopfront alterations and only one distortion is noted at the western end.

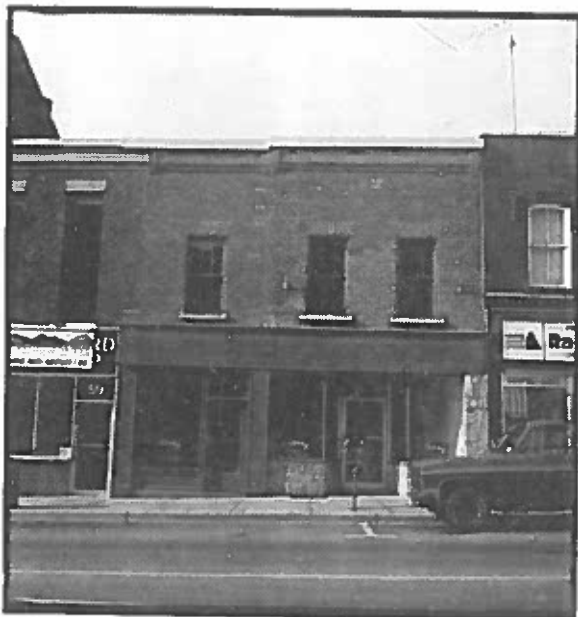
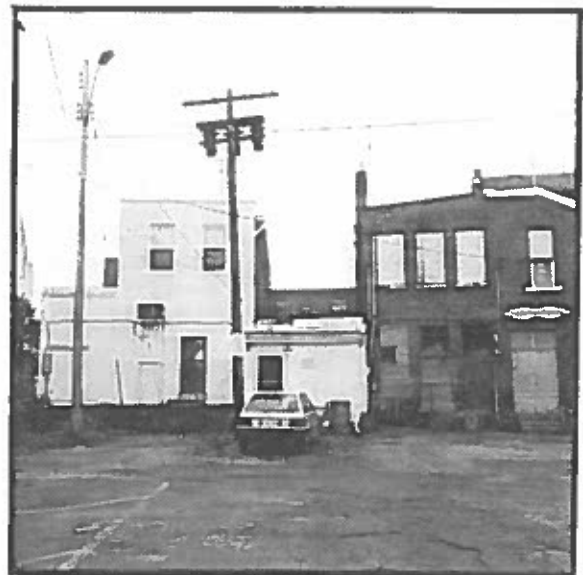
WSHCDS
Port Hope, Ontario.
Block 21: cont.

The façade is in good condition, the rear is also in a good state of repair.
