The TOWN of PORT HOPE
WALTON STREET
HERITAGE CONSERVATION
DISTRICT PLAN

WALTON STREET
HERITAGE CONSERVATION DISTRICT
PLAN

Prepared for the
LOCAL ARCHITECTURAL
CONSERVATION ADVISORY COMMITTEE

of the
TOWN OF PORT HOPE,
Ontario

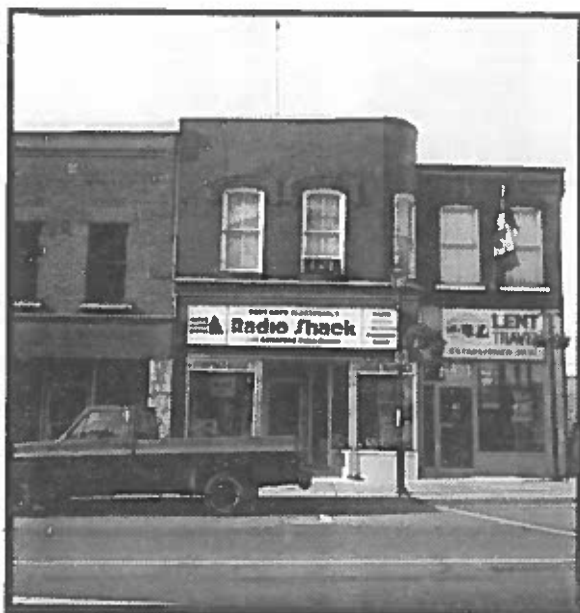
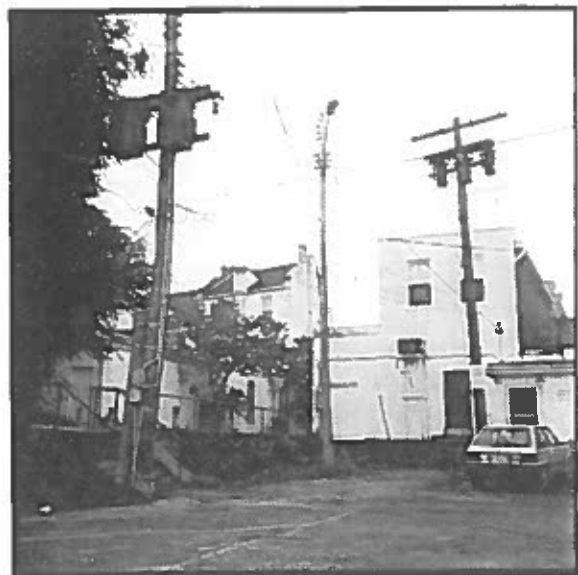
WSHCDS,
Port Hope, Ontario.
Block 23 cont.

The storefront, however, when renewed should try to incorporate more elegant metalwork, and more distinguished colouring, perhaps in a scheme cooperating with the west extension, noted here as a separate block. Spandrels below show windows would be better in a panelled design.

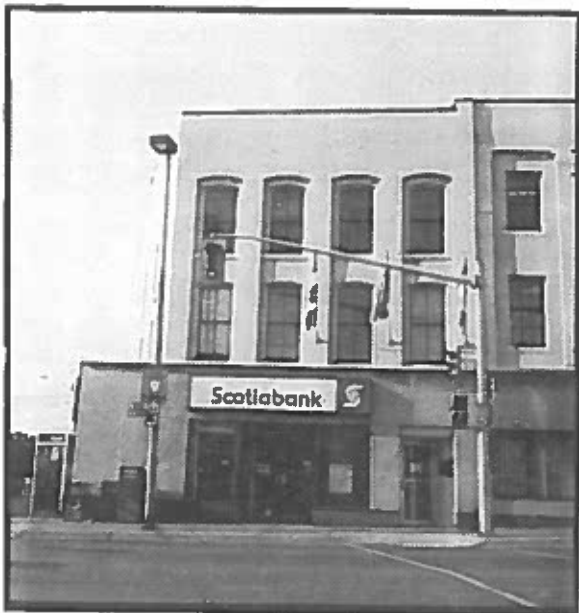
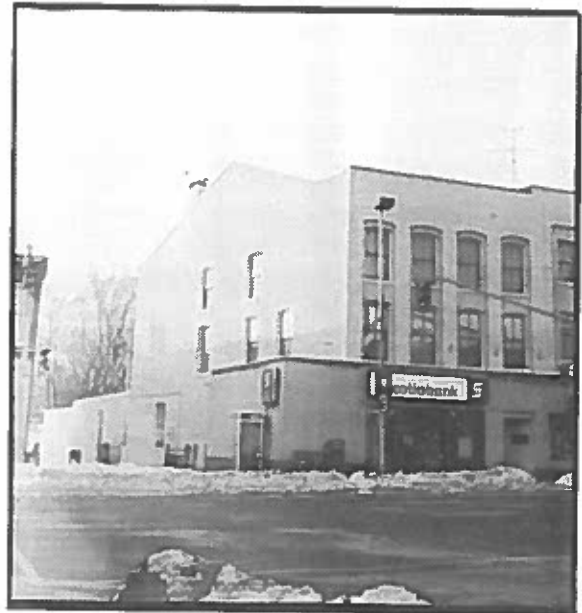
WSHCDS
Port Hope, Ontario
Block 27 cont.

In repairing the east wall this might be treated as a cavity wall effect with the stucco applied on galvanized lath over galvanized strapping, the cavity so created vented at the base and head.

This building is plagued by decaying brickwork aggravated by roofing and flashing problems. A large section of stucco had come off the east wall.

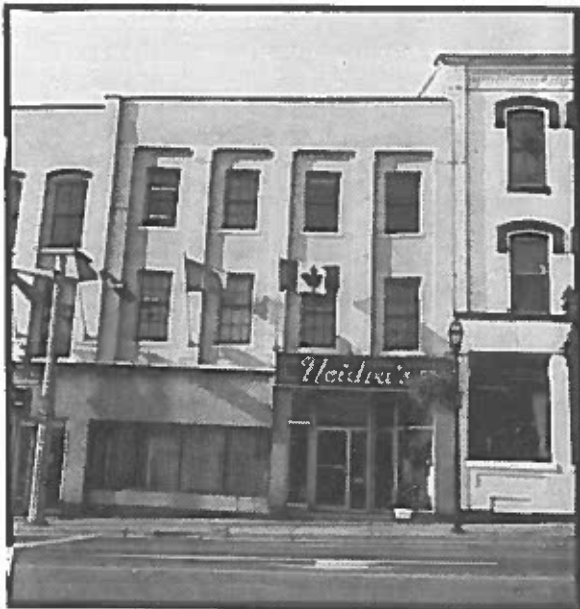
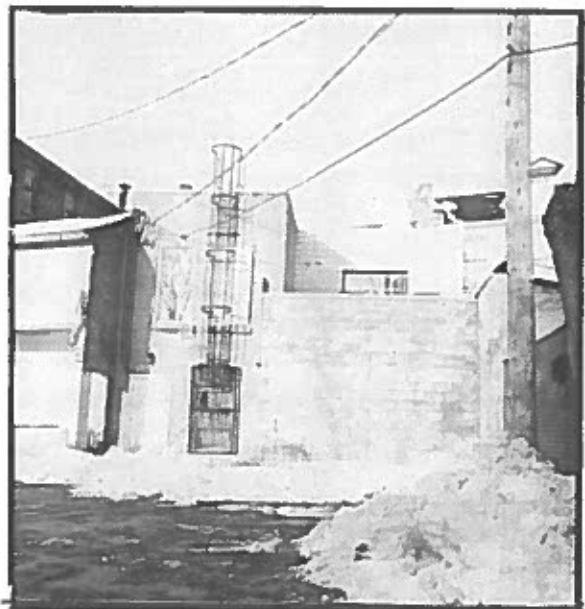
WSHCDS,
Port Hope, Ontario.
Block 29 cont.

Much the same treatment is suggested for this building as for its neighbour to the east, Block (27). This includes a common coloured background for walls with different colour to frames of openings. Also recommended is a modelling of the parapet, from simple shaded banding to trompe l'oeil cornice and panelled parapet.

The shopfront in the west section (b), unfortunately, is now misaligned with that adjacent but is a much more elegant rendering after a recent renovation which failed, however, to respect the common shopfront cornice height which needs to be addressed.

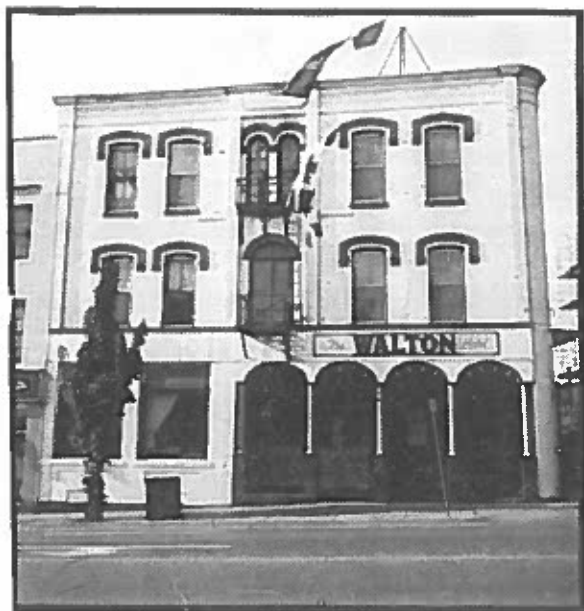
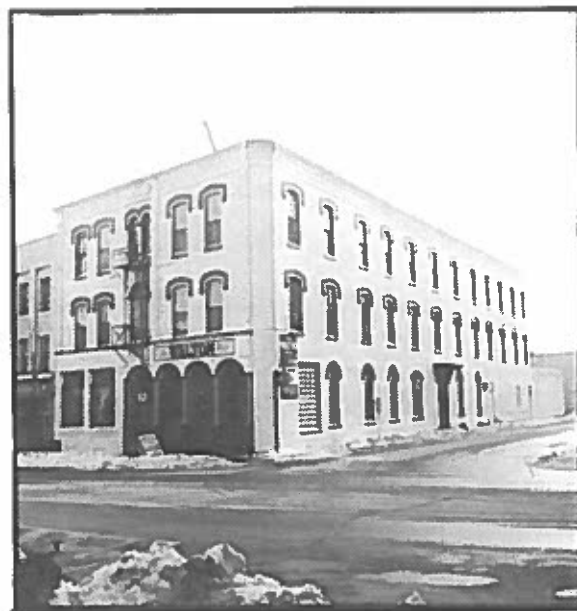
WSHCDS
Pcrt Hope, Ontario.
Block 31 cont.

Previously moisture was causing the paint to flake and copings and flashings at cornices were suspected as causing the trouble. The cornice on the John Street side is perished in part and the wood crown moulds have deteriorated previously, the replacements neither a faithful copy nor well fitted.

This is another striking block forming one side of John Street. The corner is rounded, the front divided into panels containing paired windows, the central feature narrow and more elaborate. The ornamental brick cornice is intricately contrived, the pilasters carried through it to capping at the top. The roof is flat or gently sloped to the rear. Window heads have segmental heads with brick labels in the the upper storeys and round-arched heads to the ground floor openings along John Street. The Walton Street front has a round-headed window to the centre at the second storey and paired round-headed windows above. An ornamental name panel occurs in the cornice over this central feature, but the lettering has been obscured. At ground floor level the Walton Street façade has been much altered with plate glass windows to the dining room in the east section and an arcaded front in the western two thirds creating a recessed entrance way, closed in usually with storm sash during the winter. The front has been repainted fairly recently to emphasize the ornamental brickwork.

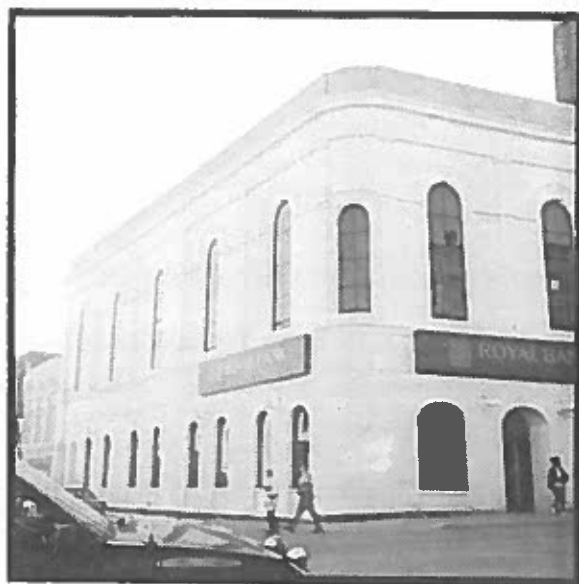
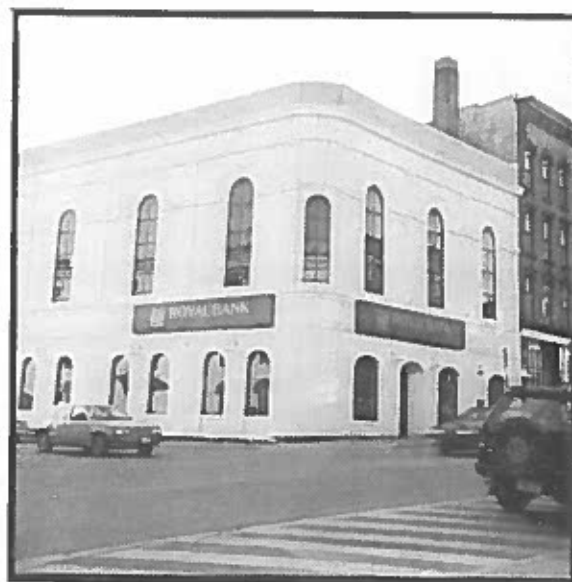
WSHCDS
Port Hope, Ontario.
Block 33, ccnt.

The exterior is now in good to excellent condition with only paintwork becoming due. The building has virtually no rear elevation as adjoining buildings hem in the corner block.

A colour scheme, in a range of warm light colours with cool contrasts incorporating the bank's own mark, is recommended. Background panels would be in light cream, pilasters, cornices and band courses in a variety of deeper gold ochre tones, the parapet relieved with panel effects. Window frames above could be a rich gold tan with cream sash, or the reverse. The lower storey would be treated as a mild contrast with a soft, warm grey as a ground colour to walls, gold ochre to the reveals or edges of openings and the deep blue of the Royal Bank to trim and window divisions to complement the signs. The whole is calculated to create an effect of great richness.

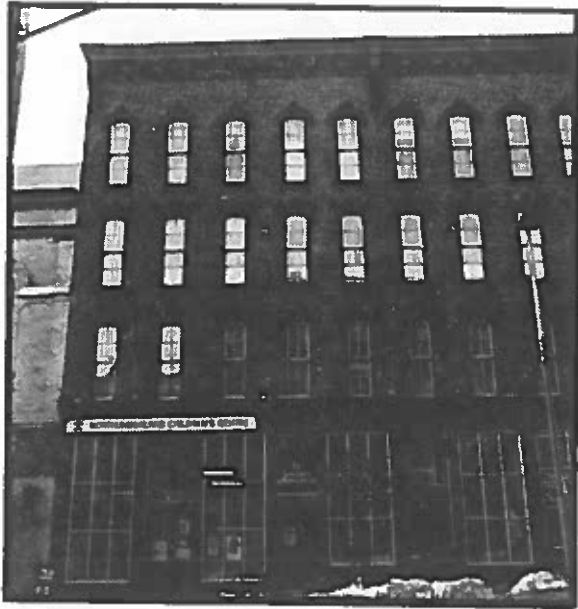
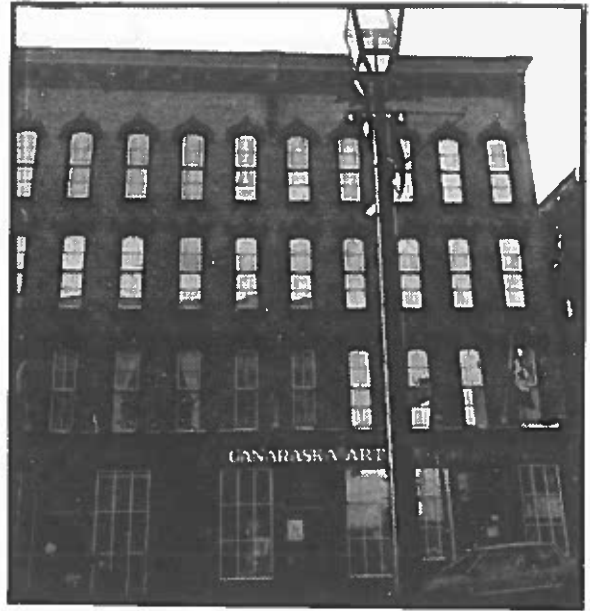
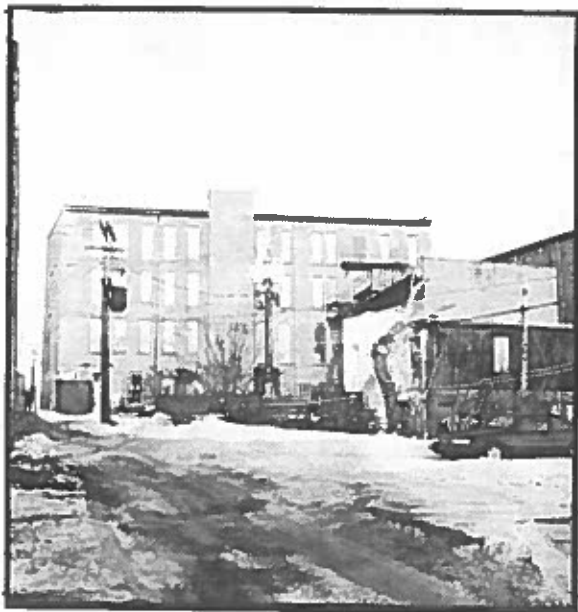
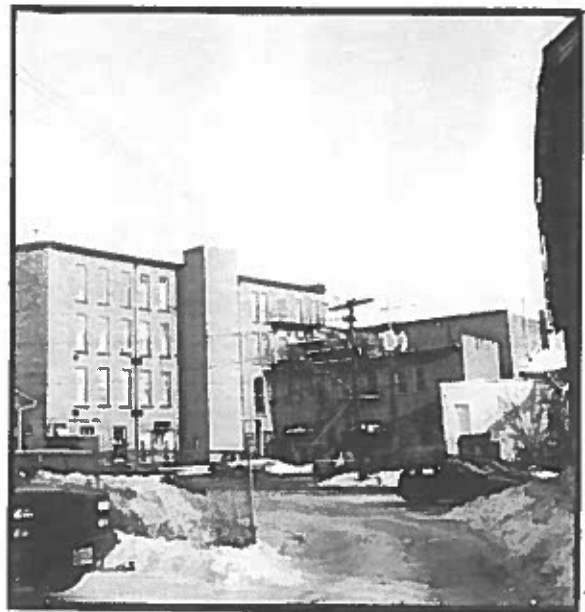
WSHCDS,
Port Hope, Ontario.
Block 35 cont.

The front cornice requires further repairs to arrest decay and prevent further damage by pigeons which use the caps of the end brackets, probably to enter the building.

It is recommended that the traditional buff stone colour be restored, as the present red brick, combined with the overshadowing effect of this building, makes this section of Walton Street a little dreary on occasion. Otherwise current colour schemes highlighting ornament follow previous suggestions and the choices made for the restored shopfronts.

It would be of great help to the appearance of this fine front if the missing window head ornament could be replaced, preferably in a less weighty and hazardous plastic replica, possibly self-coloured.

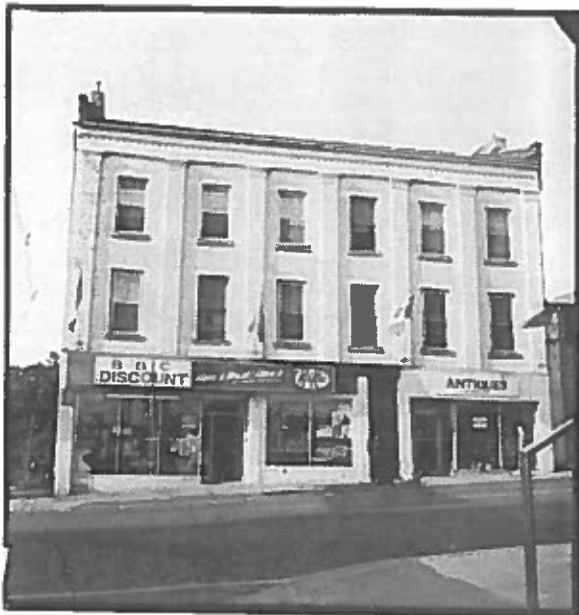
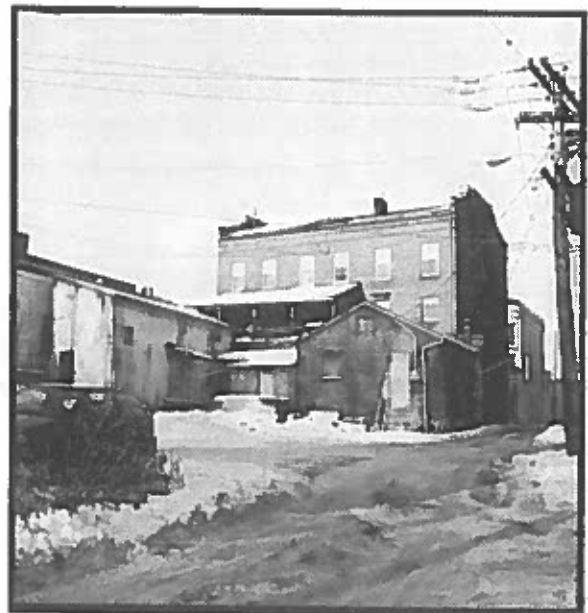
WSHCDS,
Port Hope, Ontario.
Block 37 cont.

Shopfronts could be replaced with modern counterparts favouring slender metalwork finished in gold or light bronze anodizing. A fascia should be established in common, and signs placed in alignment. Should precedent be found, a restoration of the original shopfront could be explored. An obtrusive fixed awning sprouts from the centre of the building.

The building suffers from distortions at upper storey openings due to shopfront alterations below. This coupled with the timber lintels poses a continuing problem as moisture may enter at cracks in masonry and decay the timber.

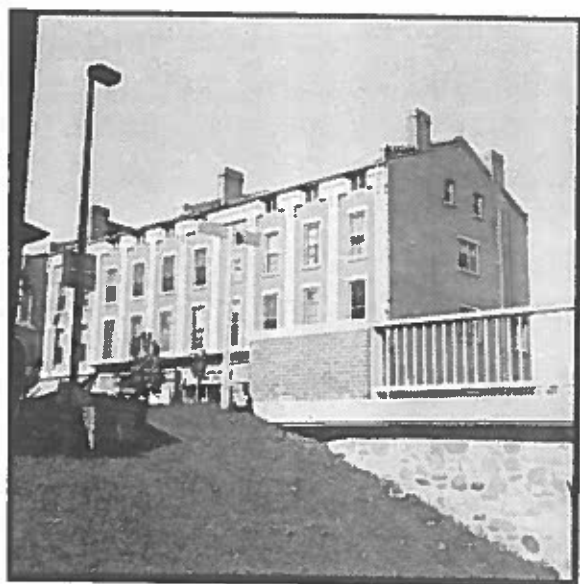
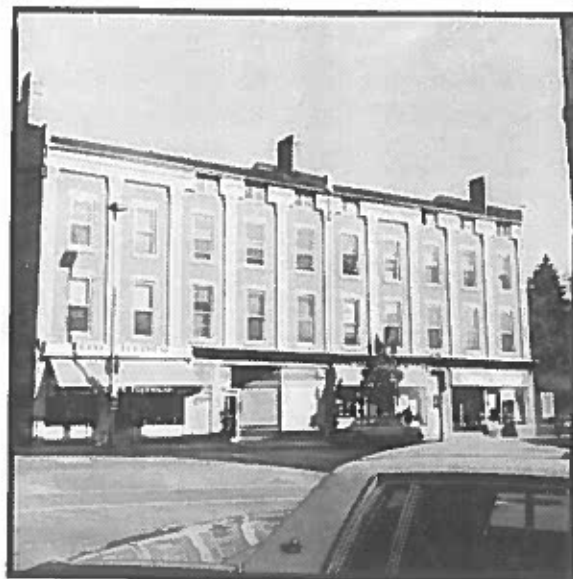
WSHCDS
Port Hope, Ontario.
Block 4 cont.

Shopfront cornice flashings are in poor condition in some cases and require attention to prevent further damage to detail or decay of the shopfront beam, if this survives.

The front was noted as in fair condition prior to the most recent repainting, and the rear and east end also in fair condition. This refers to the condition of the masonry where considerable repointing appeared necessary, a repair which would have been recommended for completion before repainting. (Repointing should be done in high-lime content mortar.)

Lintels over upper storey windows are timber and likely subject to decay. Various panel settlements above windows indicate minor structural problems possibly emanating from this or poor needling of beams in shopfront renovations. Lintels might need replacement in preservative-treated timber, stone or brick faced with stucco to simulate the original detail.

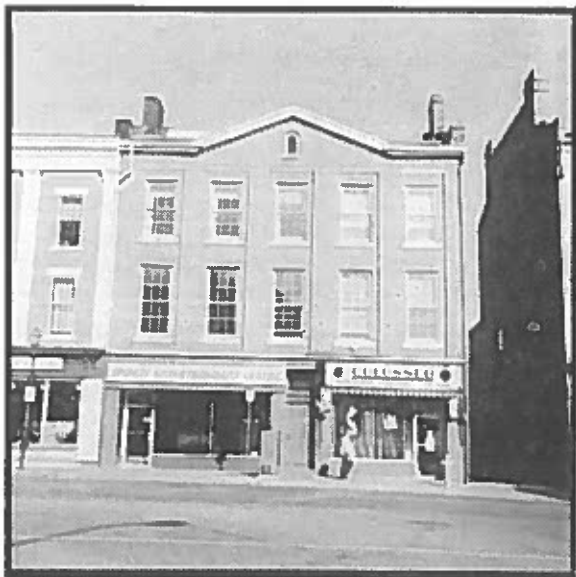
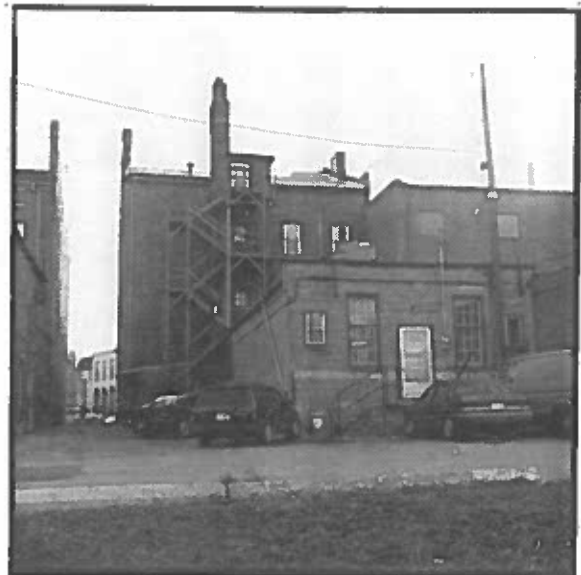
WSHDS
Port Hope, Ontario.

The exterior of the building is in good condition throughout and has been well maintained. The building has been modernized to a high standard in the past to provide good apartment space.

Regrettably the ground floor was altered earlier in the twentieth century, with the removal of the original arcading and its replacement by the then modern glass finish called "Vitrolite" now obsolete and no longer readily available. Some small improvement was effected by replacing much of the Vitrolite with smooth stucco.

Ultimately restoration of the arcading, and adaptation of the store layouts to accommodate this original feature, is recommended.

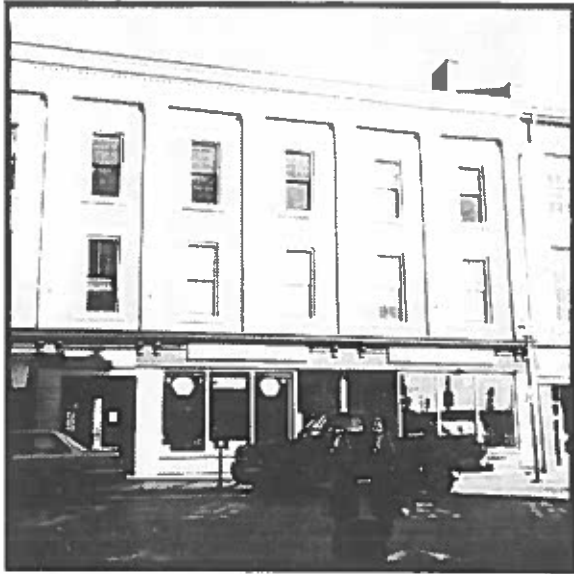
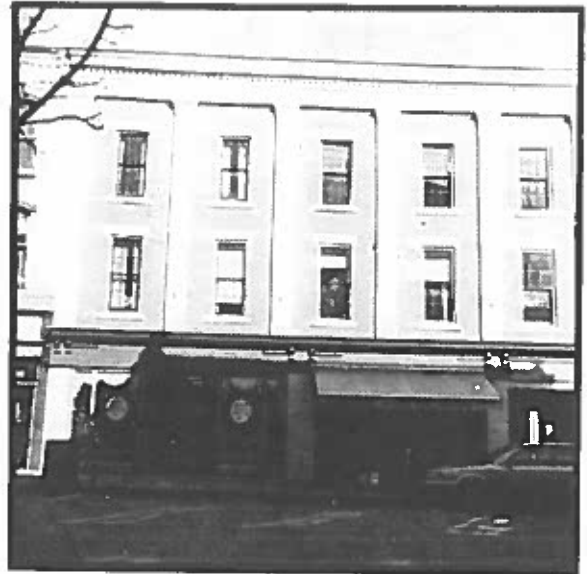
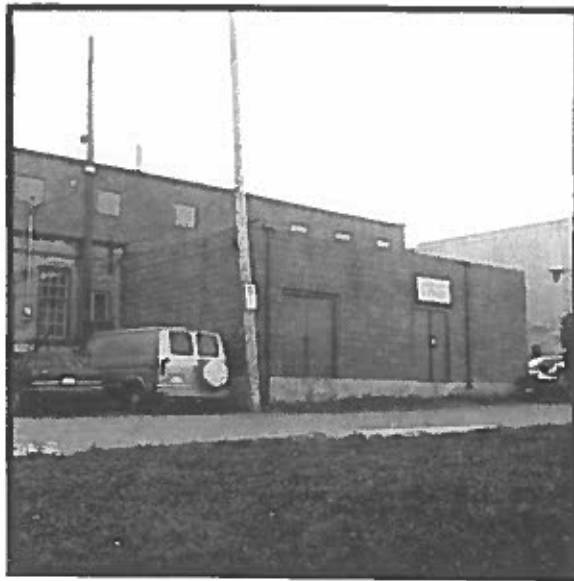
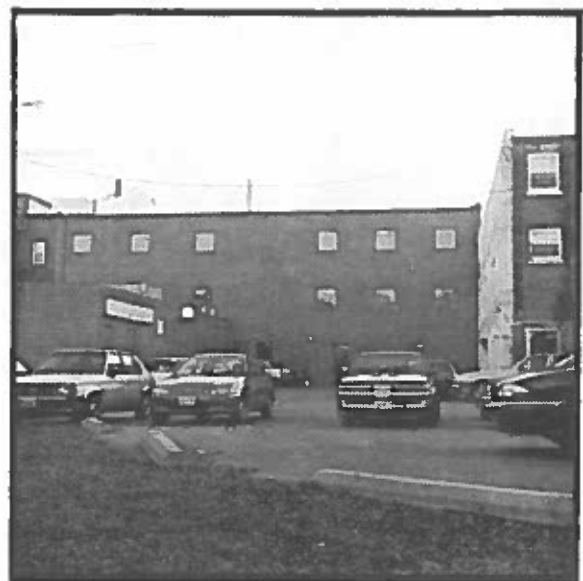
WSHCDS
Port Hope, Ontario.
Block No. 8 cont.

This building, like block (4), also has timber lintels over upper storey windows, and arch settlements have been repaired over openings. These and some sags evident were due to inadequate needling while making shopfront changes in the original building. However the façade is now anchored to the structure behind.

The condition of the front of the building is now in good condition needing only periodic maintenance.

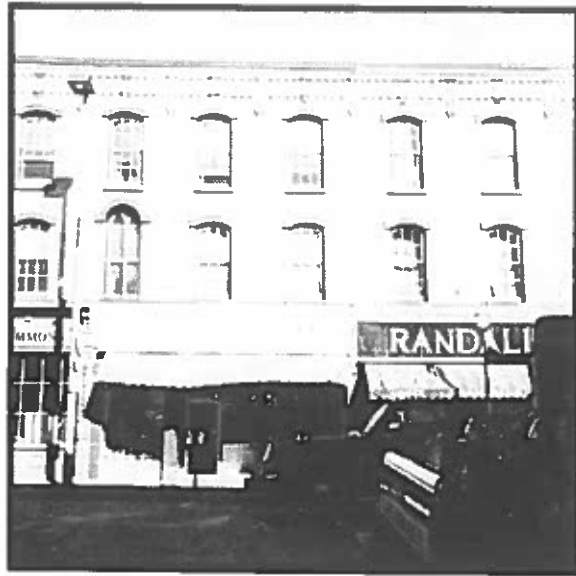
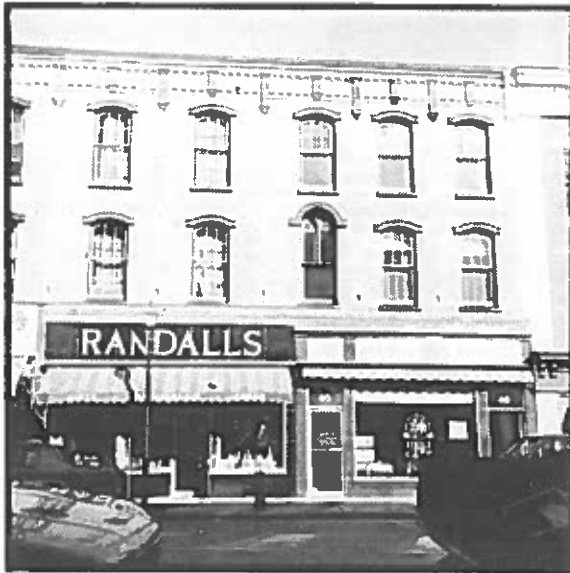
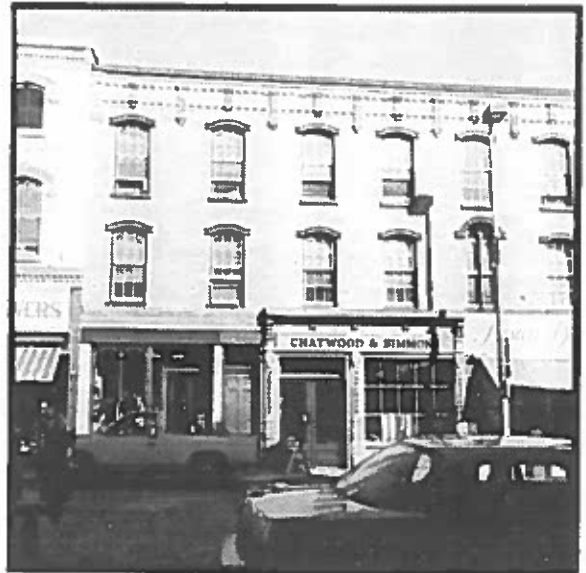
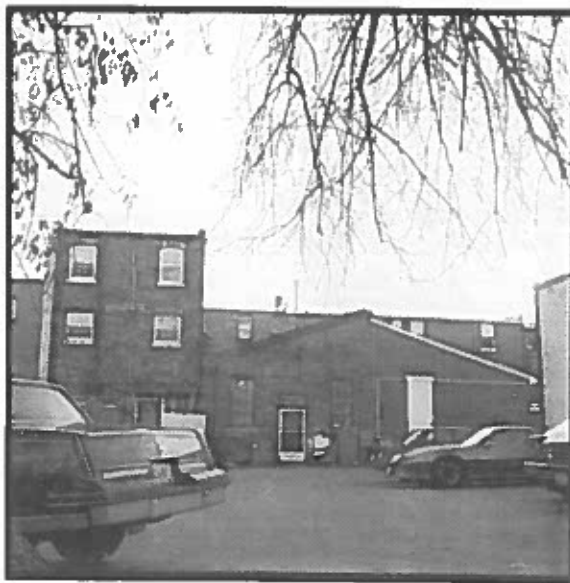
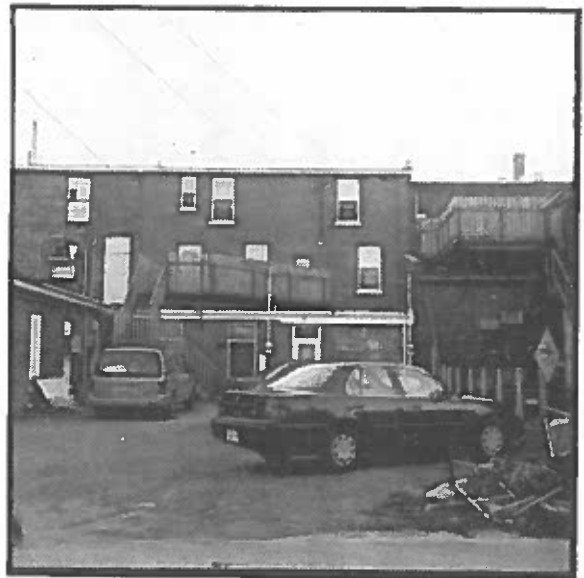
WSHCDS,
Port Hope, Ontario.
Block 10 cont.

Some upper sash require restoration, notably in section (a) where lower sash have been replaced as well as the original detail to the feature window having been destroyed. Some restoration is necessary in the other feature window of a minor nature to restore what is believed to be the original pattern of double-paned sash.

Modern shopfronts in sections (a), (b) and (e) are kept below the decorative brick banding serving as the cornice. This feature should also be honoured in sections (c) and (d) by lowering the modern fascia. The sign to Randall's is a handsome modern design using a traditional letterface. The former sign to the shoe store recorded in 1970 was of the calibre of Randall's: its replacement lacks the disciplined formality of the earlier design.

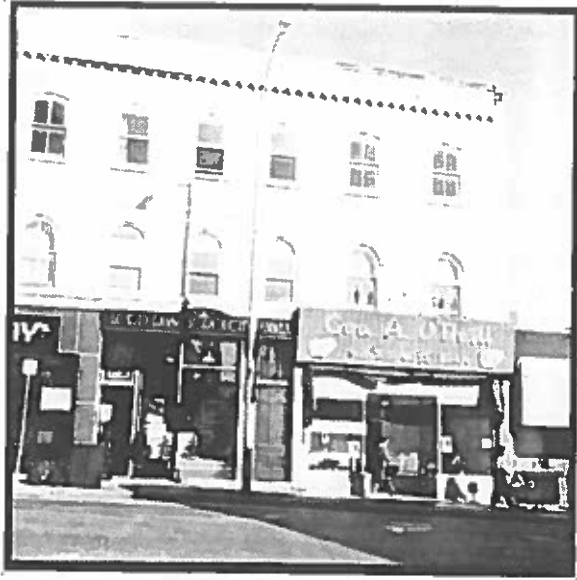
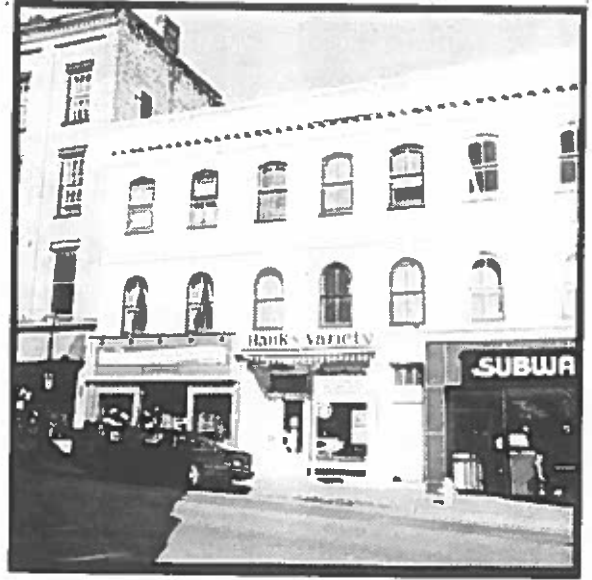
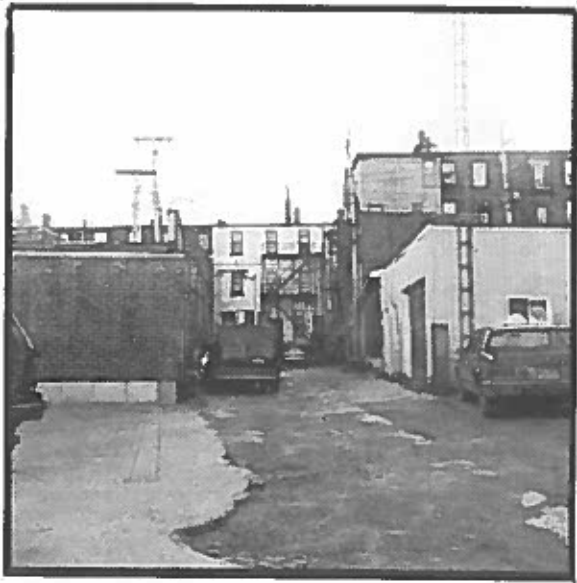
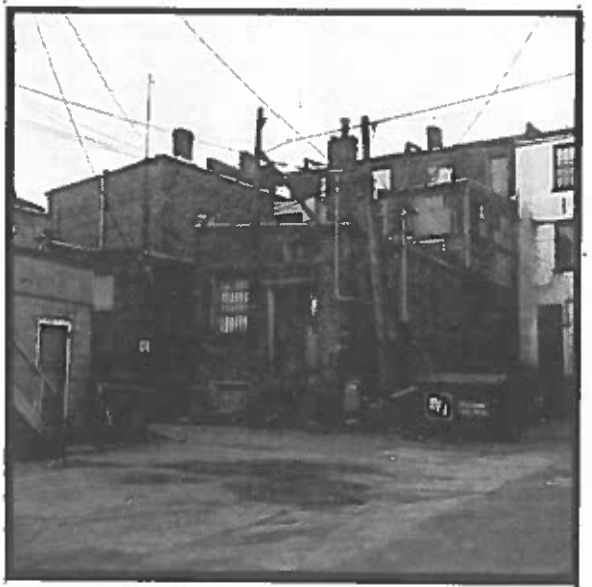
WSHCDS,
Port Hope, Ontario.
Block 18 cont.

The building is in fair to good condition at the front and poor to fair at the rear despite more recent repairs to part of the structure behind. However after a fire original window sash were replaced in the back section.

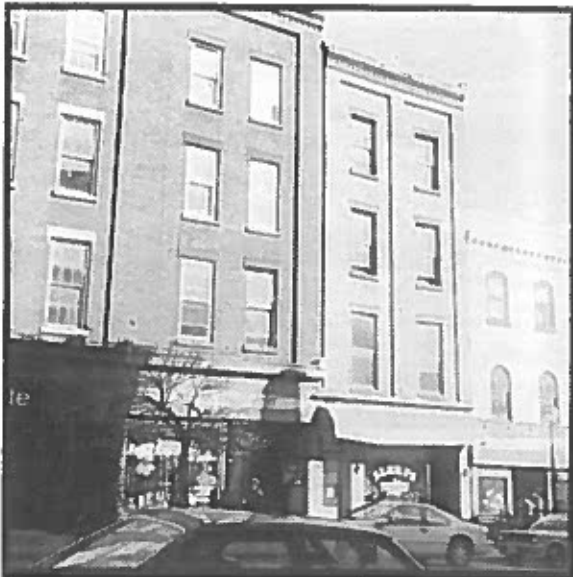
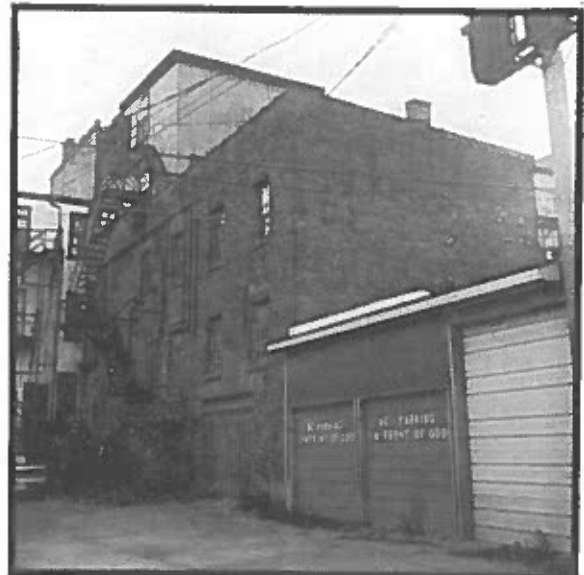
WSHCDS
Port Hope Ontario.
Block 20 cont.

The front is in fair to good condition, the rear in poor to fair condition with repairs needed to sash and masonry.

Restoration of the front, with shutters to upper floors, the sash to the second floor, is recommended. Improvement of the shopfront is also possible with redivision of the show window. Some treatment of the flanking entrances with more interesting detail to transoms is envisaged.

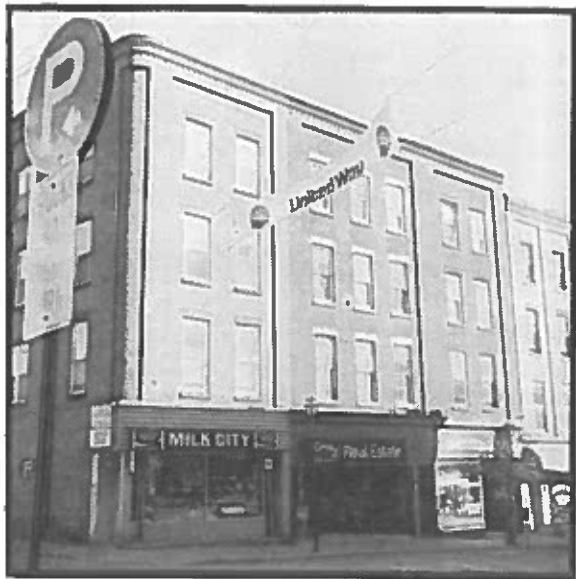
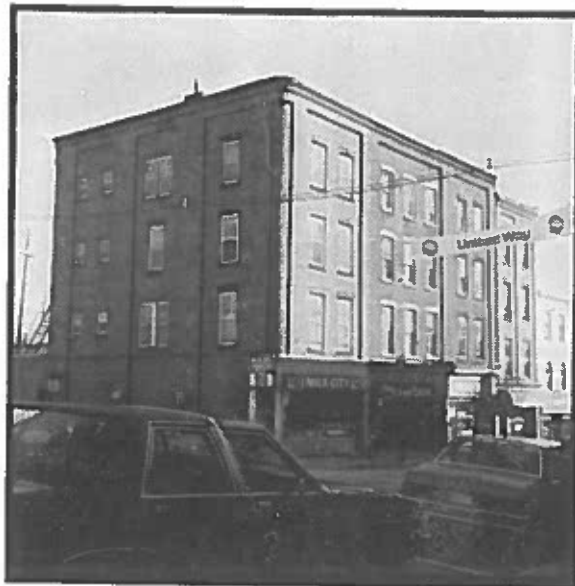
WSHCDS
Port Hope, Ontario.
Block 22 cont.

The western bay (c) has been painted, in part to conceal alteration on the Cavan Street side. Various settlements occur at the front due to inadequate precautions during shopfront changes. Rear façades are festooned with fire escapes and section (c) has a "solar" extension added to the upper storeys on top of a projecting rear wing. This is now in need of maintenance. Various openings are distorted and require repair.

The fronts, apart from the distortion visible, are in good condition generally, but the rear, as noted, is in need of attention. Shopfront metal on section (c) has taken some abuse because of its exposed corner location. Wooden lintels to new openings on the west side to Cavan Street need to be watched and possibly renewed in future.

It is recommended that the painted building be chemically cleaned carefully to remove all paint from the Walton Street front and from the pilasters and cornice of the Cavan Street front. The panels of the west side should be repainted to disguise the alterations. The remainder of the Walton Street front should also be cleaned.

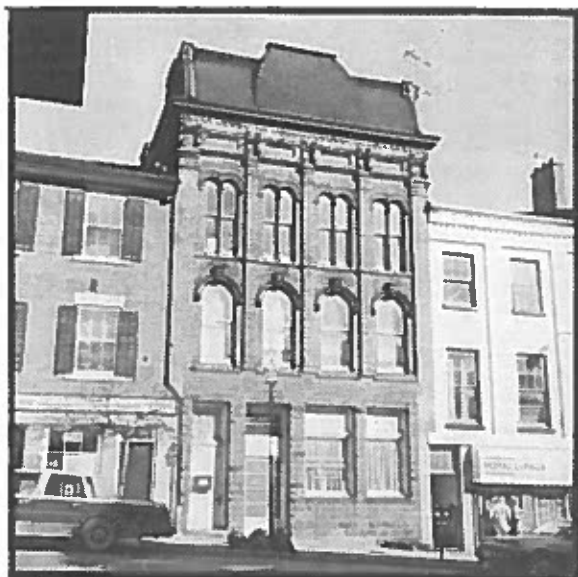
WSHCDS
Port Hope, Ontario.
Block 26 cont.

This Second Empire building originally housed a furniture emporium, was later converted to trust company offices and now serves as a law office. The details are eye-catching and represent one of the last efforts to distinctive design of Walton Street's great building period. By this time Victorian eclecticism is well illustrated in the combination of Italianate details of second floor windows, brackets to pilaster caps and elaborate cornice supporting the broken front to the false mansard hiding a shed roof. However this building conforms more to the earlier pilastered forms than the design of Blocks (12) and (18) which emphasize the horizontal effect. The building has original sash in the upper storeys, with elaborate cast iron labels with keystones to the second floor. However, the ground floor front has been substantially, and not sympathetically, altered earlier in this century. The mansard is now faced in asphalt shingle and lacks the ornamental dormers, probably oval lights originally.

The shingling of the mansard is cockling and may require attention shortly. Generally the building is well maintained.

However, the red sandstone front may suffer from winter salt damage causing efflorescence and spalling.

The ground floor front could be improved at any time replacement of stonework becomes necessary. A return to the original Victorian shopfront, of which photographs exist, would be an enhancement. Such windows could be suitably screened or curtained to cut down the sunlight into private offices, if this use should continue.

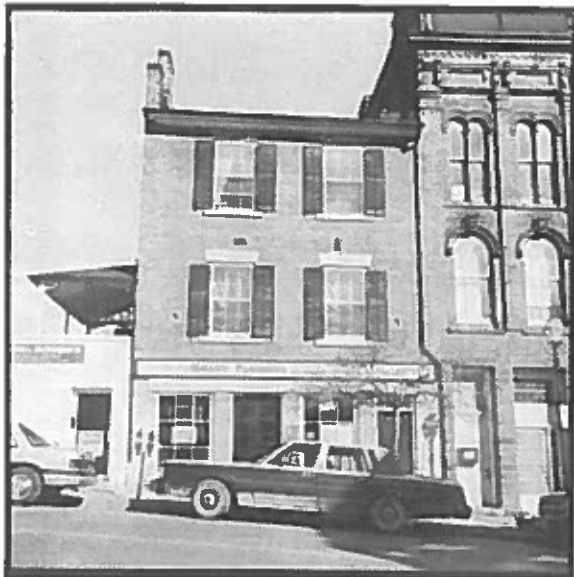
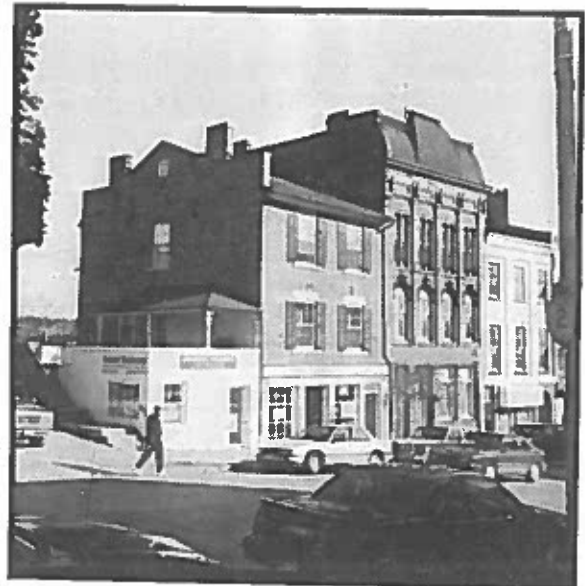
WSHCDS,
Port Hope, Ontario.
Block 28 cont.

This is the oldest building on Walton Street and has withstood the ravages of time and fire. It requires careful and continual maintenance.

A watch should be kept on vertical cracks in the masonry at window spandrels.

Despite the fire the front remains in good condition and the rear in fair order after repairs. Minor maintenance, such as painting of the storefront, is required periodically.

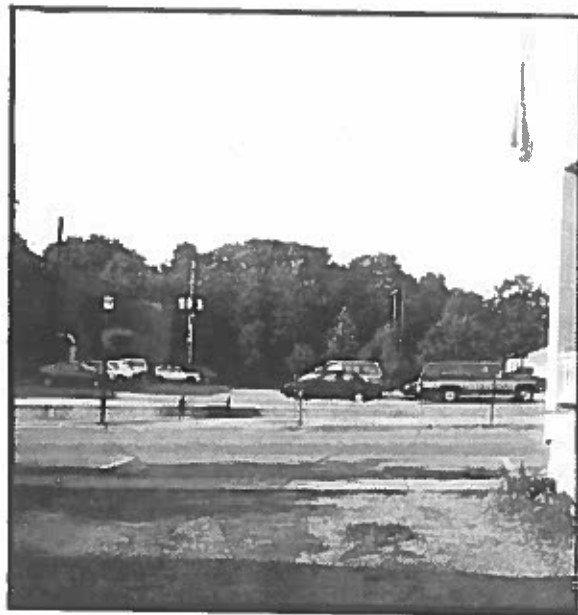
Block 45: Part of Parking Lot contiguous to Block 41.

Also noted in 1978 Walton Street Study as a former c. 1840 house of design somewhat similar to Block 43. Removed in mid-1970s.

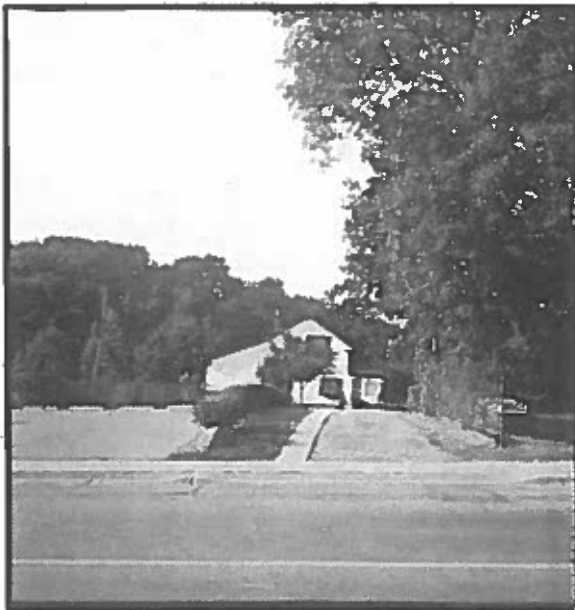
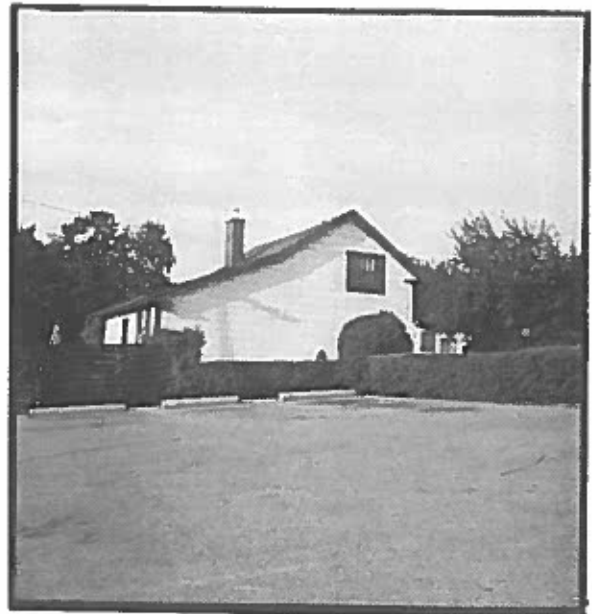
Block 47 c. 1850 frame residence, storey-and-a-half
No. 123 broken-pitch saltbox.

This is a small early frame house, basically one-and-a-half storeys, of saltbox form, set well back from Walton Street with a very narrow frontage access. Though not part of the normal streetscape of Walton because of its secluded position it is, nevertheless, an important component of the historic material of the thoroughfare by reason of its early date and special form.

The building, now clad in synthetic siding, (aluminum) has been noted as having been originally roughcast, a coarse-textured stucco. Old divided sash in six-over-six pattern are part of the original detail.

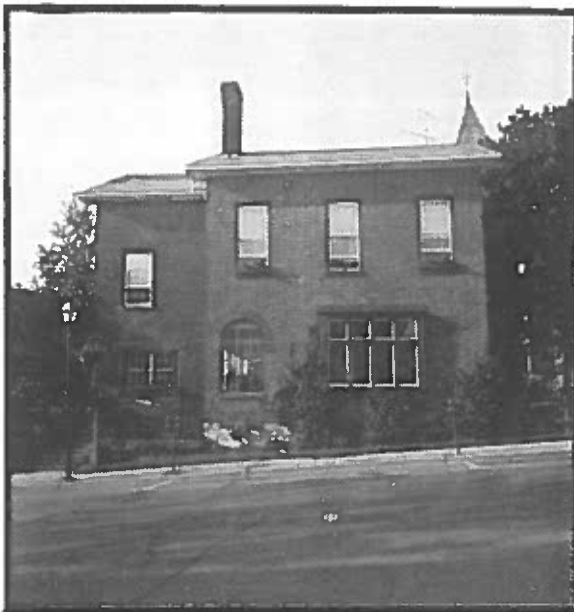
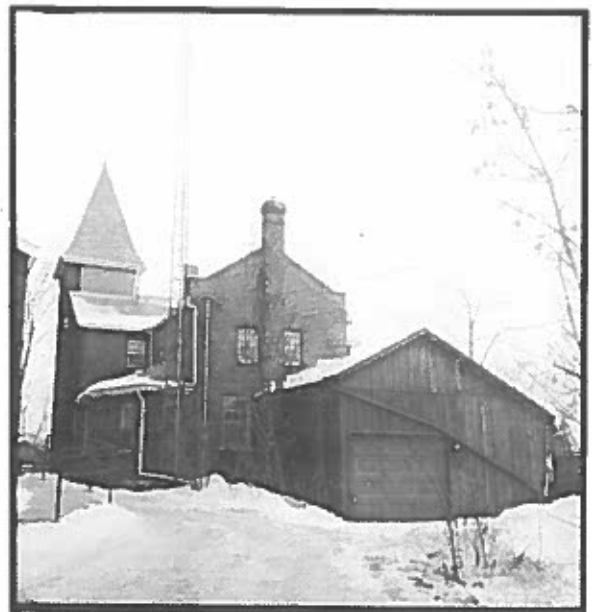
This building has seen considerable alterations to the front with English Domestic Style fenestration, the original openings still discernible. Earlier additions include, the east-side wing, a rear extension and a small, late Italianate tower in the rear angle so created, probably from the 1880s.

The rear exhibits the irregular outline of additions but has been kept in good order.

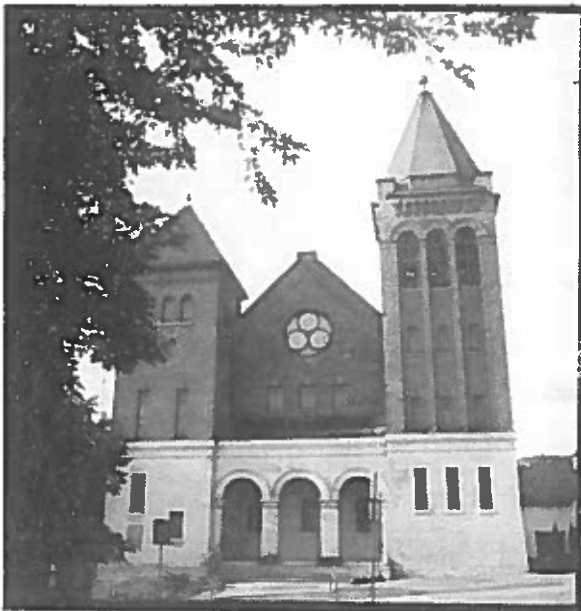
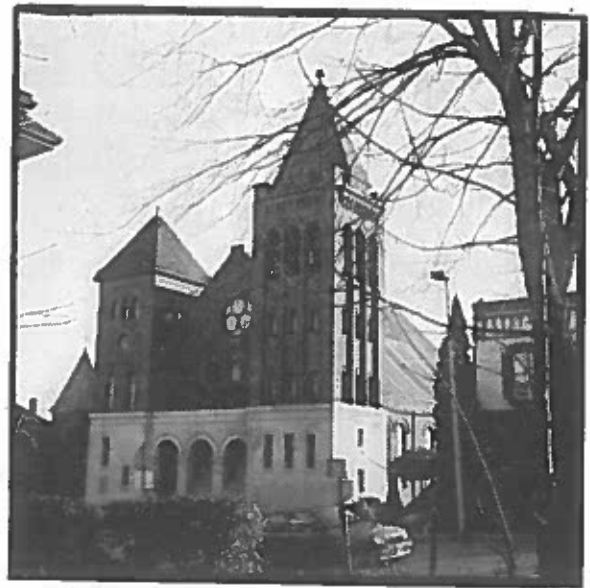
WSHCDS
Port Hope, Ontario
Block 51 cont.

This monumental composition in brick over a cast stone base is, essentially, of the Romanesque Revival. Massive towers frame the front with an arcaded porch between sheltering the tower entrances, and above, the gabled front to the sanctuary and its rear gallery. Small gabled wings contain side entrances and behind a half octagon shape encloses the attached Sunday School wing.

The building is notable not only for its rusticated cast stone base, but the smoother cast stone bases and plinth course to the towers, the same material used in the porch. Windows to towers display simple stained glass in Art Nouveau designs, the taller west tower with louvred openings to the bell stage and with a short spire above. The shorter east tower on the lower end of the slope has a hipped roof though steeper than the similar form to the half octagon back of the church. The chimney is a massive shaft very much contributing to the architectural silhouette. A fine rose window, also exhibiting Art Nouveau designs, dominates the front gable but lights only the loft space above the sanctuary.

The roofs are at present a miscellany of finishes, the tower caps being covered in asphalt shingle, possibly replacing an original wood shingle cover, the main roof over Sanctuary and Sunday School in a cement-asbestos tile, a fire-resistive replacement of the earlier twentieth century, but no longer used and difficult to repair satisfactorily. A more permanent metal covering could be entertained providing that its patterning is discreet and/or traditional, a low-rib batten-seam or standing-seam appropriate, an imitation tile to be discouraged for the roofs are important components of the silhouette. The eye-brow dormers serving as ventilators to the roof space are significant details. Also important to the design are the parapets to gables and the massive chimney stack which rises through the roof towards the south-east corner.

Deterioration of the cast stone material is showing and various incompatible patches have been attempted in the past. At some time the notable moulded cap which finished off the first storey to the front and around the towers continuing as a band at the eaves of the porch was lopped off, its profile still visible at the ends where it returns into adjoining walls. This probably perished almost completely, maybe from causes similar to those at the porch arcading and pier capitals where the iron fastenings or pins providing reinforcing to the cast in-situ ornament have rusted, in the process expanding and spalling the base material. Conservation measures will be required here and restoration of these details is to be recommended. Alternative stainless steel fastenings should be employed in this work. Otherwise the vertical cracking seen in the cast stone units may have resulted from improper curing initially for this material could well have been manufactured on the site using moulds, labour and ingredients provided by the contractor or the masonry subcontractor.

There are areas of deteriorating brickwork indicating some deleterious salt penetration from pollution, some open joints and moisture problems, aggravated under windows by the lack of drip grooves to the cast stone sills. A few bricks are decaying and will need replacement, particularly on the chimney stack and its eastern, most weathered, face. Here the lining of the chimney should be checked, for if a gas furnace is used a stainless steel flue is advocated. Masonry conservation is recommended.

Some deteriorated woodwork is also noticeable, as at tower fascias. Stained glass, so often a potential problem to casual vandalism, may need additional protection after broken or damaged sections are restored.

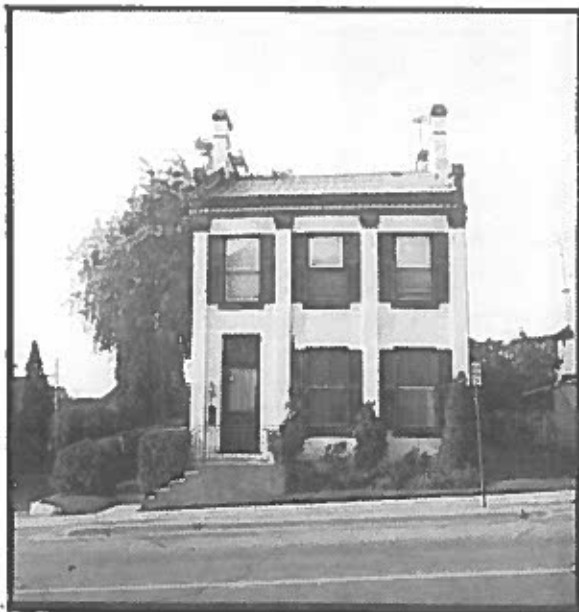
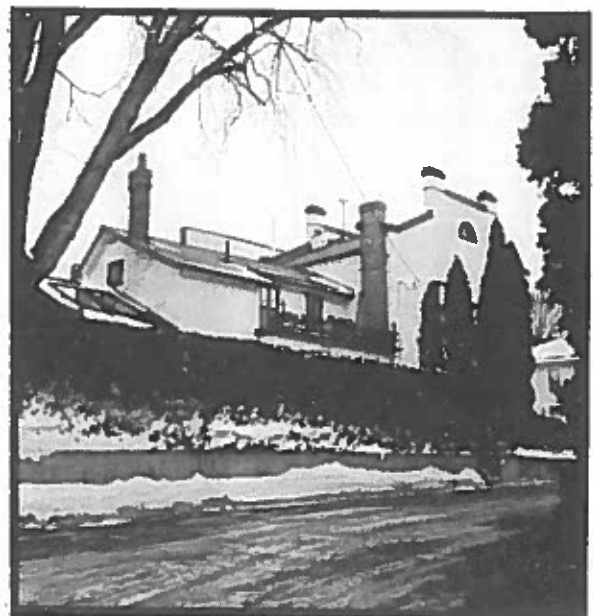
This illustrates the final transition to the residential section of Walton Street, its counterparts on the other side of St. Paul's once standing as Blocks 43 and 45. This handsome structure exhibits typical Port Hope brick detailing including a dogtoothed frieze, the design picked out in a contrasting paint scheme.

The narrow attenuated front is notable for its transomed doorcase. Windows would have had six over six sash in the original. The east gable has a half-moon window, now decorated with a fanlight, lighting the roof space .

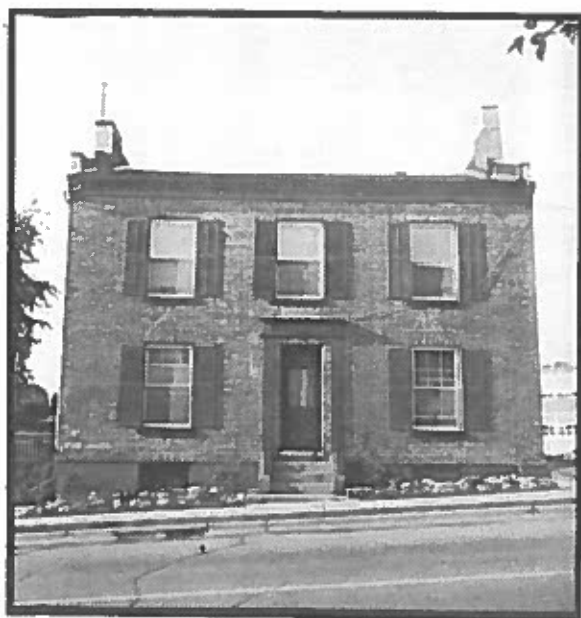
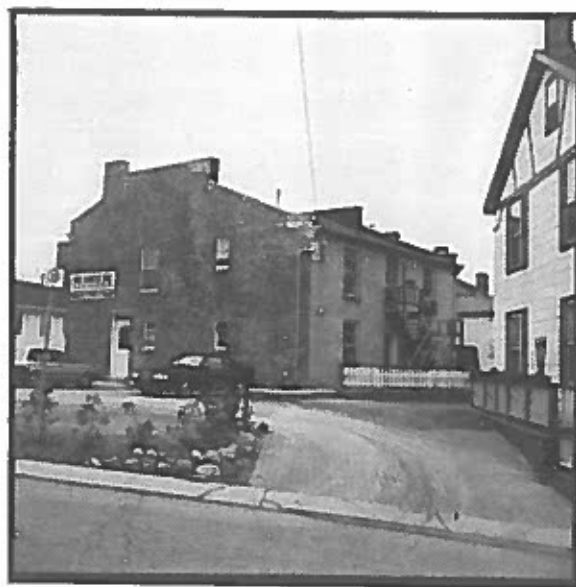
The rear of the building has been enlarged, possibly shortly after the building was erected, the roof slope extended and the back wall bedecked with a wooden fire escape, the small private yard enclosed by white paling fence. The rest of the back yard and the triangular open parcel at the corner of Pine Street South has been devoted to a parking area, the latter enclosed by a newly planted cedar hedge needing some years and much encouragement to complete its job of concealment.

At present the south-east corner of the Pine Street intersection is open and without definitive streetscape.
