The TOWN of PORT HOPE
WALTON STREET
HERITAGE CONSERVATION
DISTRICT PLAN

WALTON STREET
HERITAGE CONSERVATION DISTRICT
PLAN

Prepared for the
LOCAL ARCHITECTURAL
CONSERVATION ADVISORY COMMITTEE

of the
TOWN OF PORT HOPE,
Ontario

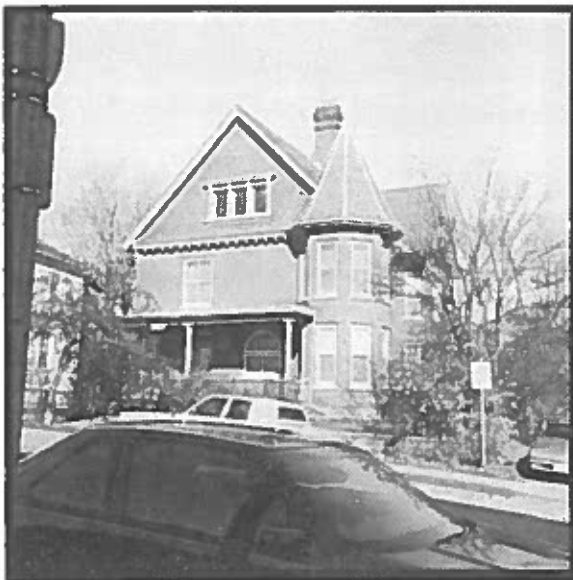
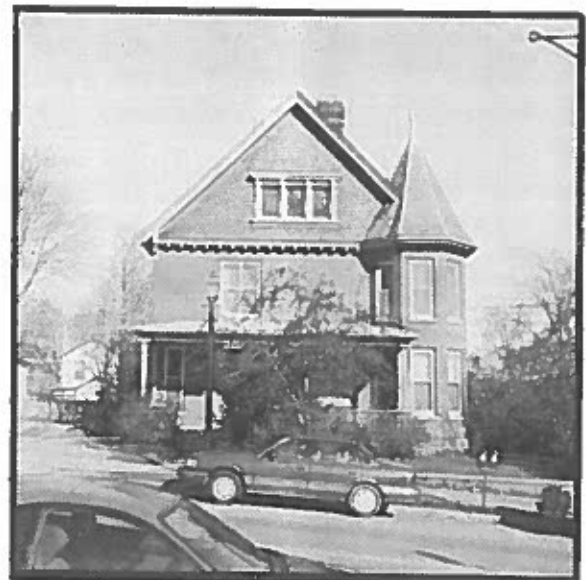
Block 30 is a high style late Victorian house in an open landscaped lot holding its own as a landmark of upper Walton Street. The building exhibits all the frills and furbelows of the Queen Anne Revival in bracketed tiled pediments to gables, octagon corner tower sporting a likewise faceted conical roof and round-head lower storey window with stained glass transom.

The house appears well maintained. In the yard is a two-car garage in poorer condition. Planting is typical shrubbery and small trees along the boundary but no distinguished landscape treatment.

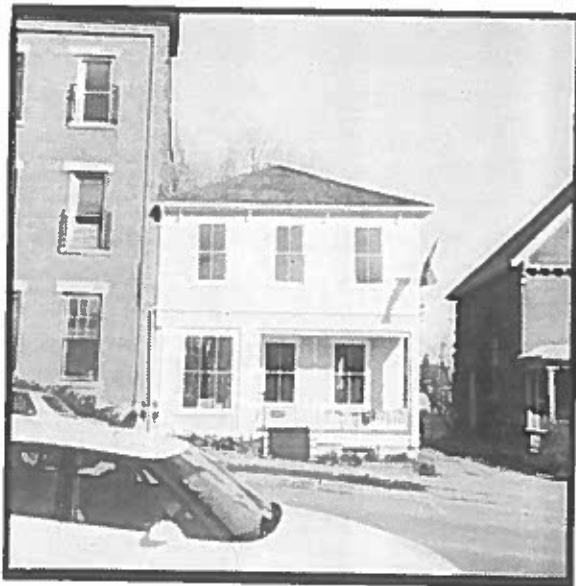
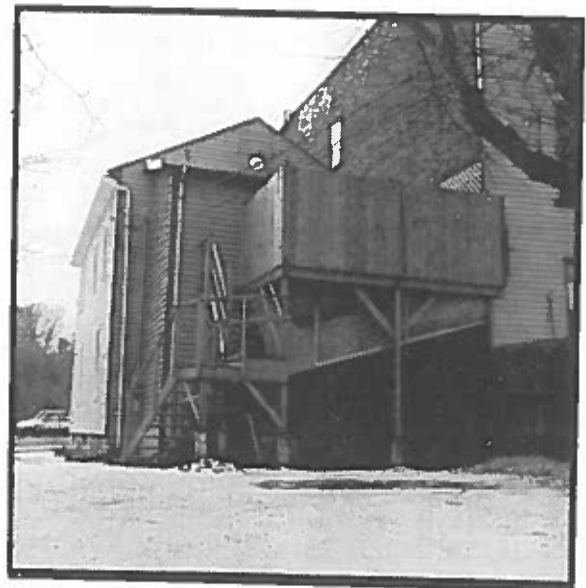
The building, after looking somewhat downtrodden for many years, underwent a face-lift and conversion to a bookstore within the last decade. It is a handsome structure which appears to have evolved from a standard three-bay design, possibly an earlier pilastered shopfront still represented by the western third, but why the east and centre thirds are recessed is not known. Brackets to eaves may indicate a later change too.

The back is a miscellany of additions with partly enclosed and exposed fire escapes still not quite finished and needing attention. The back yard provides parking for the establishment.

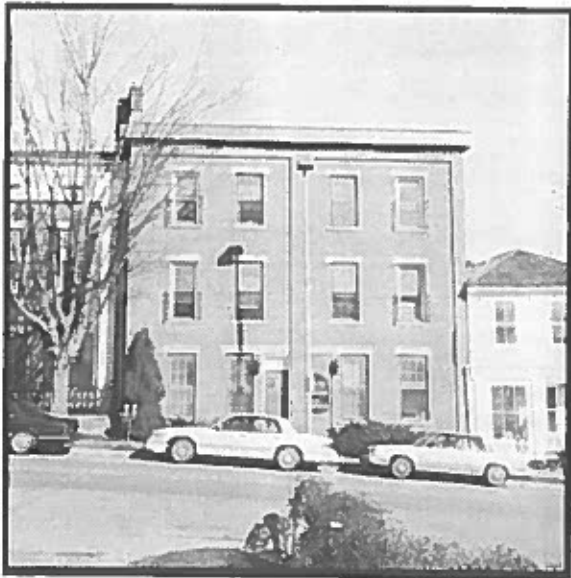
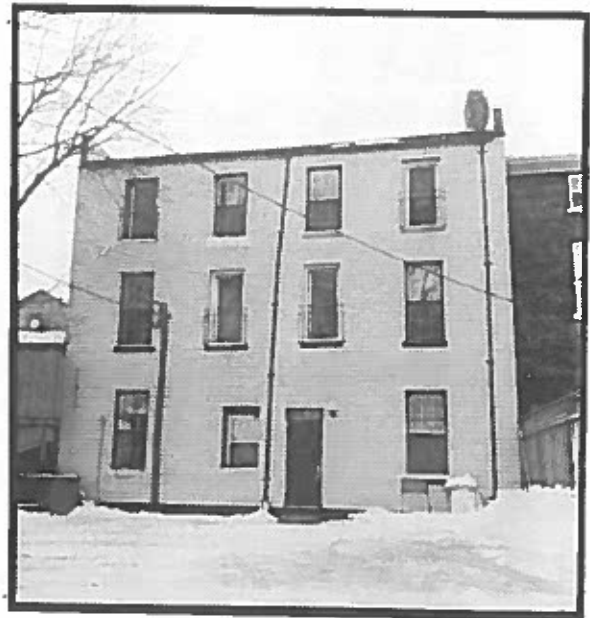
Here a commercial type block of the transitional type with plain pilasters and frieze outlining the two units is faced in a very smooth texture, sand-struck, orange-red brick of a type reported to have been imported from Oswego, New York, across Lake Ontario. The ends are a common local brick, the rear neatly re-covered in modern synthetic siding, possibly to mask a deteriorating rear wall. The building has a low-slope shed roof.

Many of the front and rear windows have the original six-over-six sash. Lintels and sills are stone to the front, most likely Cleveland sandstone from the colour, and brought to Port Hope by lake transport. Both entrances, however, have been changed, the east one blocked completely, the west one retaining a transom bar but with a modern door. The boxed front overhang to the roof possibly an extension of the roof itself may have replaced an earlier cornice or a continuation of the decorative brick frontal parapet.

The rear yard, now largely a parking area is entered from a narrow back lane, Brown Drive, off Brown Street and running parallel to Walton.

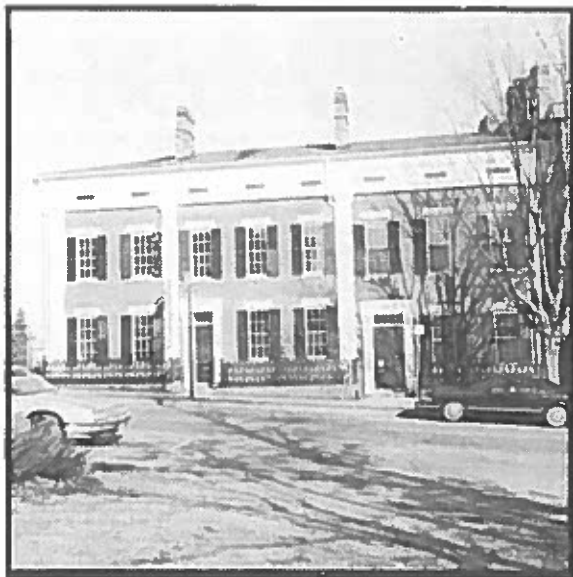
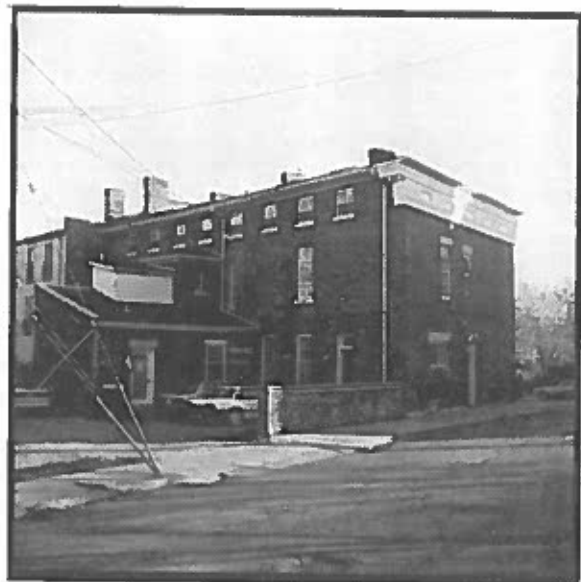
WSHCDS
Port Hope, Ontario.
Block 36 (Nos. 134-136) cont.

The so-called McDiarmid Block presents one of the "gateposts" framing lower Walton Street and emphasizes the quintessential character of this handsome downtown. The building in red brick is punctuated by boldly scaled pilasters with capitals and crowned with a plain deep cornice whose frieze is pierced with unadorned "stomachers" lighting an attic under a hipped roof space. It is wondered whether these once had ornamental grilles. Strong high chimney stacks mark the cross walls separating units. The obtuse corner is formed by bricks neatly shaped to fit the angle.

The block boasts original sash of six-over-six and two handsome doorcases with transoms and Greek-eared architraves set to the side of the three-bay units fronting on Walton. The side entrance to Brown Street, also with transom has a plain inset frame. One original window shows here, but others appear to be early twentieth century changes although these, like original windows to the street have stone lintels and sills.

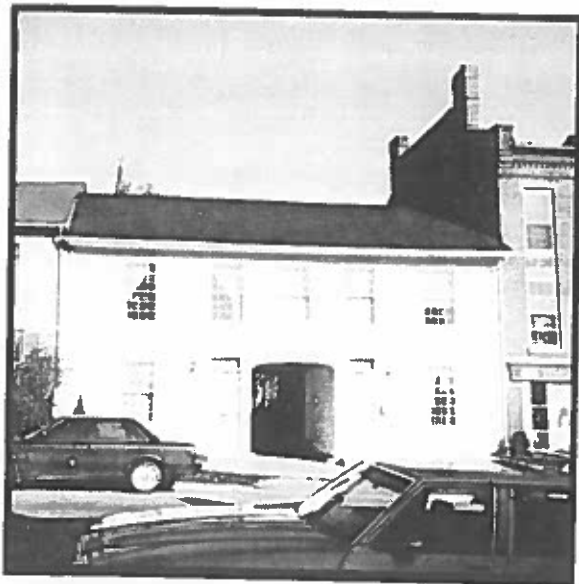
This handsome frame structure was in a forlorn state until taken in hand by a local contractor, Rod Stewart, who by careful conservation work restored much of its original character. Now a very attractive example of the earlier frame building of Walton Street it represents the neo-Classical vernacular of the time with its symmetrical disposition of openings, the divided window sash, transomed entrances with fine chinoiserie lights with panelled doors and elliptically headed centre passage.

The rear has extensions, small courtyards and parking space.

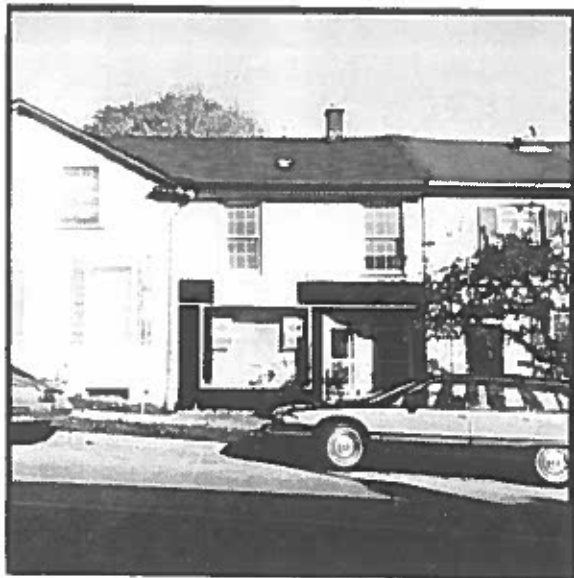
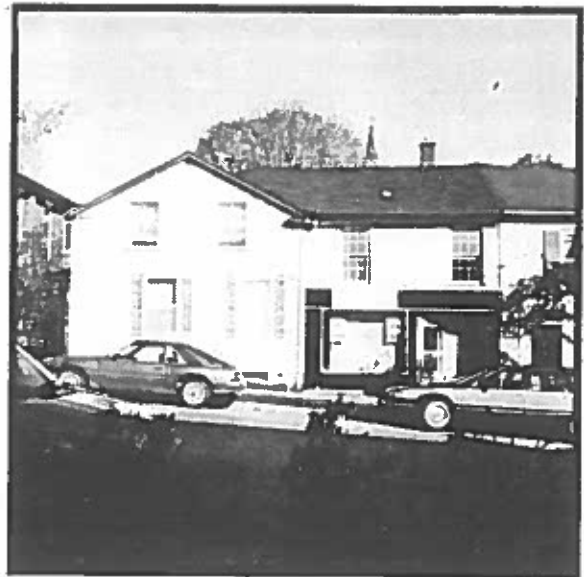
The horizontally sided (vinyl) front is set back slightly from its eastern neighbour Block 46, suggesting the latter to have been veneered later and perhaps indicating this to be a part of that building. Though the six-over-six sash survive in the two-bay upper storey the shopfront is not a very compatible intrusion here and redesign might be encouraged in a future renovation.

The rear yard is a small space, the back of the building simple.

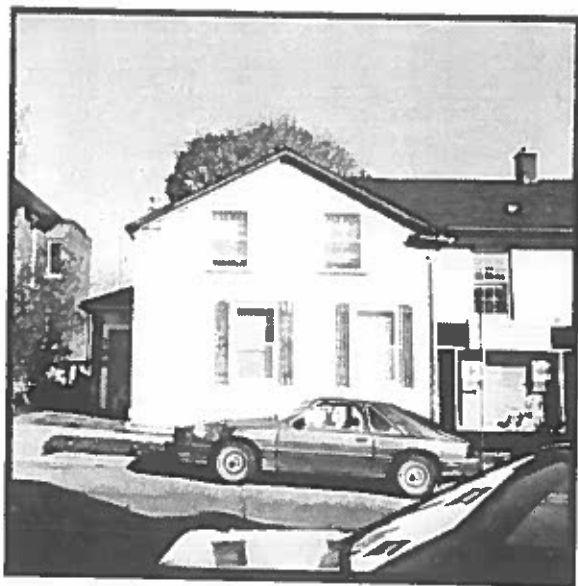
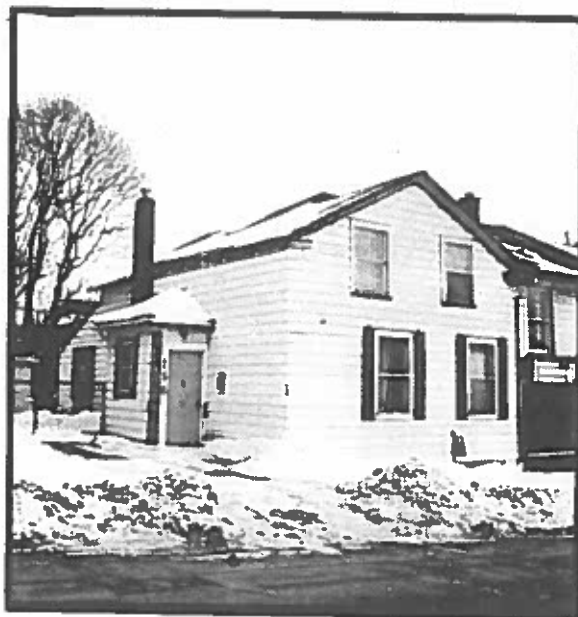
This appears here as an end to the house group noted as Blocks 44 and 46 and may well be part of a single composition. However the floor levels obviously differ to accommodate the increasing slope of the street. The entrance is at the west side protected by a vestibule.

The finish is a synthetic siding (aluminum). Window sash have been changed and were likely six-over-six originally. A small side yard occurs to the west, treated with a single-storey lean-to.

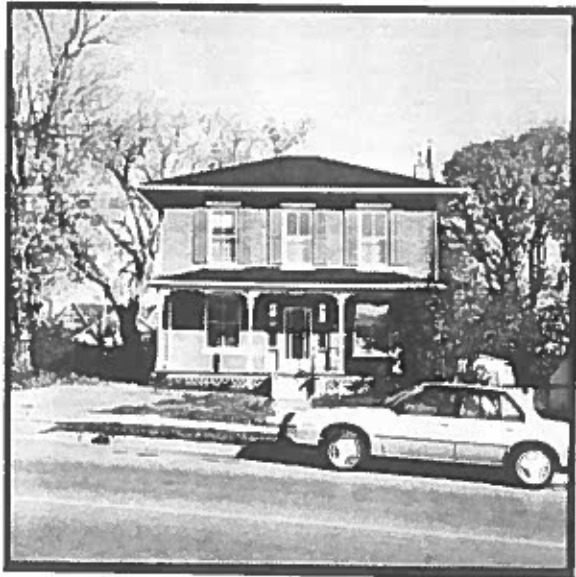
The larger front windows below and handsome broad entrance, a recessed doorcase with sidelights and transom, would seem to indicate this building to have started out as a single-storey Ontario cottage, but the brickwork is stretcher bond both below and above the front verandah. The house had end chimneys. A rear extension projects towards the east.

A parking space is provided on the west side of the lot and a small yard, inaccessible to a vehicle, occurs behind.

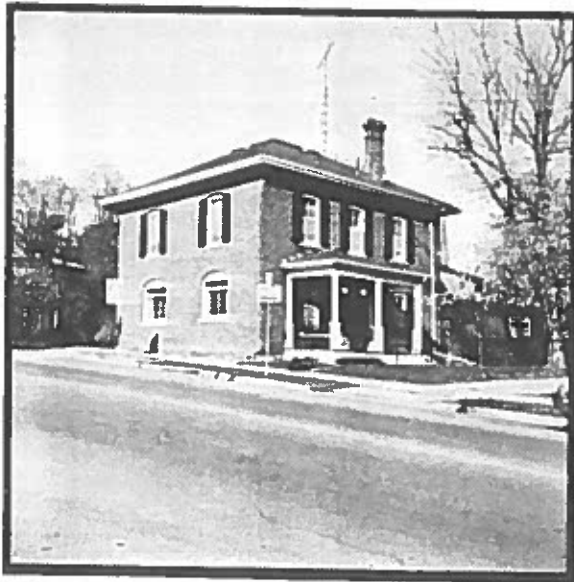
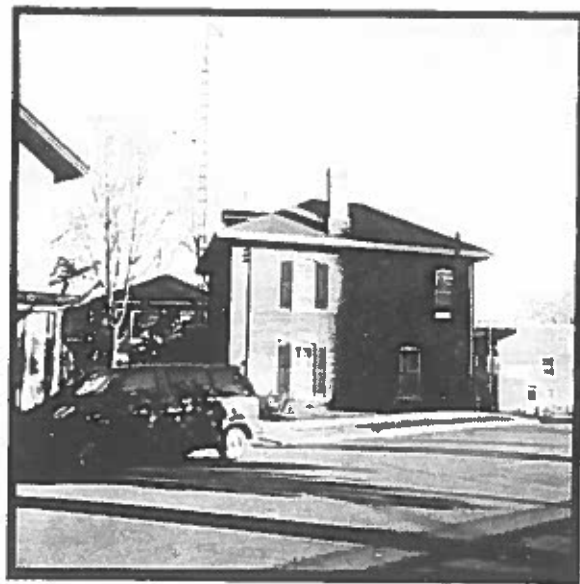
The house forms the corner piece to the Walton Street Heritage Conservation District marking the north-east angle of the Pine Street North intersection. It is a typical Port Hope house form with entrance front turned internally to face down Walton and protected by a porch extending from the corner two thirds across the east front. The house is roughly square with chimneys at east and west ends, the former the entrance "front". Ground floor windows facing Walton are wider and elliptically headed with transom partly filled in, probably to fit a storm sash. A continuous vertical joint occurs in the ground floor masonry midway along the Walton Street front and just to the right of the south (or right) window on the Pine Street side which seems to indicate a recessed entrance with umbrage originally, or, remotely, provision for a storefront at this prominent corner. Perhaps the entrance proved impractical and the elliptical windows were added c. 1900 at the time this was filled in and the main entrance changed to the east side. The building's alignment with Walton places it askew to Pine North where the corner is obtuse so that a curious effect is created when looking north along Pine.

The house has a small lean-to and tight yard behind.

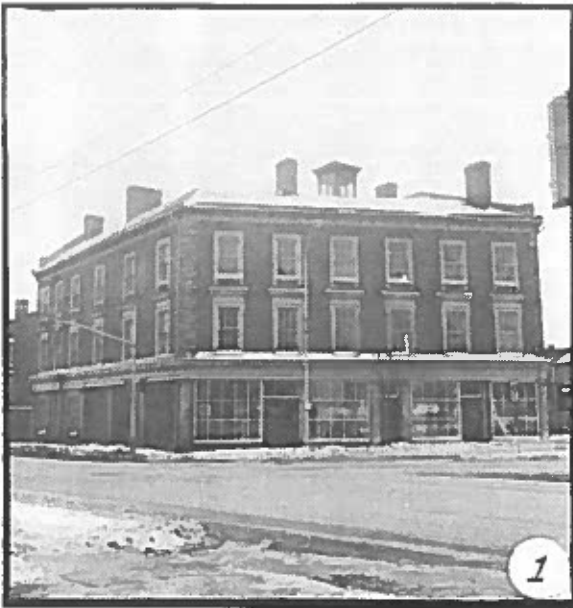
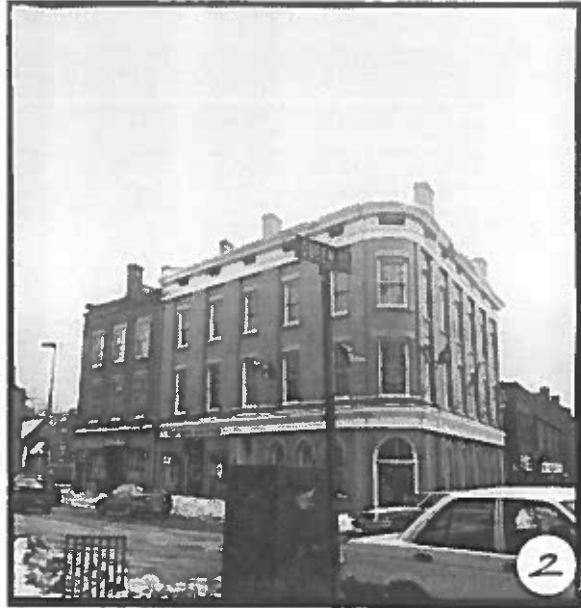
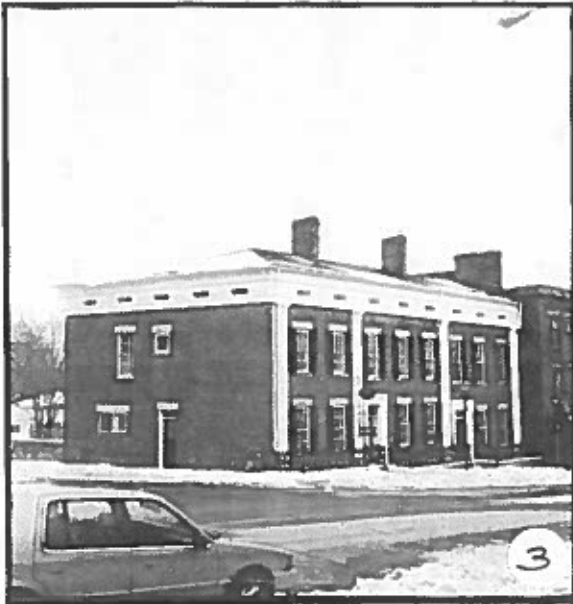
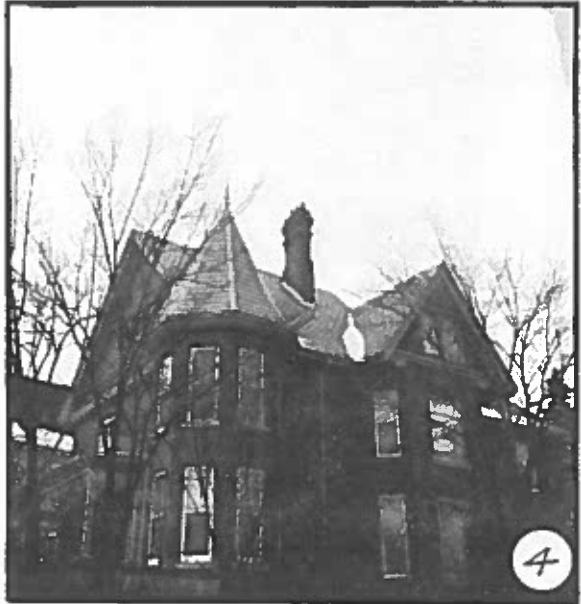
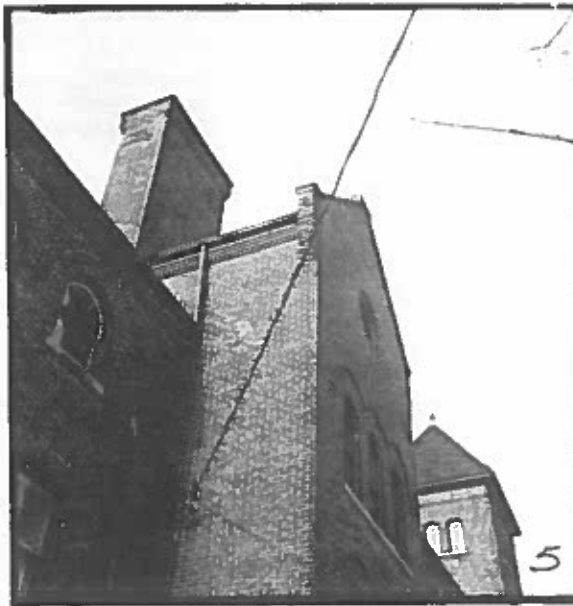
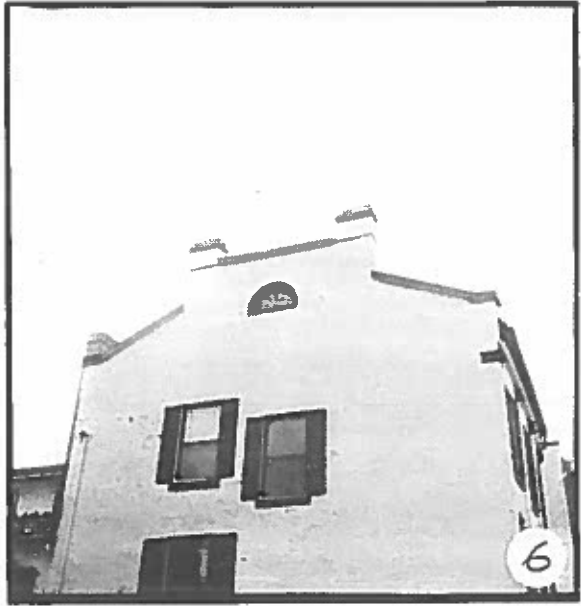
1. View of six of seven handsome chimneys all restored to Block 1.
2. Chimneys of Block 9, also restored, as those in the adjoining Block 7 beyond where the stacks now serve as vents.
3. Dignified chimneys to Block 36, with another stack adjoining to Block 34 beyond.
4. Elaborate stack of Block 30, the final feather to this highly decorative silhouette.
5. Monumental stack towards rear of St. Paul's Presbyterian Church, Block 51, an unforgettable incident in that building's complex outline.
6. Twin chimneys springing from the east parapet of Block 55.

Chimneys are an essential decorative and formerly functional element of any building's silhouette. They received as much care in their architectural design as other features and their loss always leaves the building without the proper "feather" to its cap. Albeit fireplaces and stoves have been superseded for heating, nevertheless chimneys can still serve as vents, to hide unsightly plumbing stacks or heating flues or as ventilators to attic spaces.

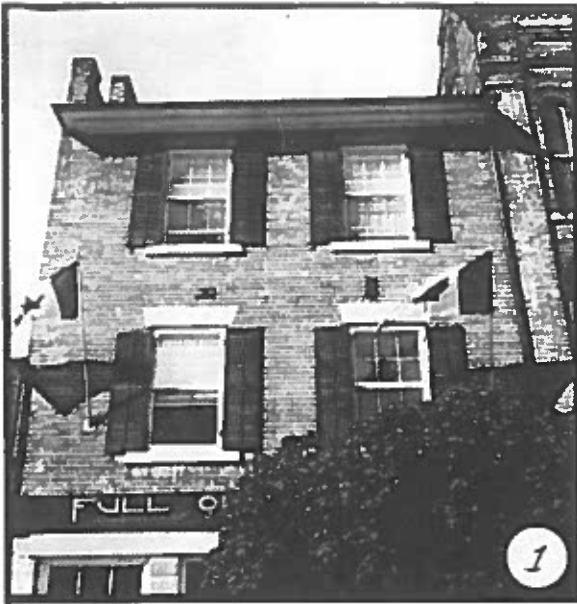
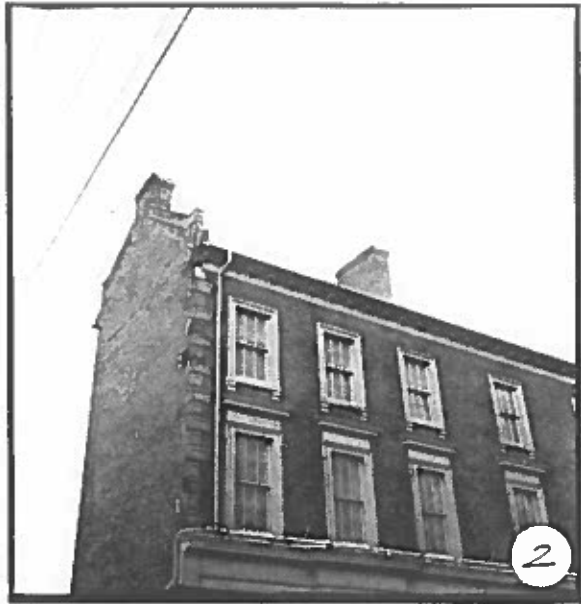
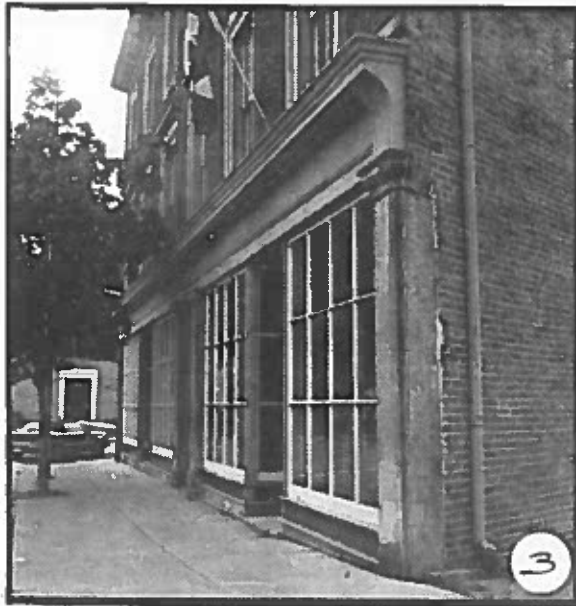
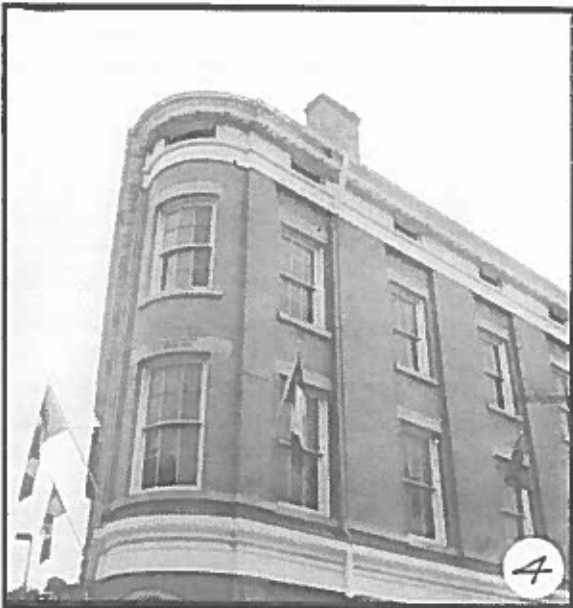
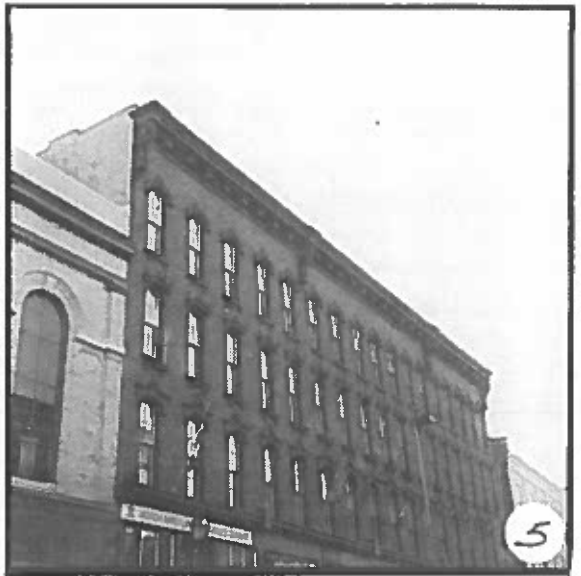
1. Simple eaves cornice to Block 28, a building of c. 1841.
2. Bracketed eaves cornice of Block 1, built in 1845 and heralding later developments of the Italianate.
3. Restored shopfront cornice to Block 1.
4. Strong Greek Revival cornice to Block 9 also built in 1845. The "stomacher" windows in the frieze are "blind" openings, the glass reverse-painted in dark green.
5. Bold cornice to the St. Lawrence Hotel of c. 1853, by Mervin Austin, the grandly scaled and highly ornamental main brackets with large modillions between.

Ornamental treatment of cornices comprises a frieze or lower vertical member forming a band at the top of the wall, a bedmould between this and the soffit or horizontal overhang and an edge or fascia sometimes with a crown mould, but often replaced by an attached eavestrough where the gutter is not a built-in feature. Intermediate bracket devices, in the shape of consoles, modillions, mutules or other forms, sometimes interrupt the bed mould.

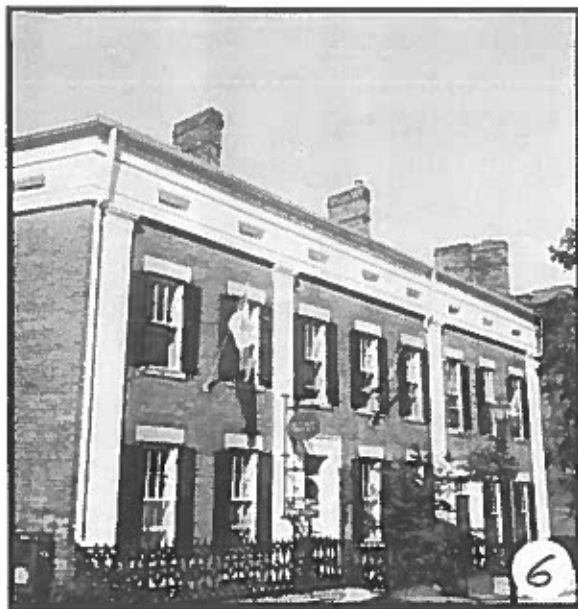
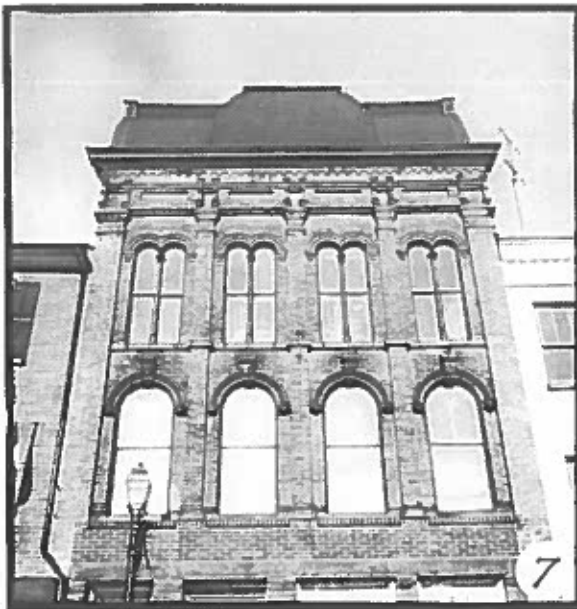
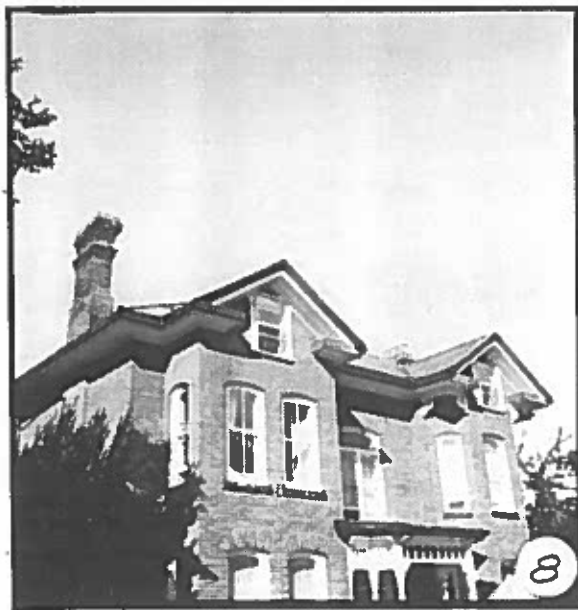
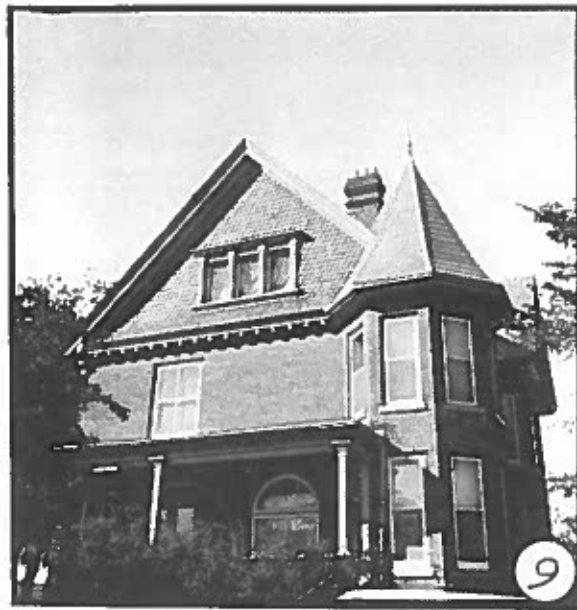
Cornices contd.

6. Greek Revival cornice of Block 36 with "stomacher" windows in the deep frieze detail.
7. Capitals and band courses lead up to eaves cornice of Block 26.
8. Gable details with eaves returns on Block 38. The original chimney too, is noteworthy.
9. Pediment, tile-clad, with bracketed lower cornice and plainer raking cornices to gable on Block 30.

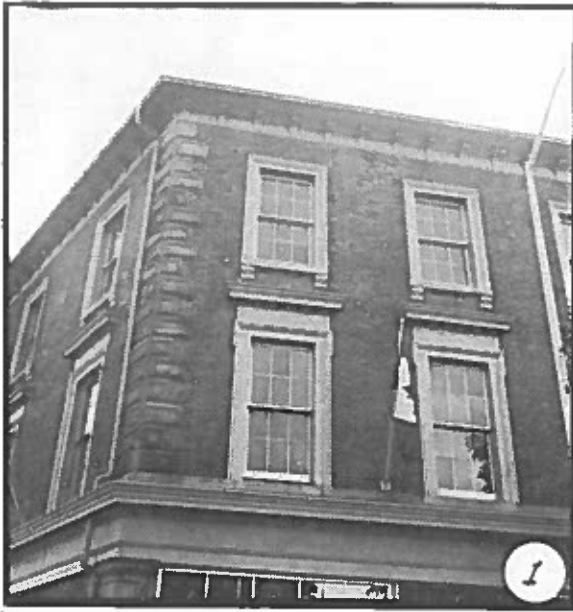
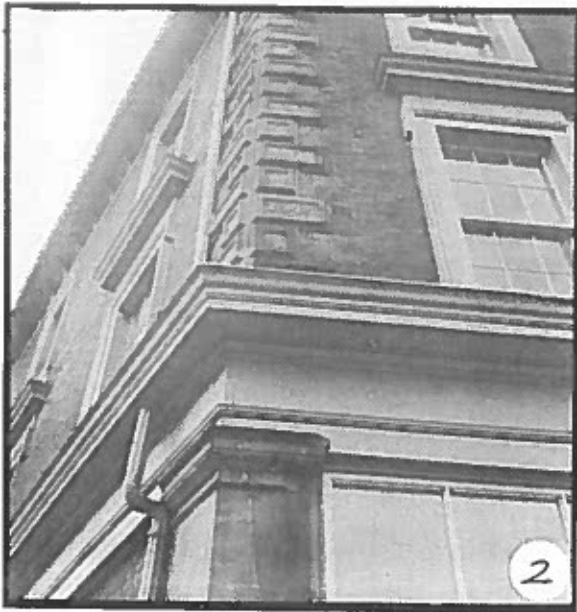
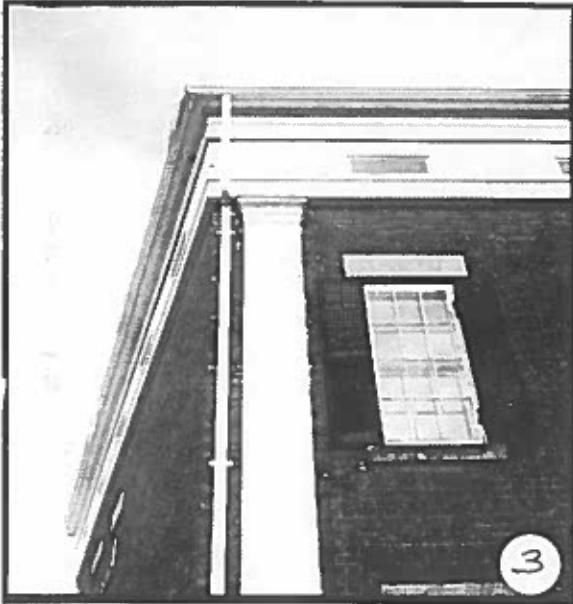
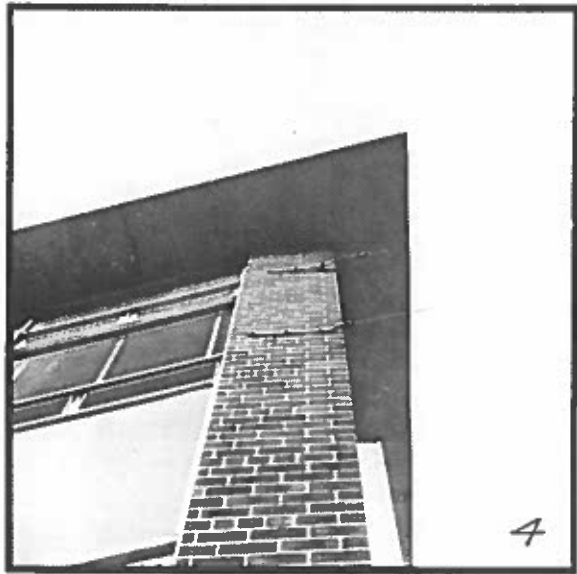
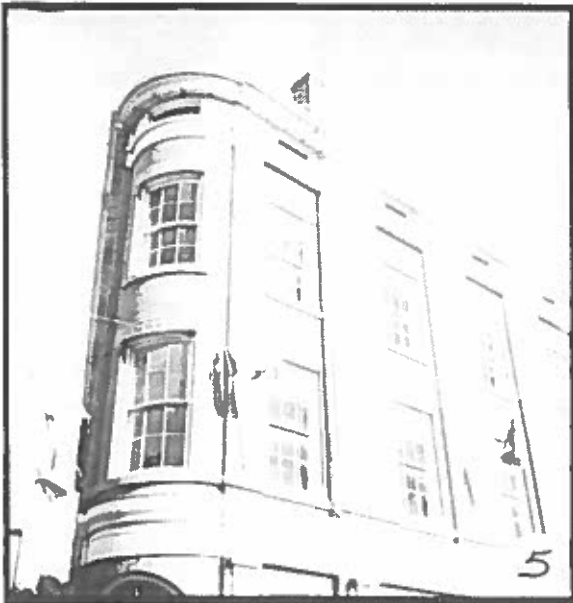
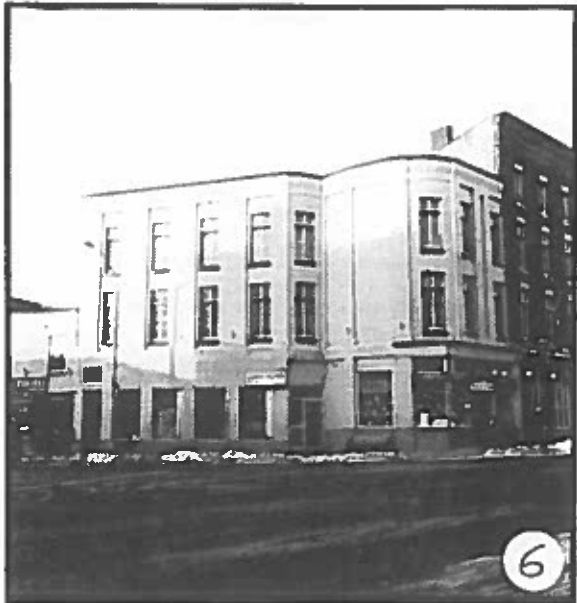
CORNER TREATMENTS

1. Block 1 with shaped decorative stone quoins to the obtuse-angled south-west corner of Walton and Mill Streets.
2. The 1845 datestone worked into the corner of Block 1.
3. Shaped corner bricks forming the obtuse angle of Block 36 at Brown Street.
4. A strange modern relapse in Block 14 where no decorative advantage was taken of this acute-angled opportunity: a misadventure to be neither condoned nor repeated.
5. The rounded corner of Block 9, also dated 1845, to the acute-angled south-west corner of Walton and Queen Streets.
6. Its generously rounded counterpart in Block 11 to accommodate the obtuse-angled south-west corner of Queen.

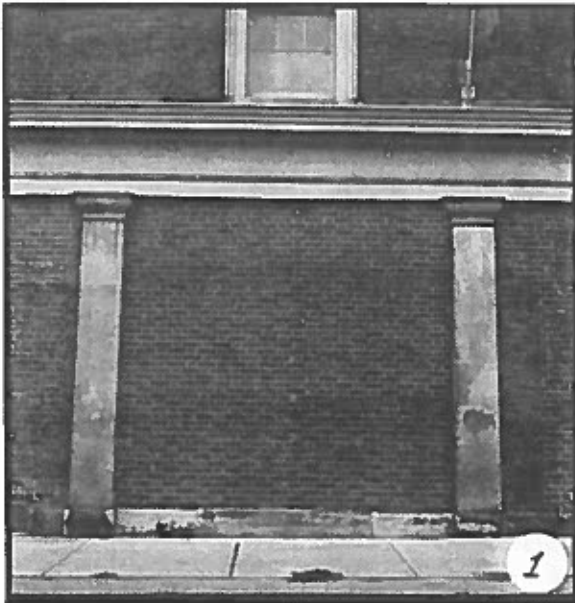
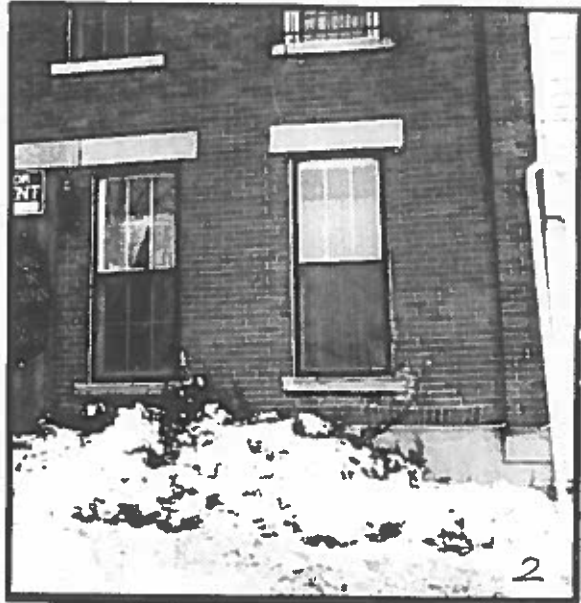
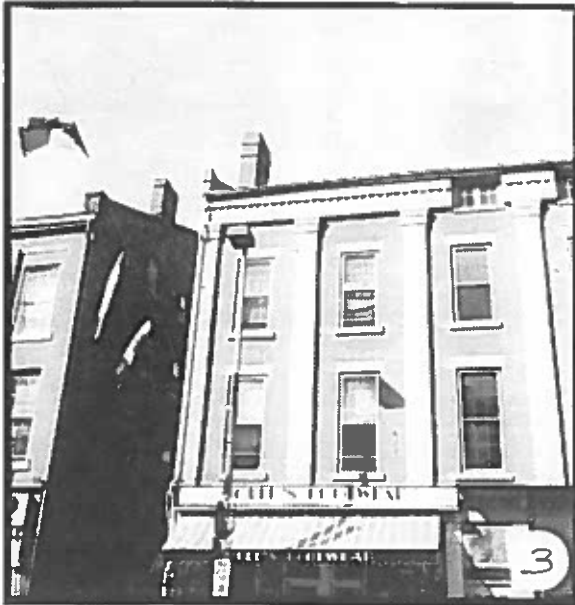
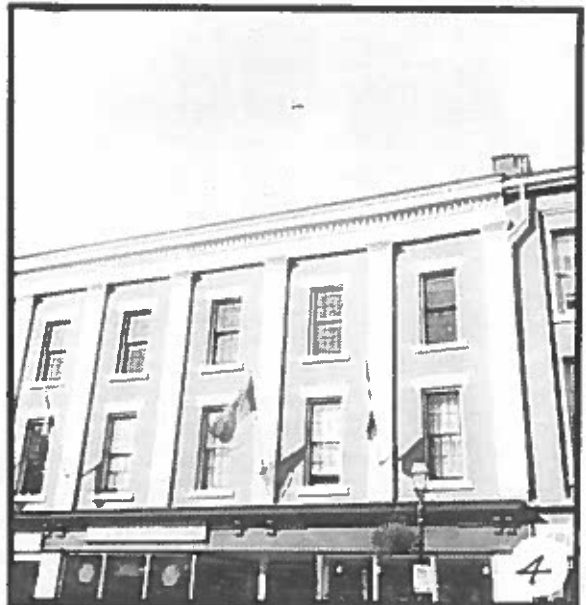
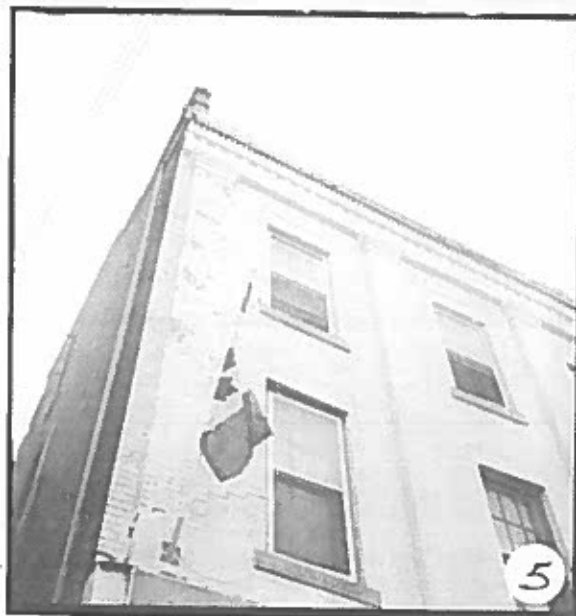
1. Fine Flemish bond brickwork framed with stone pilasters in lower on Mill Street front of Block 1.
2. Stretcher bond masonry of Block 34 executed in smooth-faced orange-red brick, reputed to have been imported from Oswego, N.Y., and laid with fine joint. Note signs of settlement at corner of building.
3. Pilastered design of Block 4 with decorative frieze above, a building said to have been designed by Mervin Austin, architect of Port Hope's Town Hall of 1851.
4. Block 8, a similar treatment of the façade rescued from the devastating fire of 1980 which resulted in a new structure behind.
5. Block 37, another version of the pilastered design of the 1840s and 50s.

Brickwork is one of Port Hope's great specialities, the tradition of fine bricklaying in elaborate patterning a most noteworthy aspect of its dignified and formal main street buildings. This continues into residential building too, but later examples tend to be more simply treated. The ornateness of Block 26 and St. Paul's Presbyterian Church (Block 51), confirms a tradition which starts with finely executed bond patterns and branching out to encompass pilaster treatments and the elaboration of cornices, friezes, band courses and window labels.

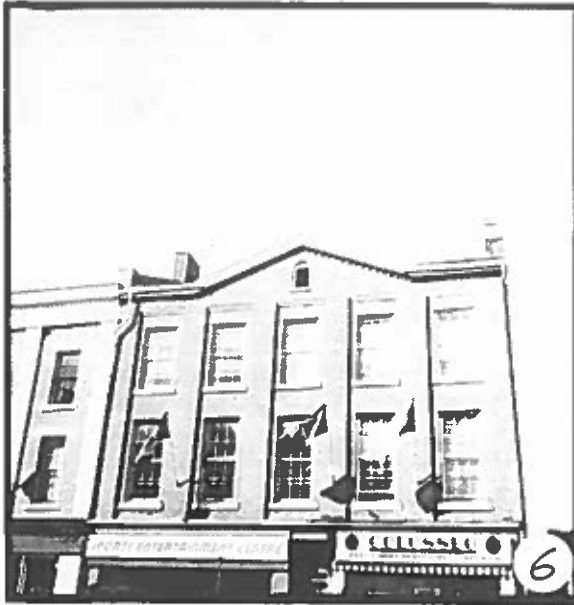
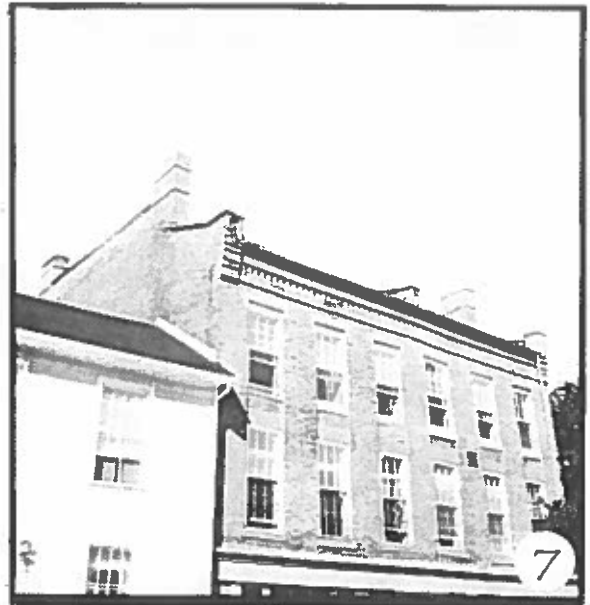
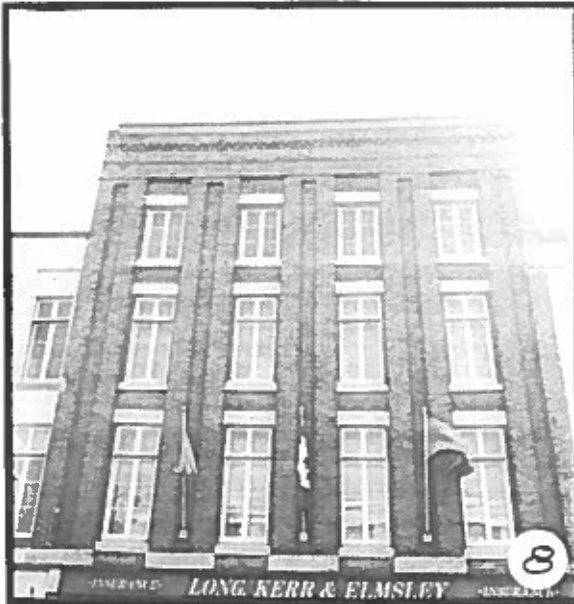
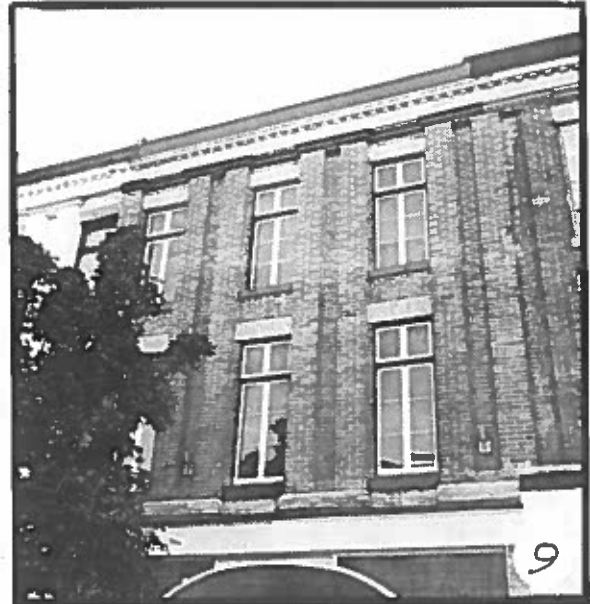
Brickwork continued

6. Block 6, the pier-and-panel design of the former American Hotel of c. 1844, the focal point of Queen Street.
7. Block 40, a tighter pier-and-panel design in a commercial type building in the Transitional Residential Sector. The ornamental brick frieze and corner corbelling are noteworthy.
8. Double pilaster design of Block 13.
9. Detail of restored upper front of Block 15, Section (b) illustrating a two-storey version of the double pilaster design with "white" brick relief in arches and frieze.

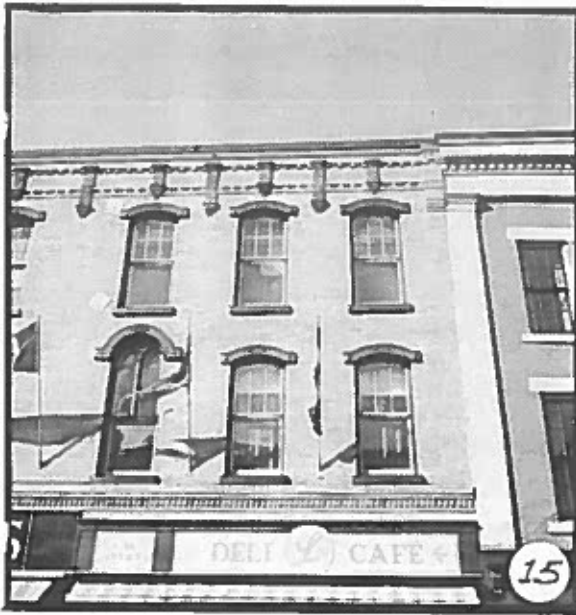
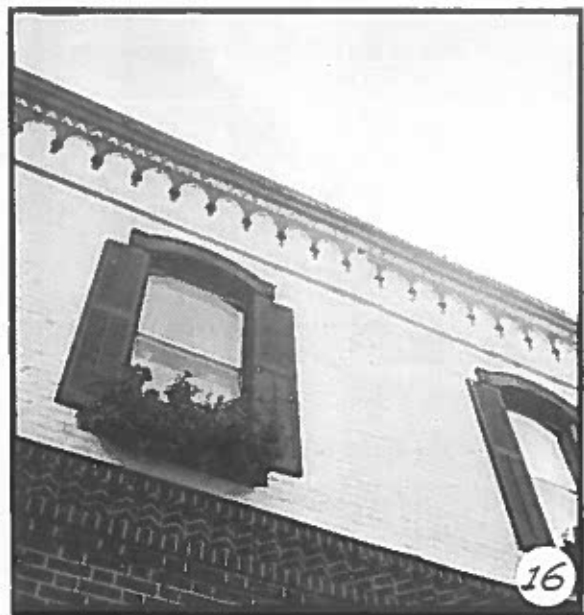
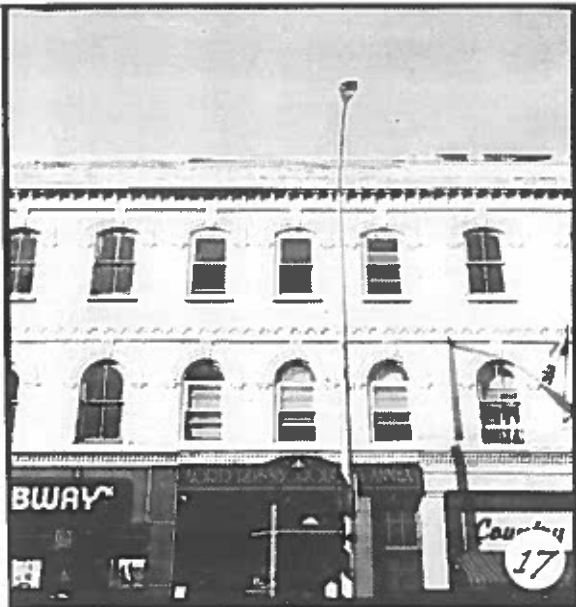
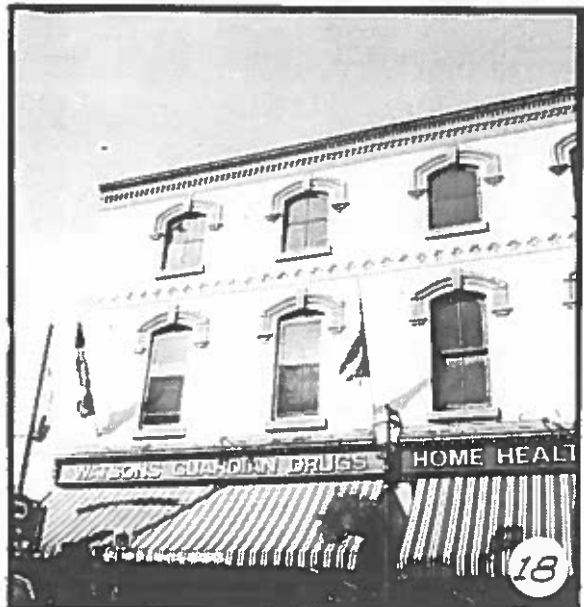
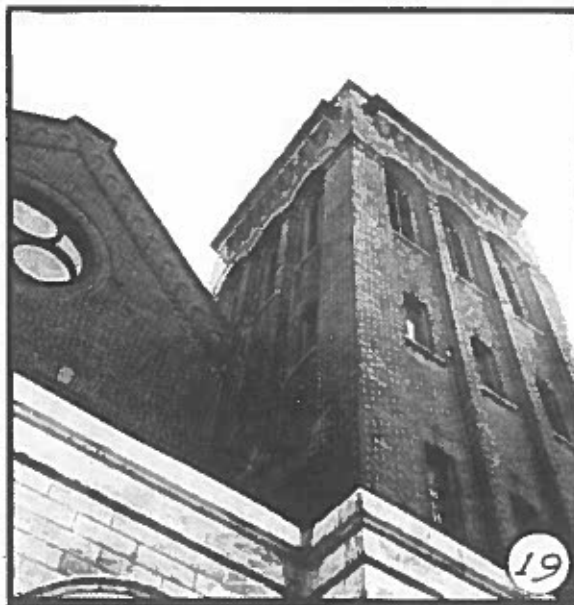
Brickwork continued

15. Plain wall with brick bracketed frieze in Block 10.
16. Bracketed detail of Block 53 showing connection between sections.
17. Ornamental horizontal banding, cornice and parapet, and labels to windows of Quinlan Block (18) of 1867.
18. Horizontal banding, labels to windows and decorative frieze to Block 12 of the late 1860s or early 1870s.
19. Fine decorative brickwork of west tower to 1906 St. Paul's Presbyterian Church, Block 51.
