The TOWN of PORT HOPE
WALTON STREET
HERITAGE CONSERVATION
DISTRICT PLAN

WALTON STREET
HERITAGE CONSERVATION DISTRICT
PLAN

Prepared for the
LOCAL ARCHITECTURAL
CONSERVATION ADVISORY COMMITTEE

of the
TOWN OF PORT HOPE,
Ontario

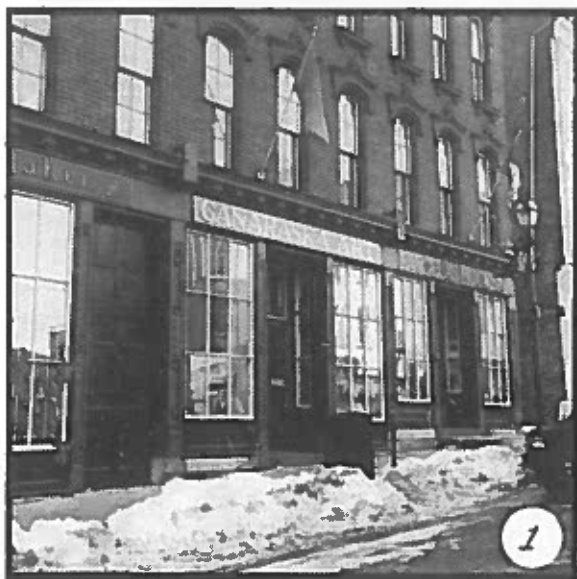
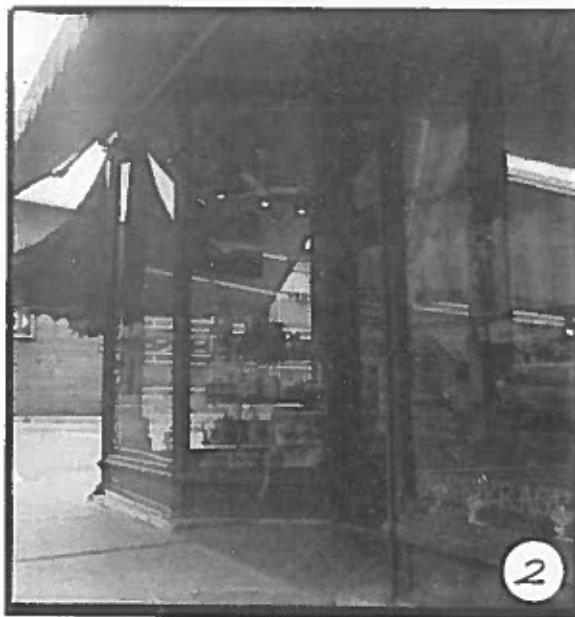
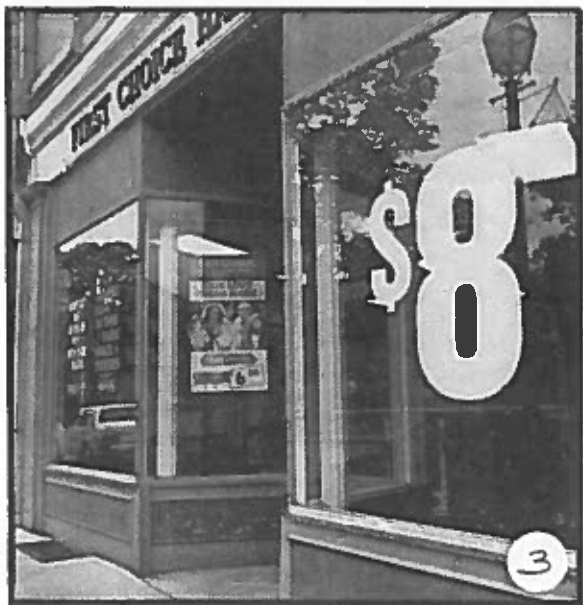
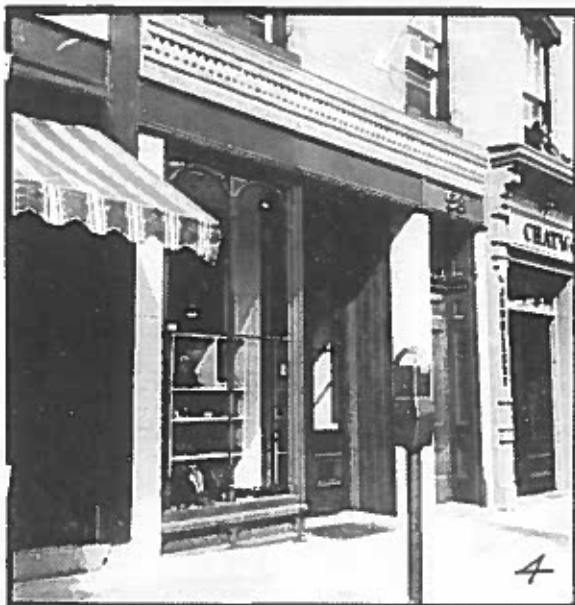
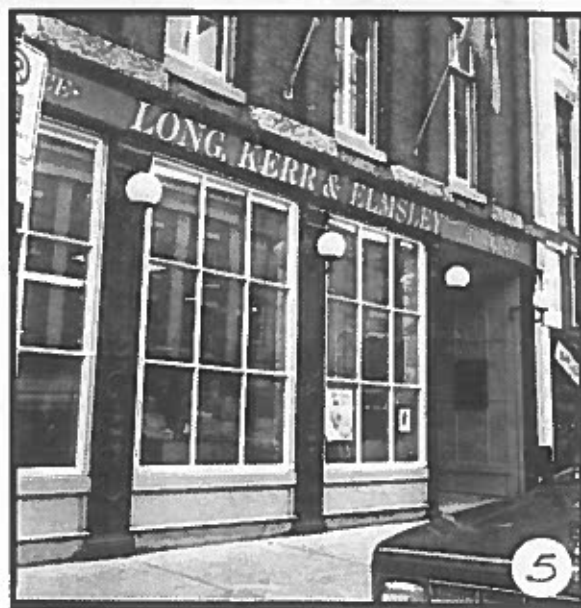
CAST IRON

1. Shopfronts of Block 35, the St. Lawrence Hotel, reputedly designed by Mervin Austin, the Rochester, N.Y., architect responsible for the 1851 Town Hall and Block 4, showing ornamental cast iron fronts to cross walls and intermediate columns to shopfronts.
2. Decorative cast iron supports incorporated into corners of windows in Block 12, Section (d).
3. Intermediate fluted columns inside later shopfront to Block 9, Section (a). The highly decorative neo-Classic capitals are hidden by the modern dropped ceiling.
4. Cast iron intermediate support to corner of window in Block 10, Section (e).
5. Recycled decorative cast iron facings in Block 13 salvaged from the demolished Sculthorpe Building on the site of Block 39.

Cast iron was used both structurally and decoratively in Port Hope where Helm's Foundry was a thriving industry at the time of the town's greatest building boom. The patterns in some cases may have originated elsewhere, design copyright was unknown at the time and recasting from imported material seems to have been a common practice.

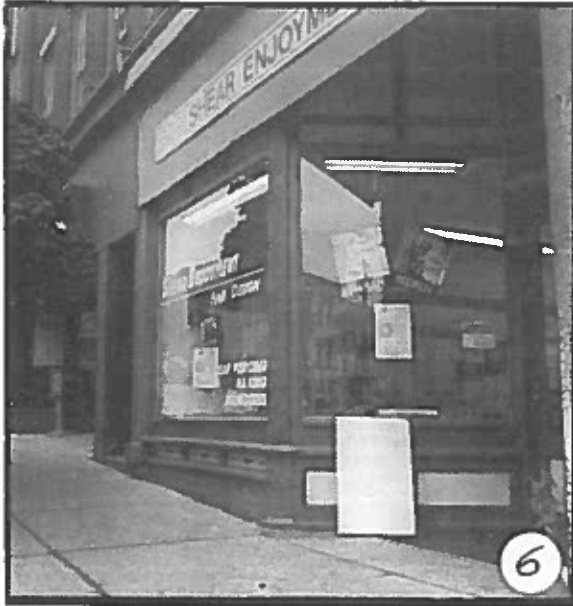
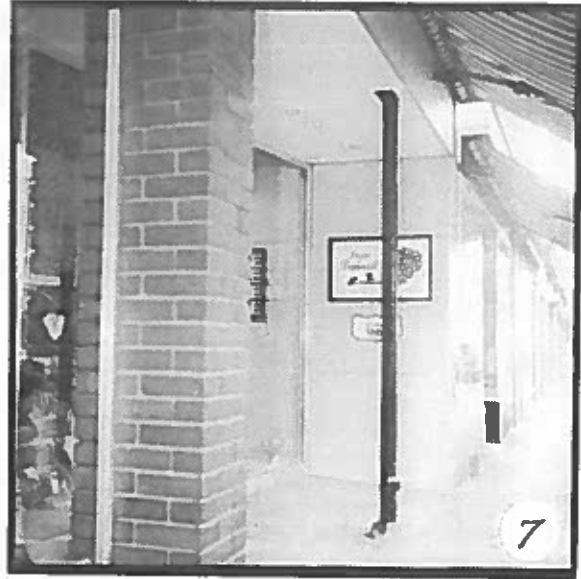
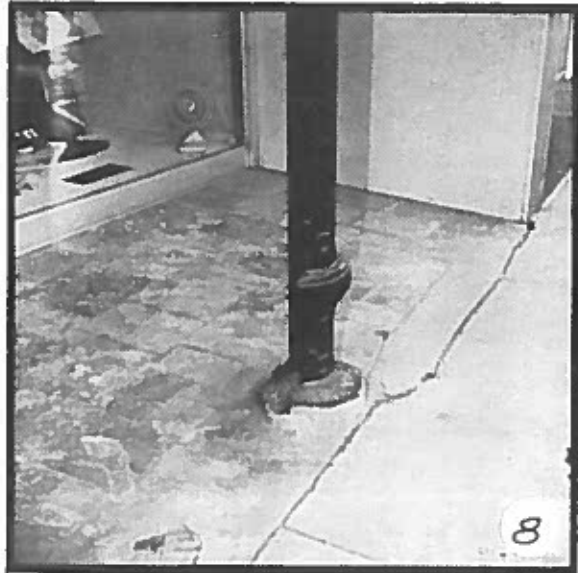
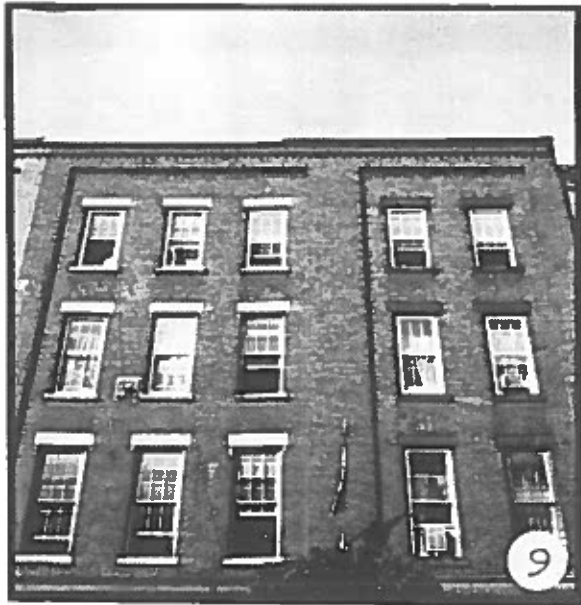
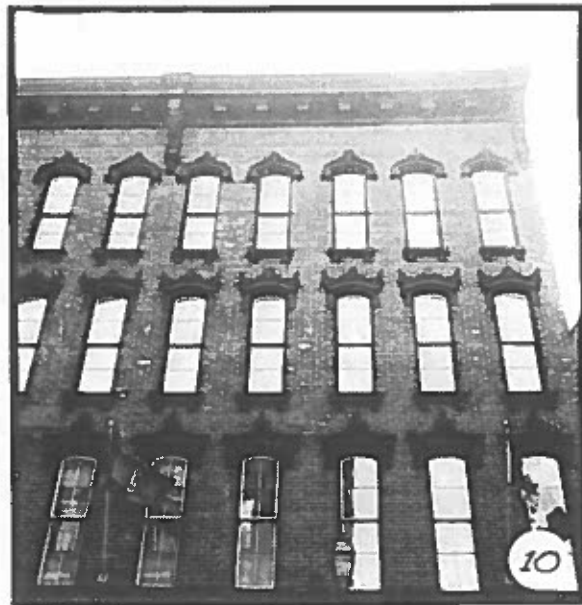
Cast Iron continued

6. Cast iron intermediate column support in corner of window to Block 22, Section (a).
7. Cast iron intermediate support left exposed and seemingly vulnerable in recessed shopfront modernization of Section (C) of Block 10.
8. Base of column shown in (7) showing material support at its minimum.
9. Cast iron, both structural and decorative; window lintels and sills of Block 22, a detail also used in slightly later Block 20 next door to east.
10. Decorative labels to the St. Lawrence Hotel by Mervin Austin, Architect. Pendant ornament below side brackets has been removed, for safety reasons.

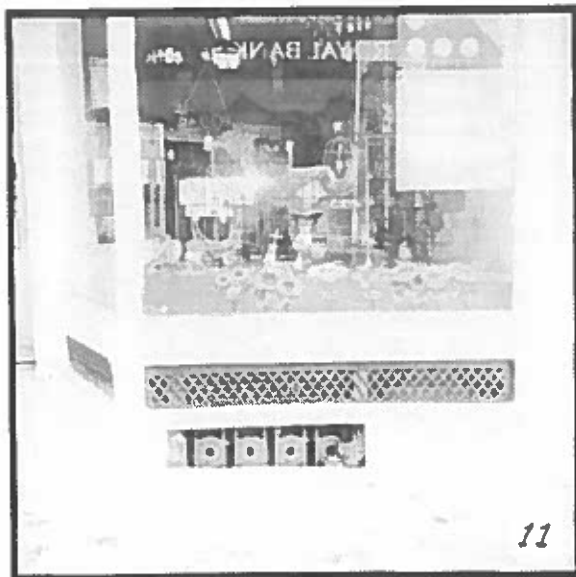
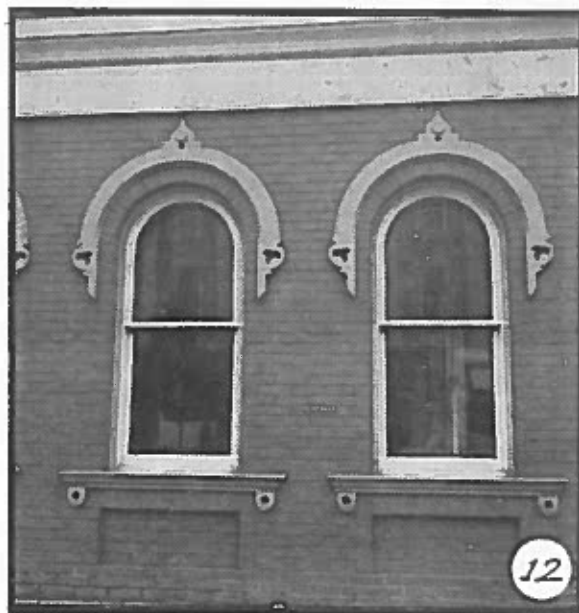
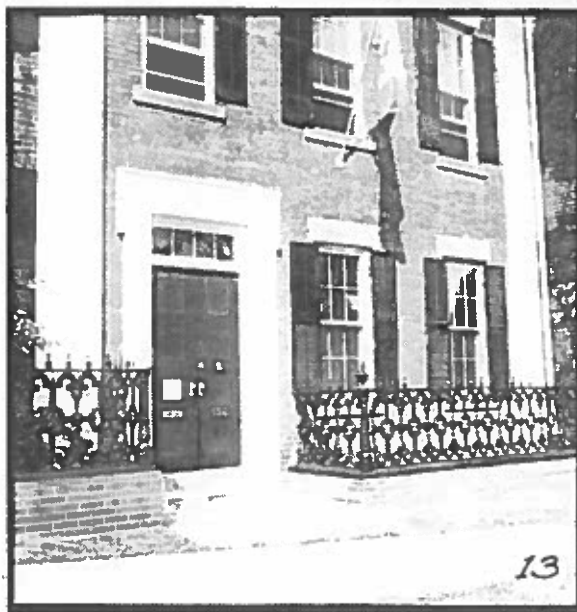
Cast Iron continued

11. Decorative cast iron grilles in spandrel of shopfront and to basement opening below in Block 18, Section (d).
12. Decorative cast iron labels created for "new" front following the detail of a later alteration to Block 9, Section (b) with outline copied from visual evidence left of this 1870s renovation to the 1845 Gillett Block. The labels likely had decorative mouldings like those on the second floor windows of Block 26, but this three-dimensional detail could not be ascertained.
13. Decorative cast iron fencing enclosing front areaways of Block 36.

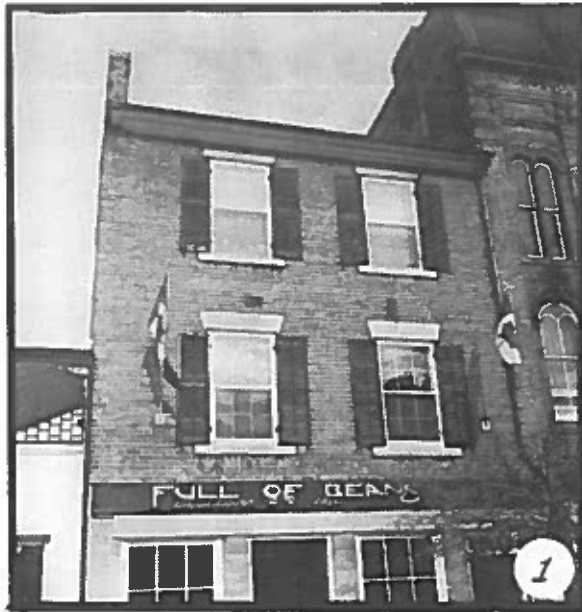
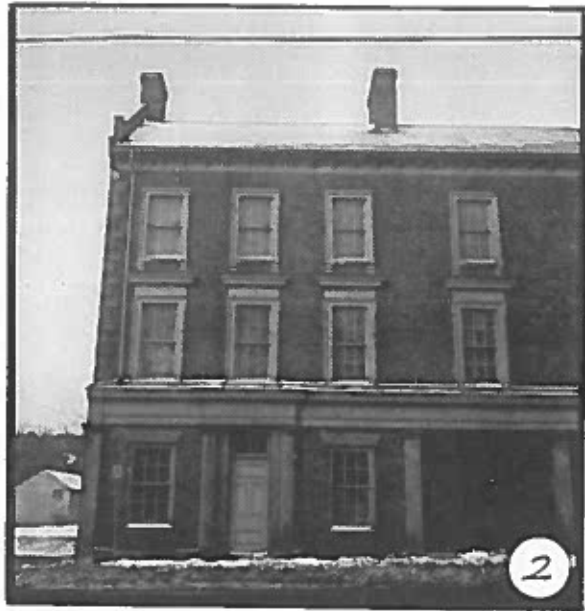
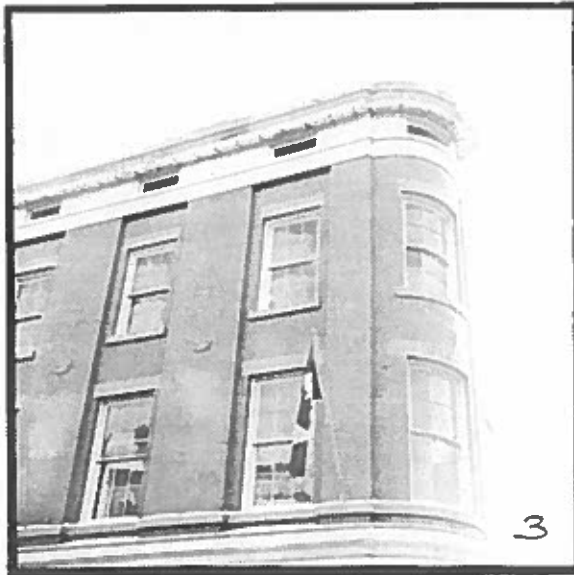
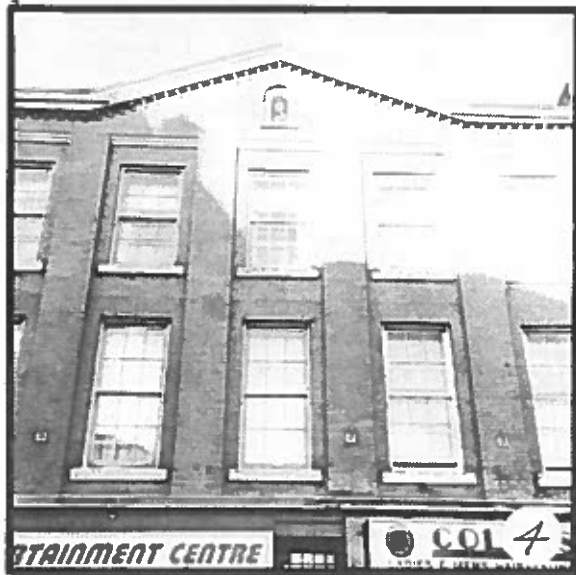
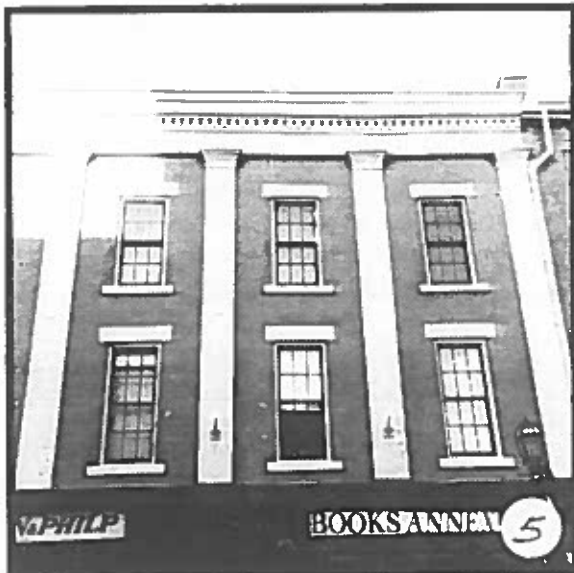
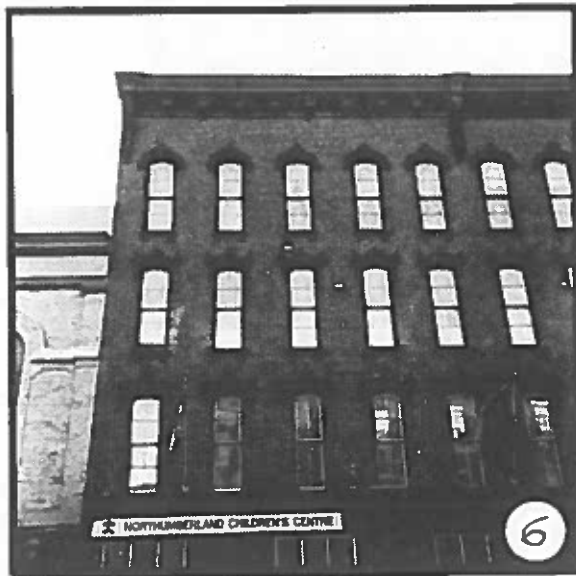
WINDOWS

1. Simple six-over-six sash from c. 1841 in Block 28.
2. Elaborately treated window openings of Block 1 of 1845, similar to those restored in Block 7.
3. Restored windows of Gillett Block (9) of 1845 using heat-treated glass of inferior quality reserved for greenhouses to achieve the mirror effect of older glazing and curved sash with faceted glazing.
4. Early sash in Block 6, the former American Hotel.
5. Restored windows to Walton Street front of Block 8; some second storey openings had been modernized to provide upper show windows.
6. Windows of Block 35 of c. 1853, the St. Lawrence Hotel, decreasing in height as well as in the elaboration of hood moulds or cast iron labels in succeeding upper storeys, with tall narrow shape of the Italianate.

Windows are a prominent feature of buildings and fortunately most have remained intact in the District. However there is increasing erosion by modern substitutions which do not follow original detail, often accomplished in only one section of a block so that the unity and integrity of its design are seriously compromised. Many original sash, often divided into many panes, are now over a century old, their survival attesting to their superior material and construction. Rather than outright replacement conservation is economically possible while achieving improvement simultaneously with more efficient weatherstripping. Wood is still superior thermally. Old glass, distorted and with blemishes, creates an unmistakable mirror effect adding livelines to the façade.

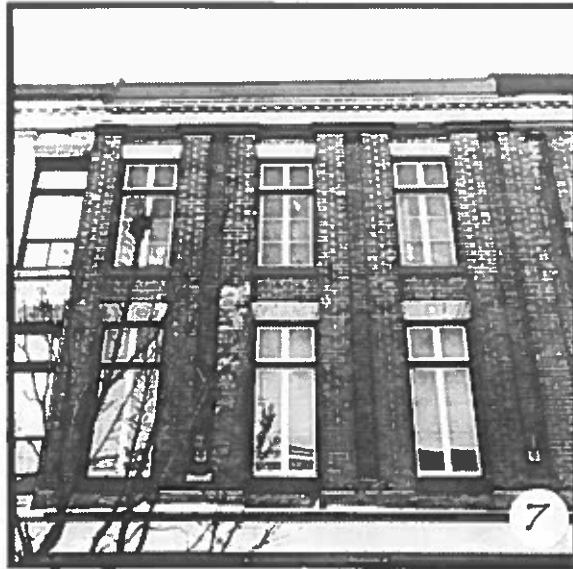
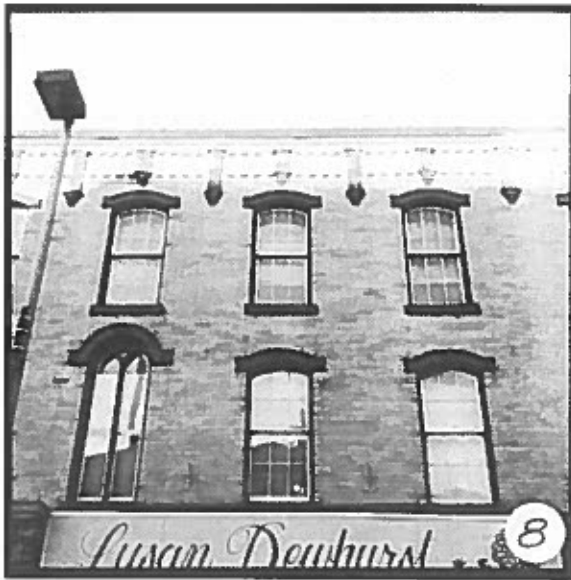
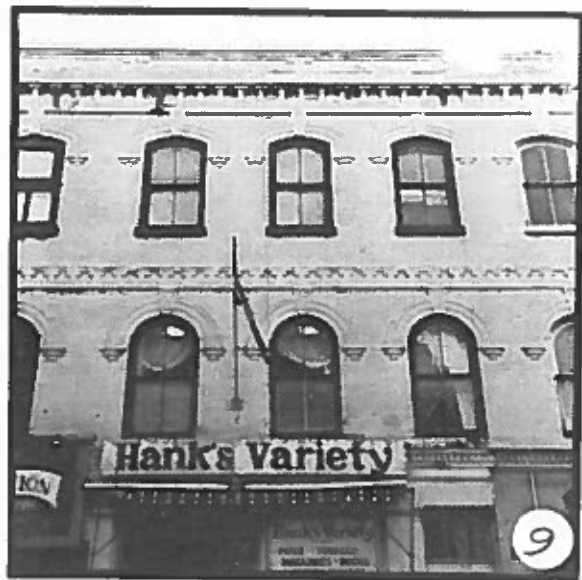
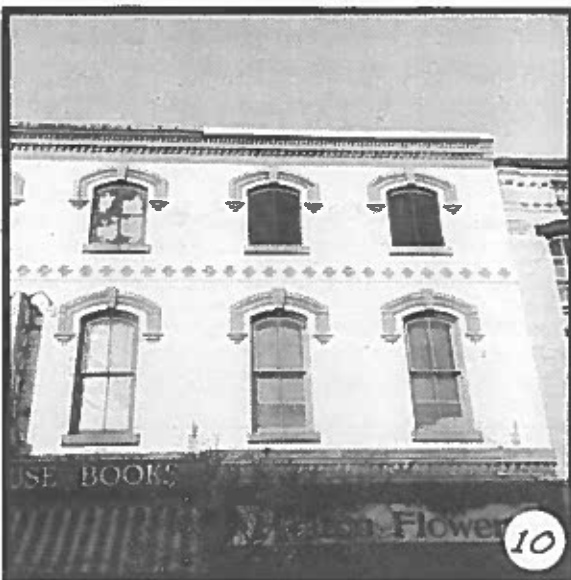
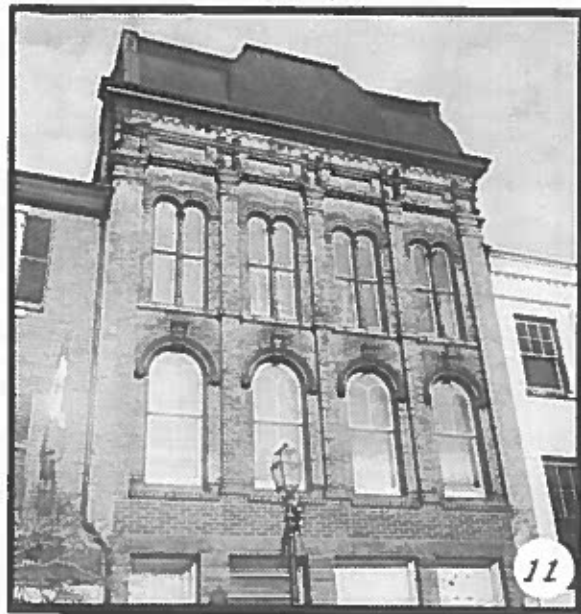
Windows continued

7. Curious windows of casement design operating as double-hung sash, shown in restored front of Section (b) to Block 15, but common to twin-pilastered buildings, Blocks 11 and 13 also.
8. Six-over-six windows with segmental heads in Block 10, with specially shaped window, reminiscent of Gothic Revival, in stair hall of second storey.
9. Upper windows in Block 18, the Quinlan Block of 1867.
10. Segmentally-headed windows with labels and original two-over-two sash in Block 12, interesting because third-storey has back-painted "blind" windows to roof space, all for the cause of good architectural manners.
11. Late Italianate variations in upper windows of Block 26.

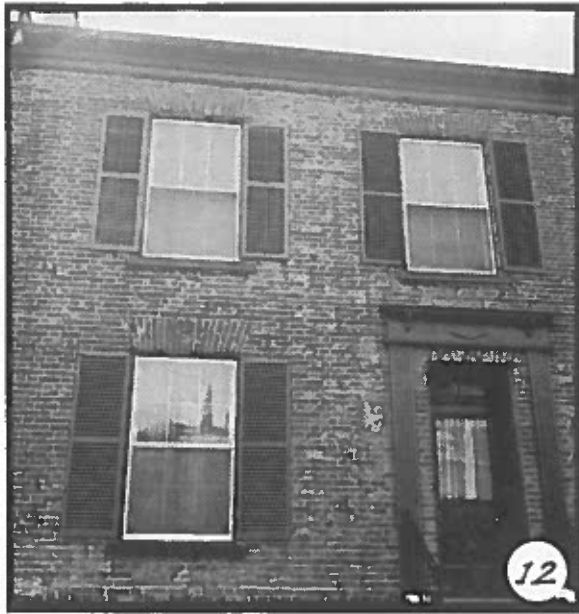
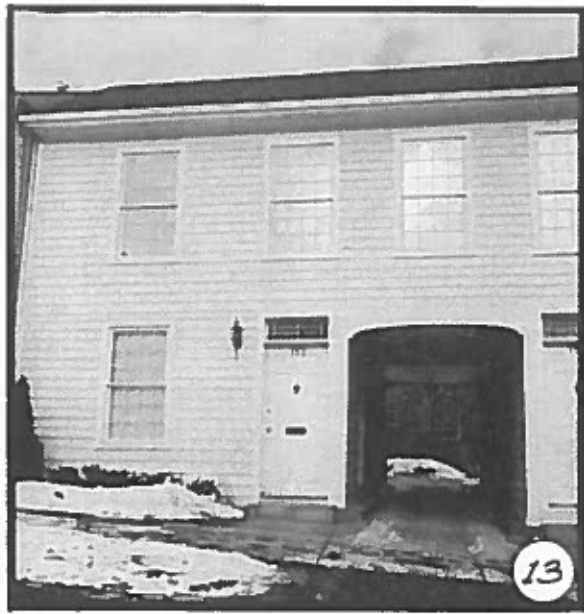
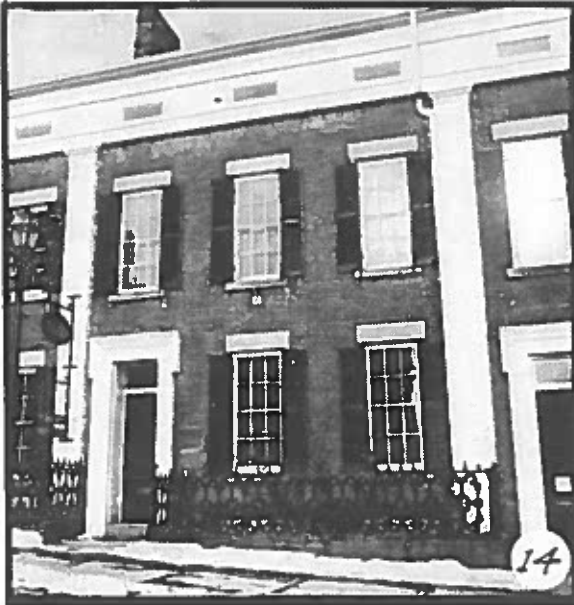
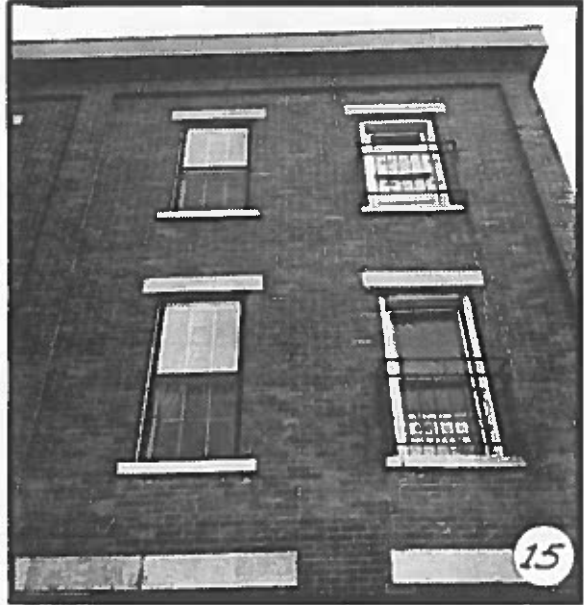
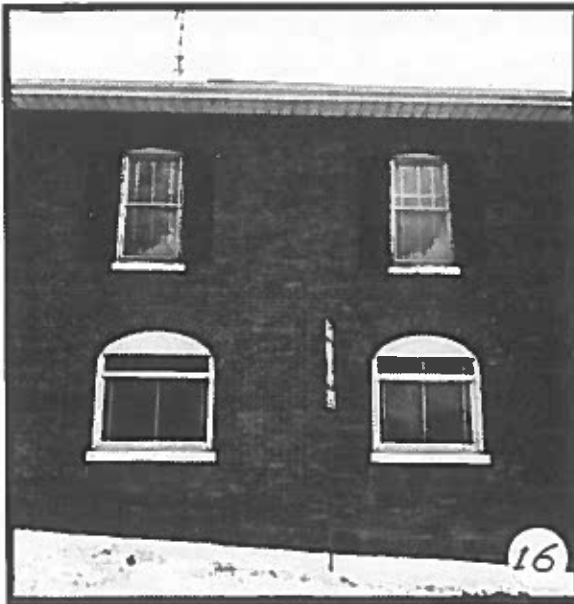
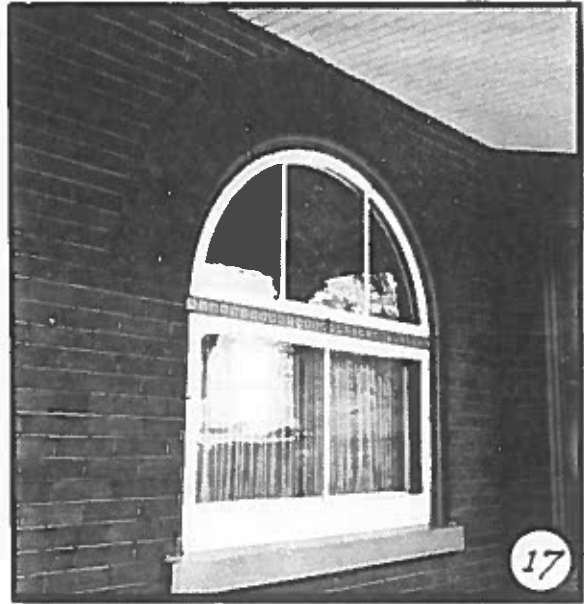
Windows continued

12. Early divided sash in Block 57 at south-east corner of Pine. The doorcase is a modern appendage in the traditional manner.
13. Twenty-four paned windows restored to Block 42.
14. Tall, narrow windows of the Greek Revival in Block 36.
15. Original six-over-six sash in Block 34, with less fortunate modernization alongside.
16. Windows to Block 52 at the north-east corner of Pine, showing segmental heads to upper openings with lower more elaborately treated wide elliptically-headed windows with most of the transoms sadly blotted out of view by infilling to accommodate modern storm sash.
17. Elaborate front window of Block 30 with transom filled with highly ornamental glazing with leaded, bevelled and stained glass.

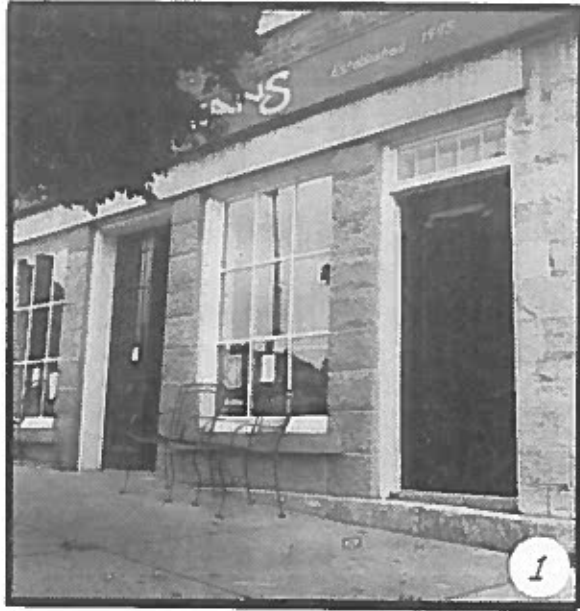
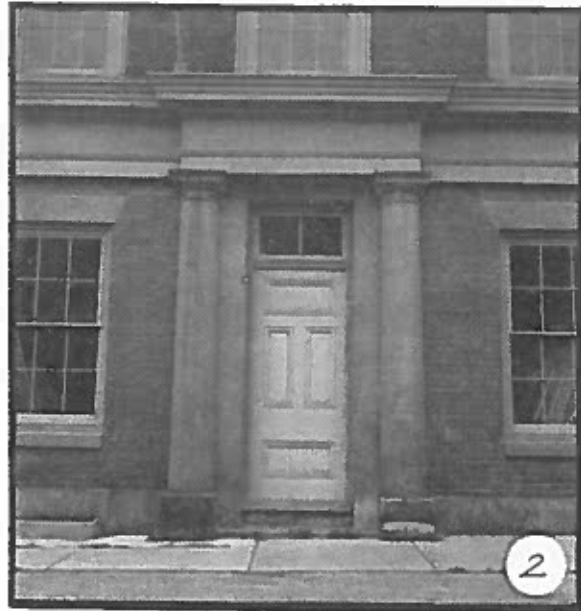
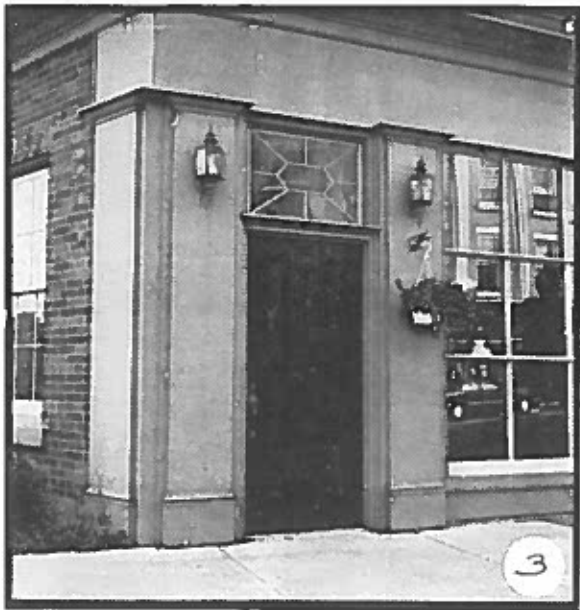
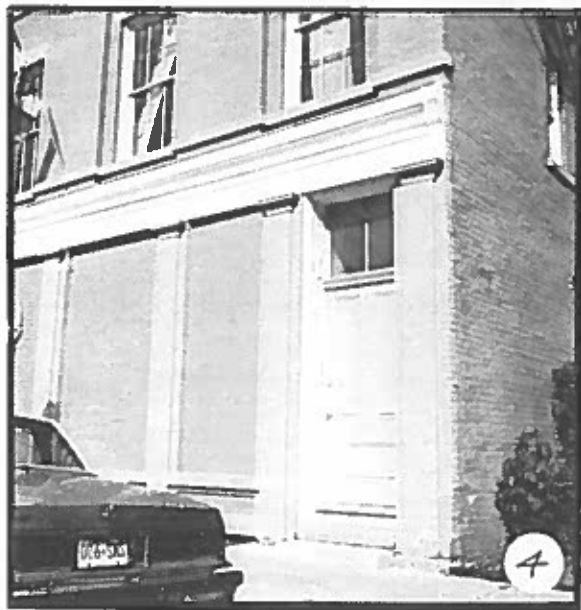
ENTRANCES

1. Doorways of Block 28, c. 1841, that to shopfront with divided glazing original and replaced in restoration, that to side entrance, of single-panel design, restored later.
2. Mill Street entrance to Block 1, handsomely devised with attached columns and entablature to enclosing doorcase.
3. Two-panel design with ornamental transom to side entrance of rebuilt front to Block 7.
4. Queen Street side entrance to upper floors of Block 9 of 1845.

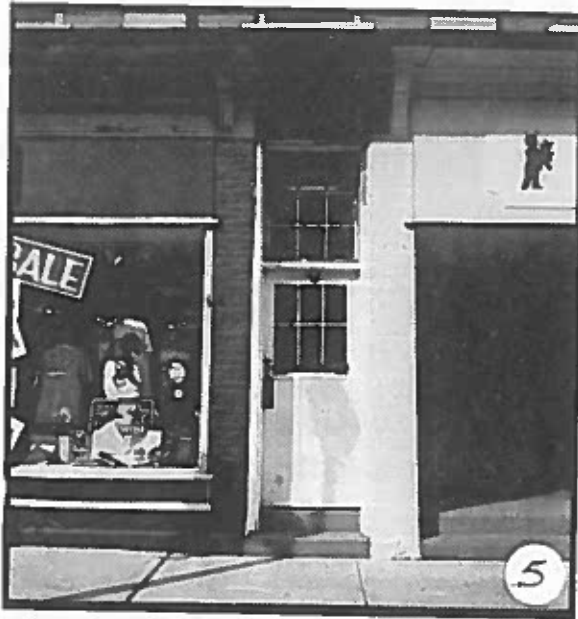
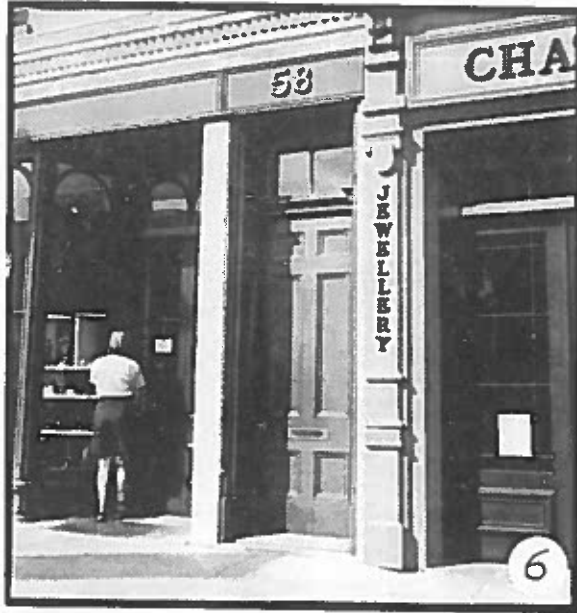
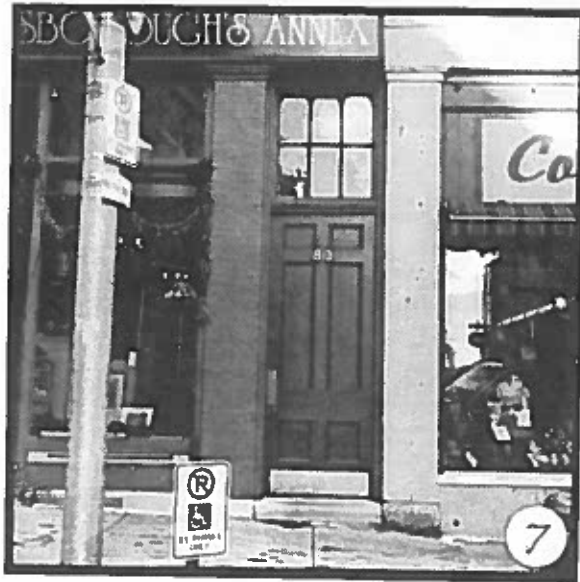
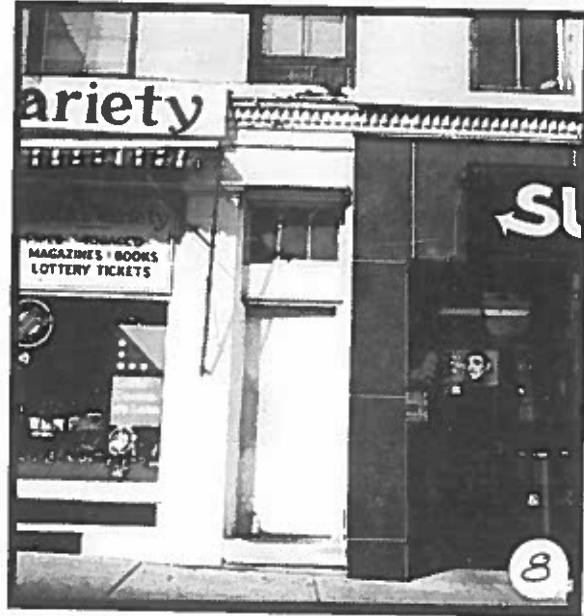
Entrances continued

5. Entrance to upper floors of Block 4, Section (a) with simple divided transom above, but door renewed.
6. Handsome side entrance to Block 10 Section (e).
7. Original side entrance with door restored to east side of Section (b) of Block 18 of 1867.
8. Another side entrance to Block 18 in Section (d) where divided transom survives in part, but door has been replaced.

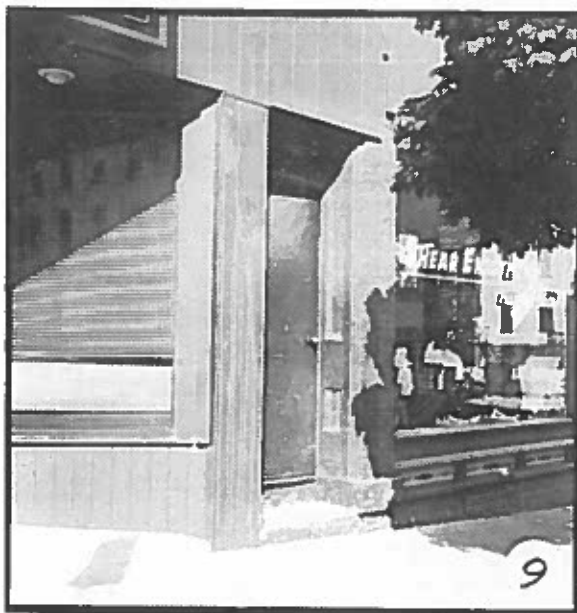
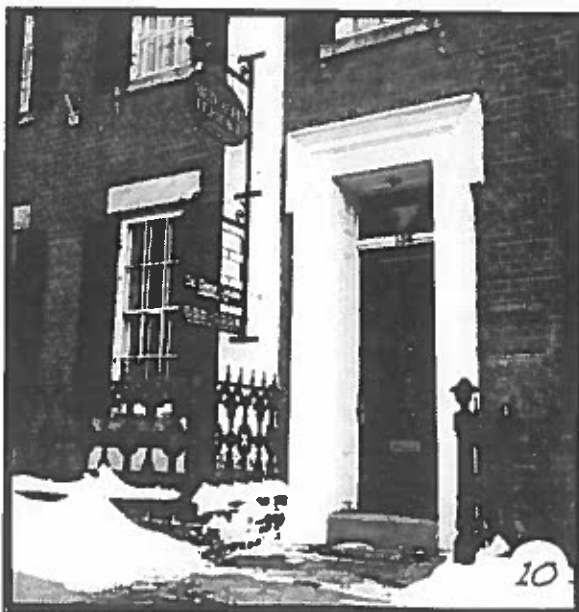
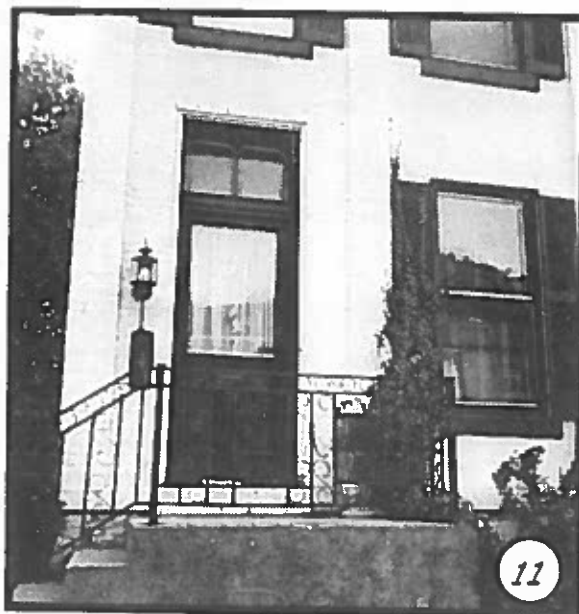
Entrances continued

9. Tantalizing fragment of detail in panelled reveal to much altered side entrance to Section (b) of Block 22: possible starting point for restoration of original, the panel heights indicating the same in the door.
10. Greek Revival doorcase to Block 36, Section (b) with panelled reveal, transom and door with glazed upper section probably replacing earlier moulded panels.
11. Entrance to Block 55, with door altered to provide glazed panel.

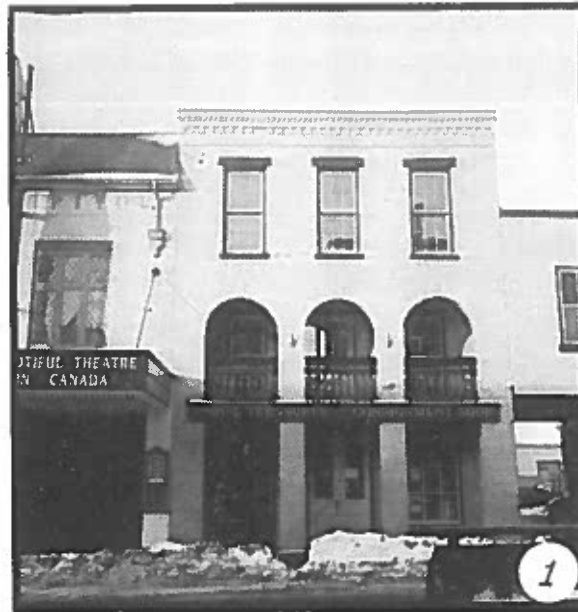
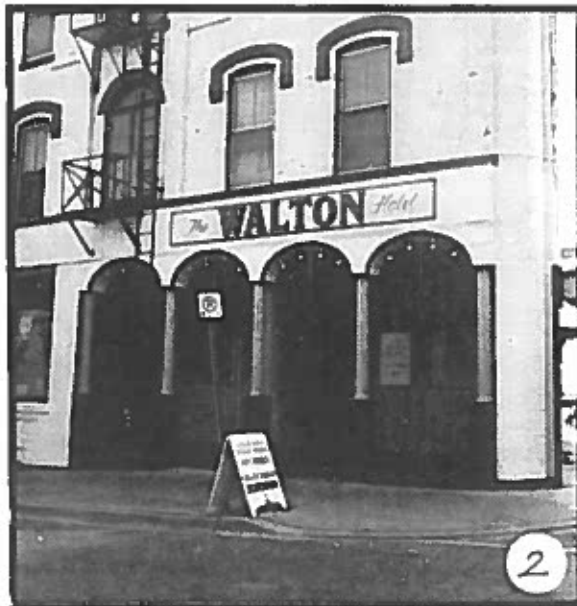
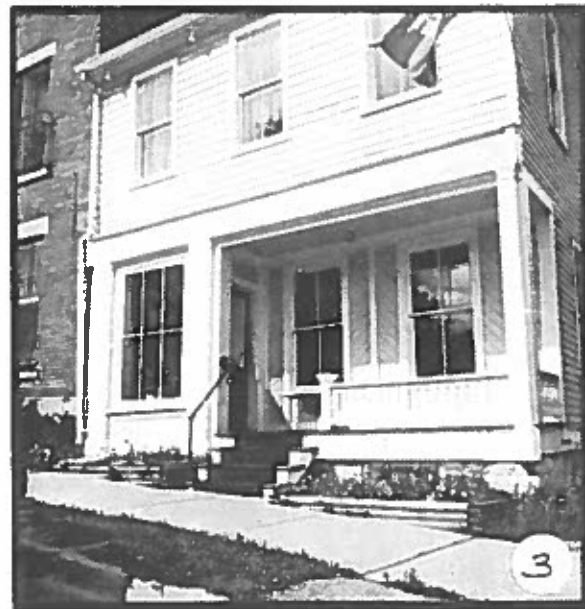
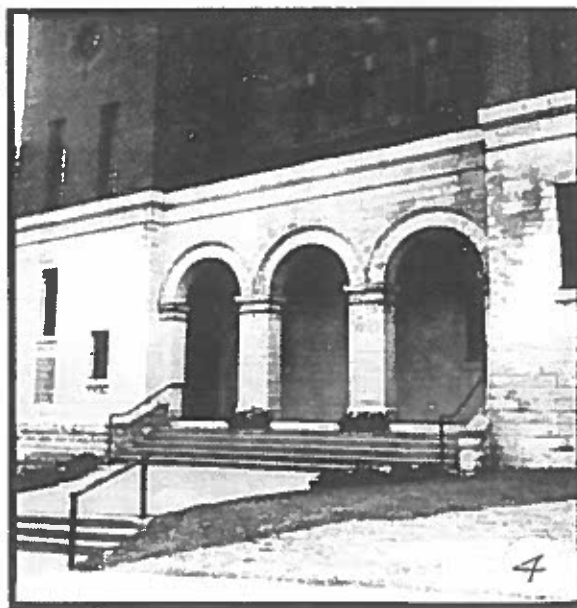
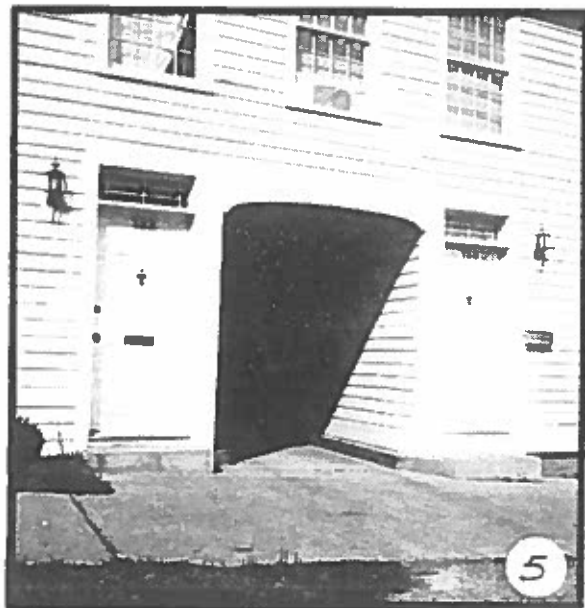
PORCHES AND VERANDAHS

1. Arcaded two-storey building, recently restored, and believed to have been built as a hotel, on west side of Queen Street adjoining rear wing of Block 11. Block 6 at the head of Queen, also originally a hotel, once had an elegant arcaded lower storey of five round-arched openings.
2. Arcaded umbrage protecting main entrance to hotel in Block 31.
3. Umbrage to Block 32, believed created later from a pilastered lower storey comprising an earlier shopfront.
4. Arcaded porch sheltering entrances at base of towers of St. Paul's Presbyterian Church of 1906, (Block 51), the lower storey finished in cast stone.
5. Arched carriageway to rear courtyard of Block 42.

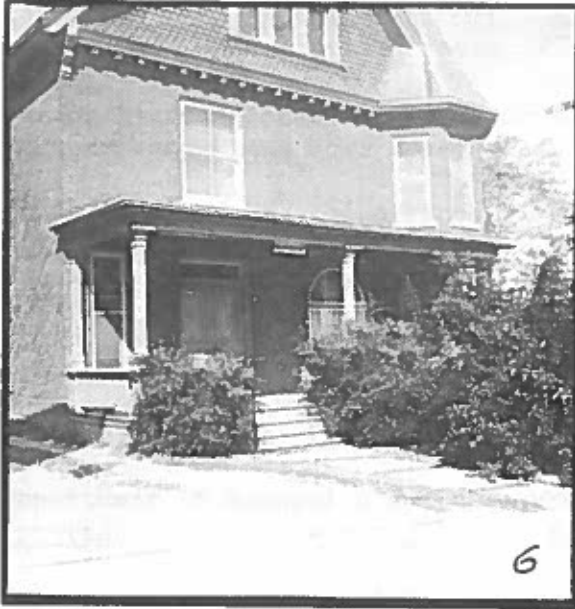
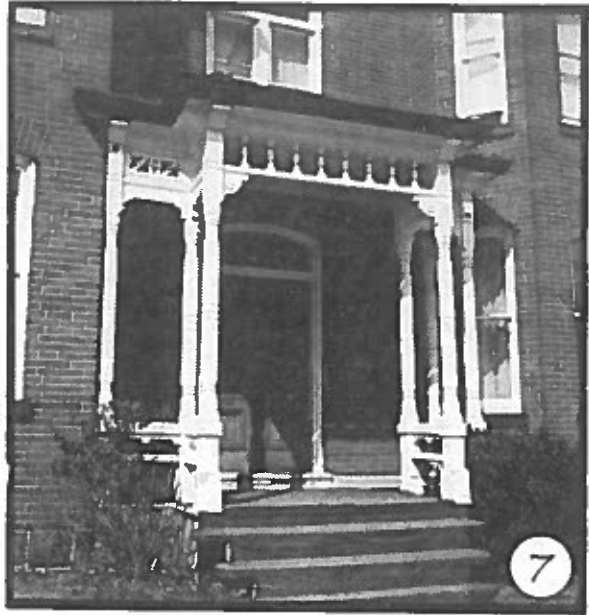
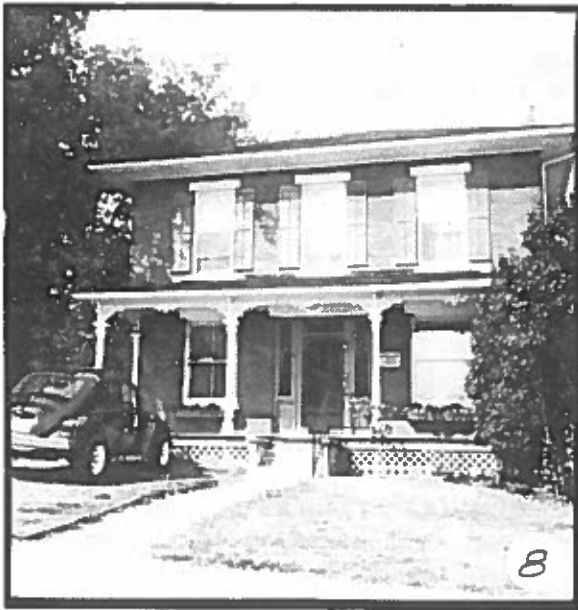
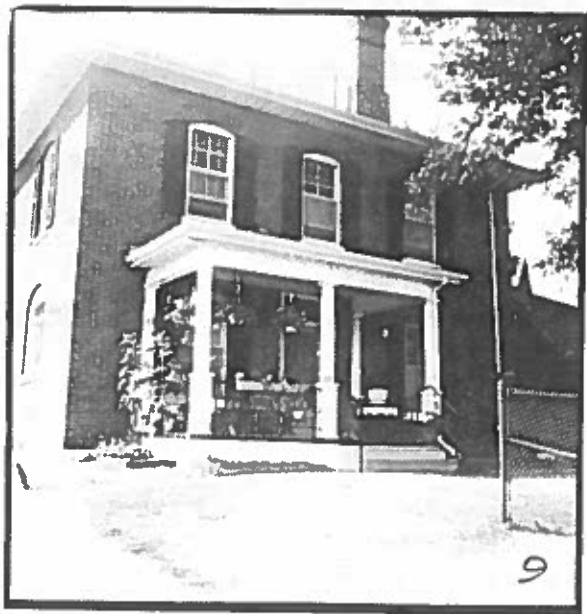
Porches and Verandahs continued

6. Verandah to Block 30, c. 1895.
7. Entrance porch to Block 30, showing spindlework frieze.
8. Verandah to Block 50.
9. Porch sheltering entrance to Block 52.

Block 30 is a high style late Victorian house in an open landscaped lot holding its own as a landmark of upper Walton Street. The building exhibits all the frills and furbelows of the Queen Anne Revival in bracketed tiled pediments to gables, octagon corner tower sporting a likewise faceted conical roof and round-head lower storey window with stained glass transom.
